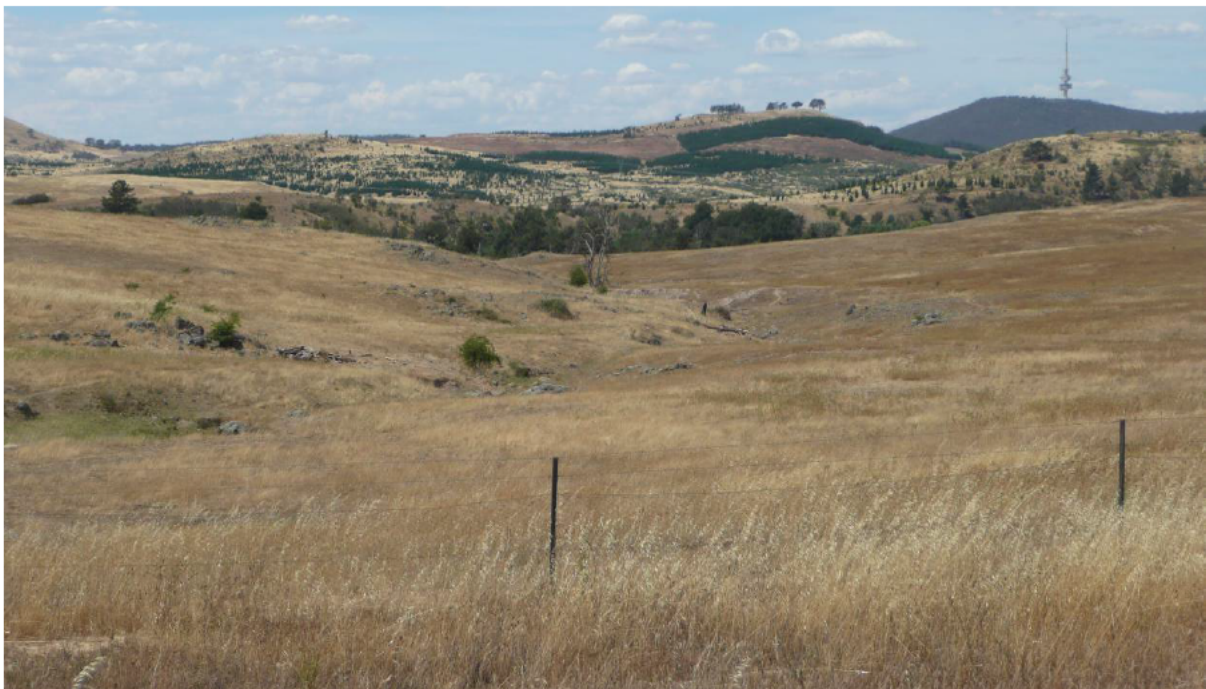
Holdens Creek draining to Molonglo River - grazed area in foreground, pine regrowth and plantations on hills in distance

The western or downstream part of the study area has been, and continues to be grazed by stock. Adverse impacts associated with stock grazing (which are generally not associated with grazing by native animals) typically include:

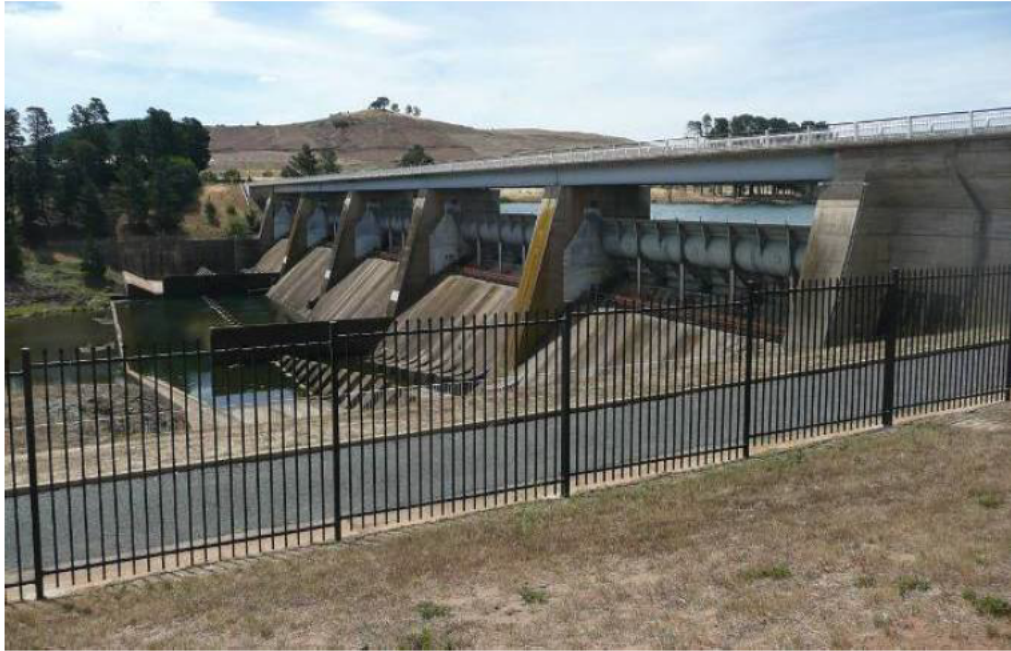
Scrivener Dam upstream of the study area (January 2010)

The study area is part of the Lower Molonglo River corridor, which is defined as the river downstream of Lake Burley Griffin. The Lake was created following construction of Scrivener Dam across the Molonglo River in 1963. Water flow in the river is regulated by the dam.

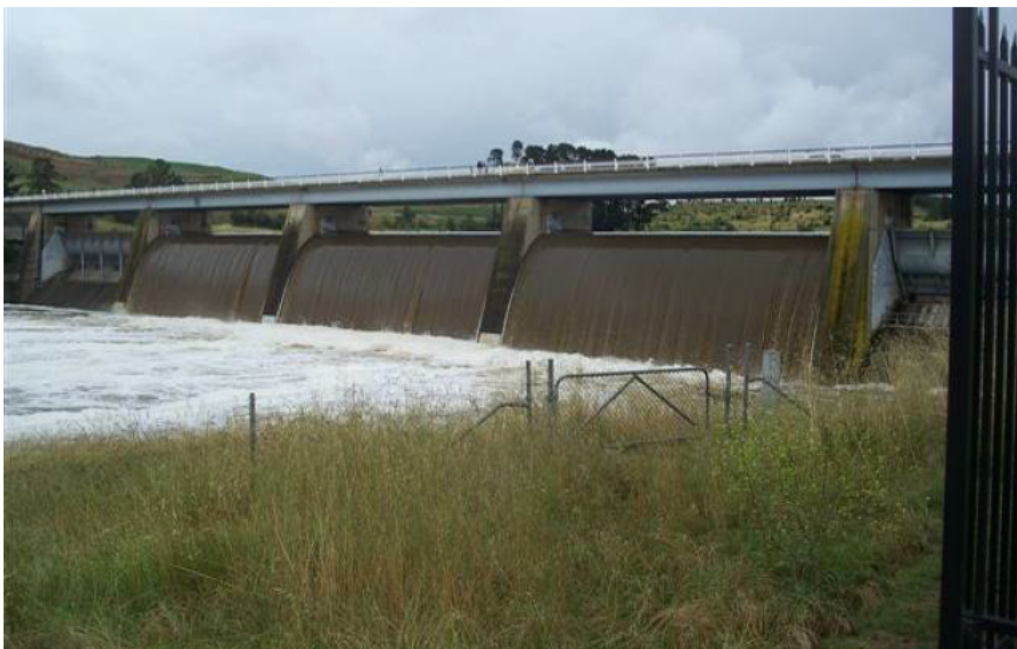
Scrivener Dam – three floodgates open following heavy rain in December 2010

The Territory Plan codes do not allow for swimming in the Molonglo River because of poor water quality (refer to **Section 2.4**) and the variable water level following rainfall or release from the dam. Water is not typically released from the dam unless there is heavy rainfall upstream. Rapid increase in water level in the river can also be associated with rainfall in the catchment.

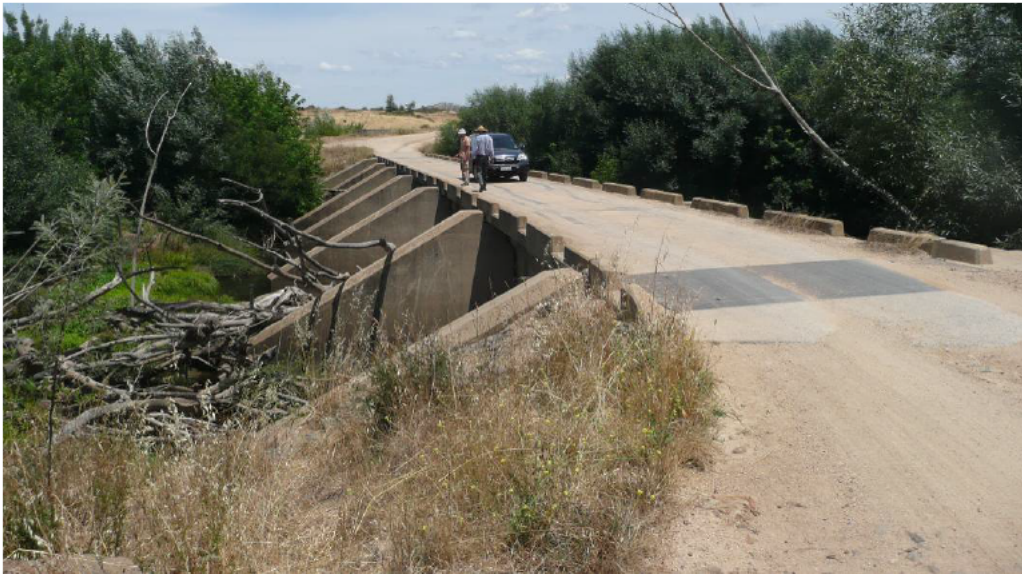
Clos Crossing

There are two locations where the tracks cross the river – Clos Crossing and Southwell's Crossing. Both are concrete structures, although only Clos Crossing is wide enough to allow a car across.

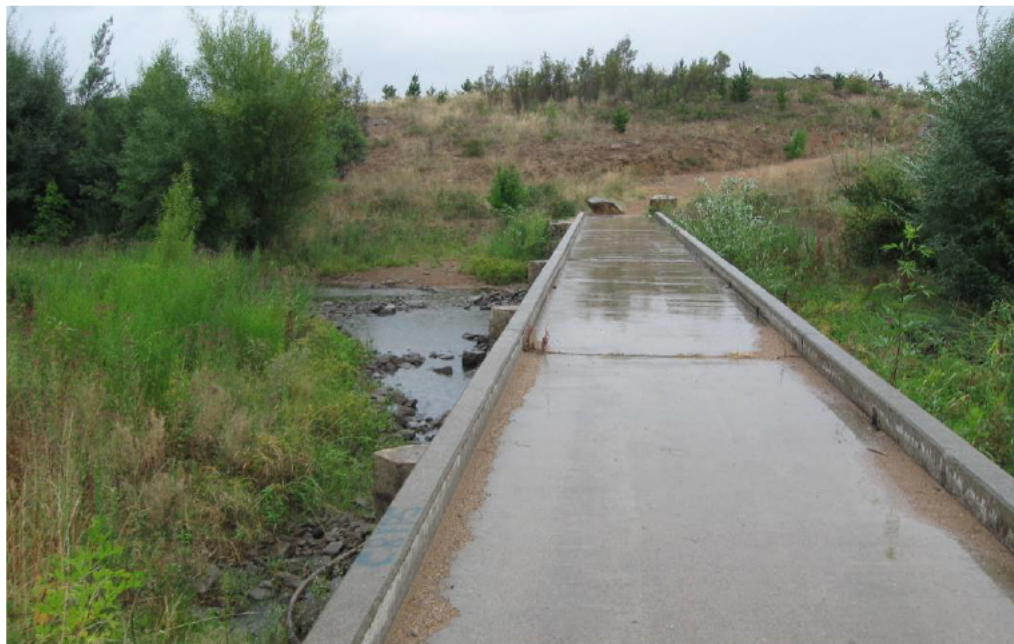
Southwells Crossing

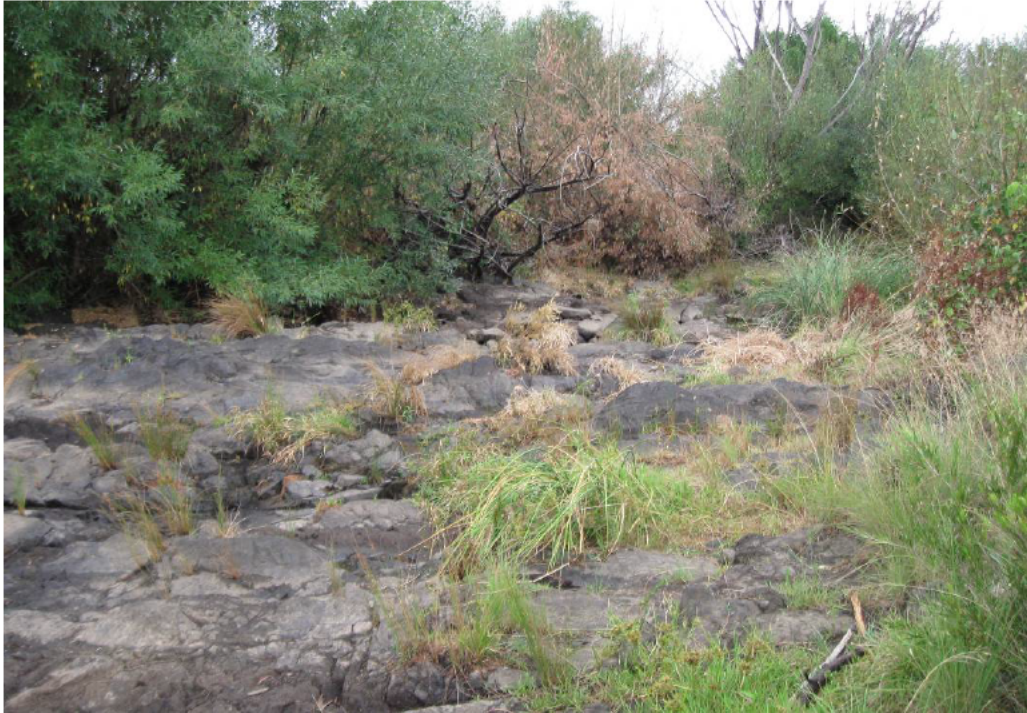
Dry rocky crossing immediately upstream of large pool (see photo on following page)

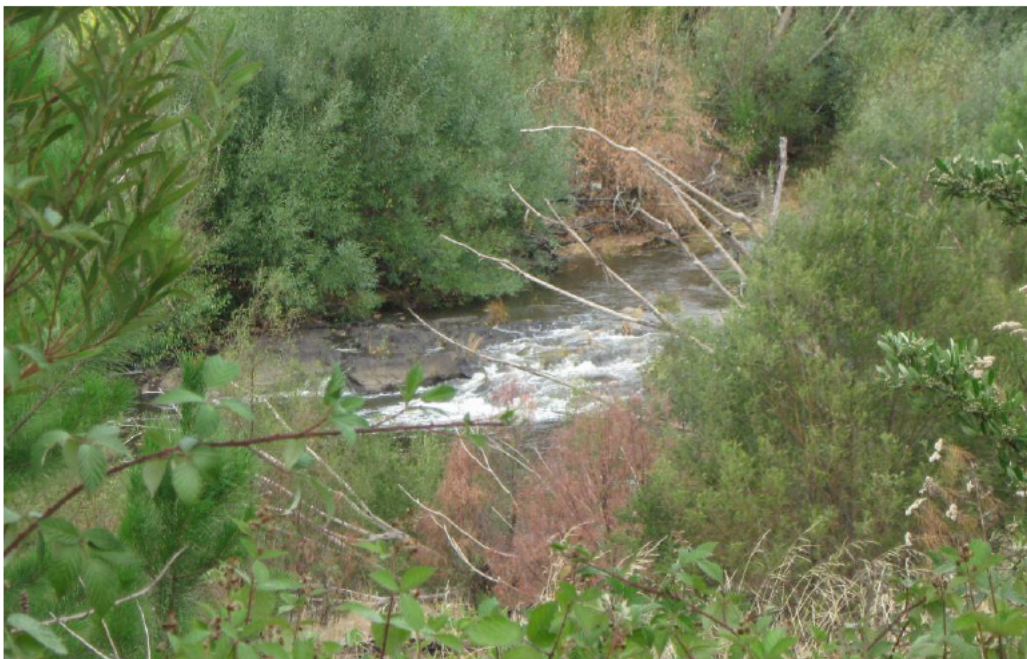
Rocky crossing under water later the same day following rain upstream

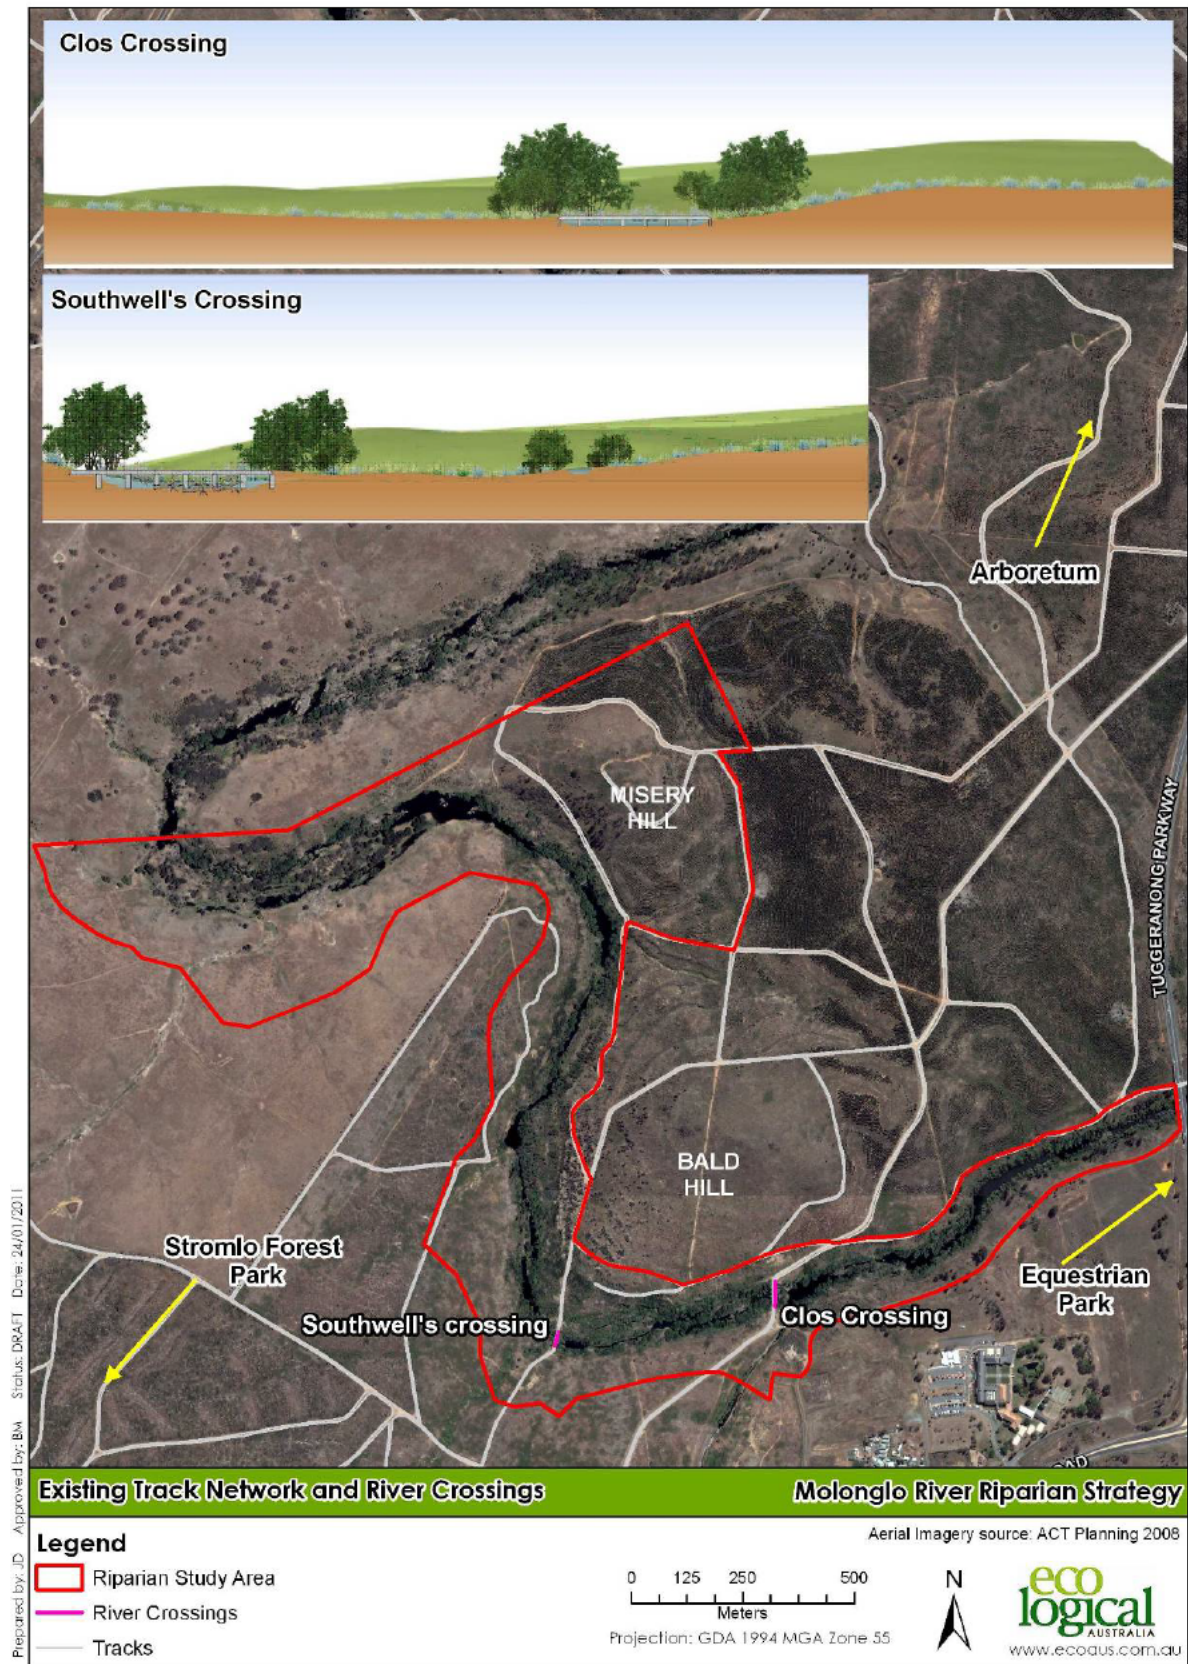
Figure 4: Existing track network and river crossings

Unsealed tracks throughout the area (shown in **Figure 4**) are used for recreational activities such as horse and mountain bike riding, walking, cross-country running, orienteering and recreational off-road vehicle use. The tracks provide linkages with Stromlo Forest Park, the Arboretum and Equestrian Park. The main tracks through this area are part of the Bicentennial National Trail, which is a 5,330 km marked route along the Great Dividing Range of eastern Australia.
