Charnwood Group Centre Stage 1 Site Investigation Report

**Environment, Planning and
Sustainable Development
Directorate (EPSDD)**

14 August 2024

JPS Engineering Consultants

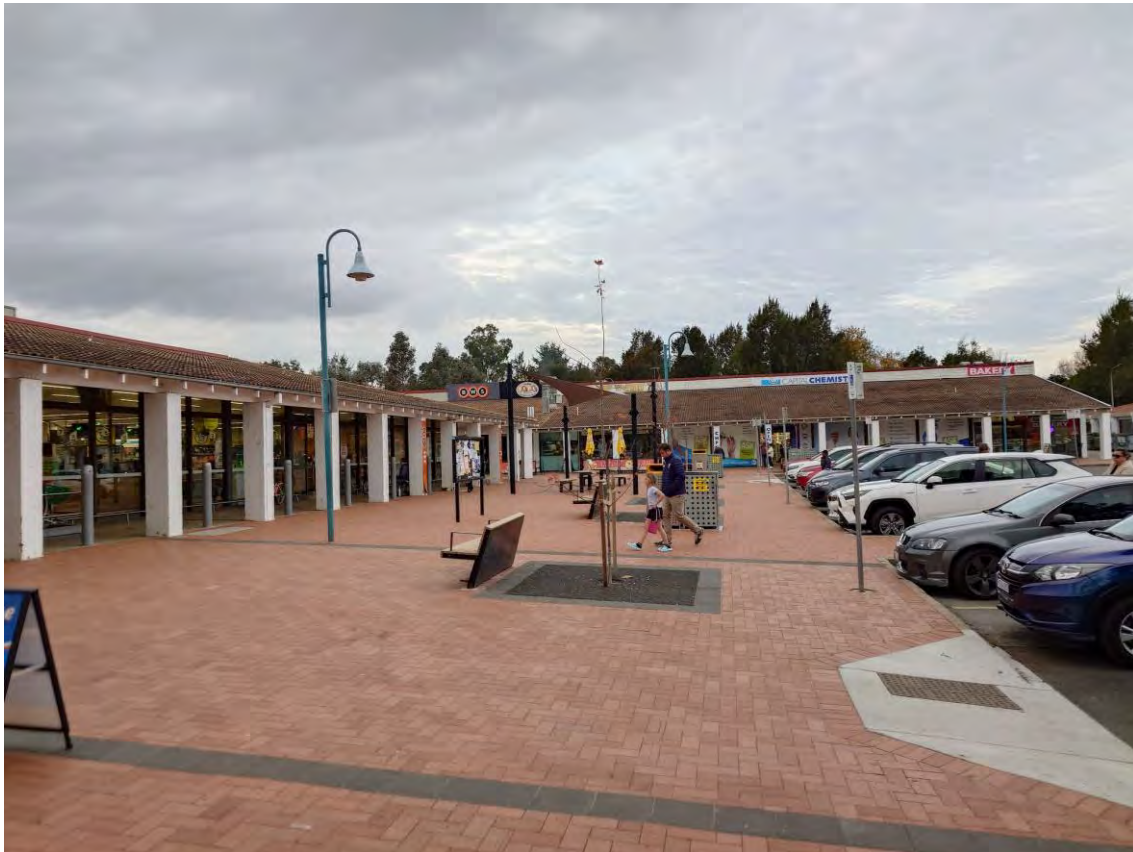
Figure 8 – General Site Photo of Group Centre

The photos taken in Figure 8, Figure 9, Figure 10, Figure 11, and Figure 12 provide a general overview of the group centre from different visual aspects. The photos show the site's condition, current infrastructure, topographical features, car parks, and some of the existing trees present within and surrounding the site. See also Figure 13, which is an ACT Government container deposit collection facility, north of the western car park.

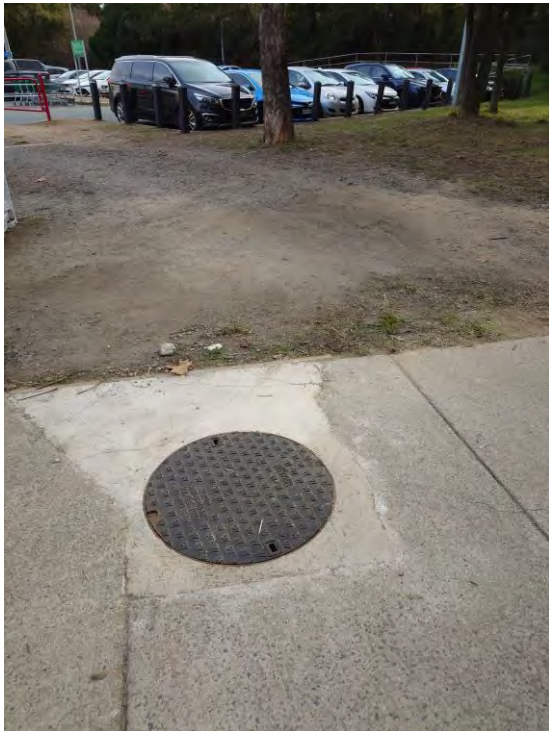
Figure 15 – Sewer Manhole over DN300 Main North of Charnwood Place (west)

- The western most blocks in the group centre drain toward a DN300 trunk sewer main that runs through the western car park. All blocks connect to a DN150 main before branching into the DN300 main. Refer to Figure 15, Figure 16, Figure 17, and Figure 19 for photos of the manholes that were identified over the DN300 main in the western car park.

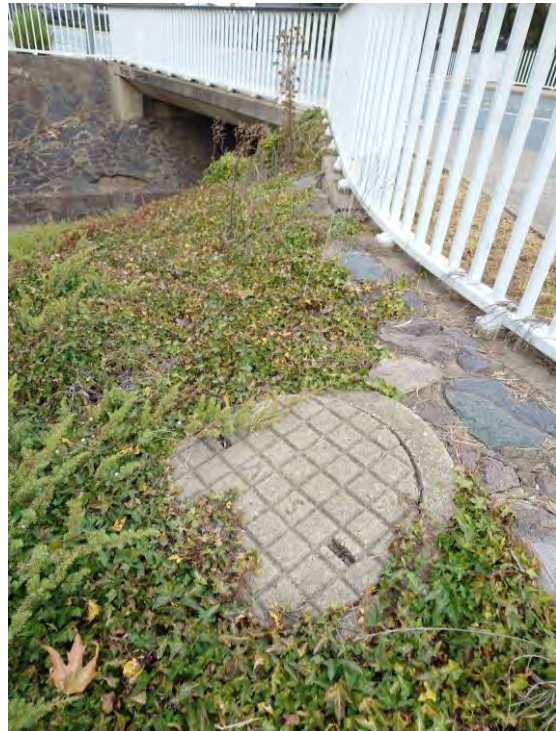
Figure 21 – Sewer Manhole at DN300 and DN525 Junction in Lhotsky Street

- The DN300 sewer main in the western car park continues south in the east verge of Charnwood Place (west) and connects to the aforementioned DN525 sewer main in the northern verge of Lhotsky Street. Just prior to its connection to the DN525, the DN300 main crosses through the open space area – Block 11 Section 95. Figure 20 is a photo of a manhole over the DN300 sewer main in the open space block and the photo in Figure 21 is the manhole where the DN300 main connects to the DN525 sewer in Lhotsky Street.

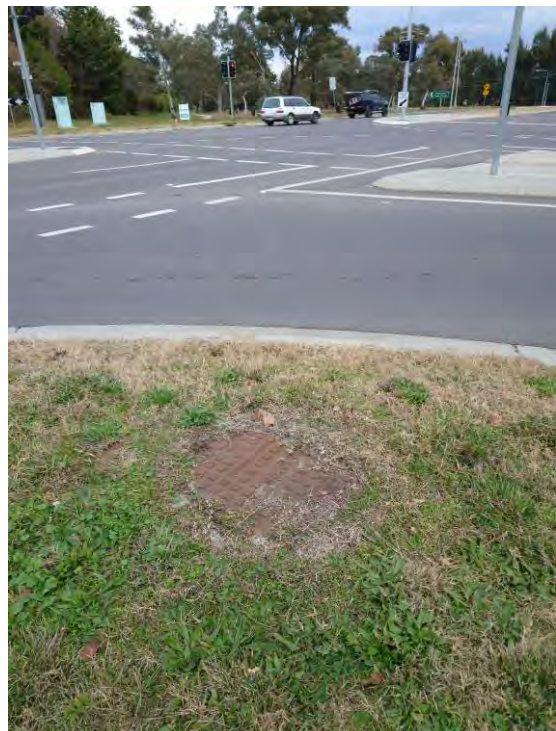
Figure 22 – Sewer Manhole over DN300 Main at Intersection of Lhotsky Street and Tillyard Drive

- Beyond Lhotsky Street, this DN300 sewer main upsizes to a DN600 trunk sewer. See Figure 22 for a photo of the manhole at the intersection of Lhotsky Street and Tillyard Drive where the DN300 main upsizes to a DN600 main.

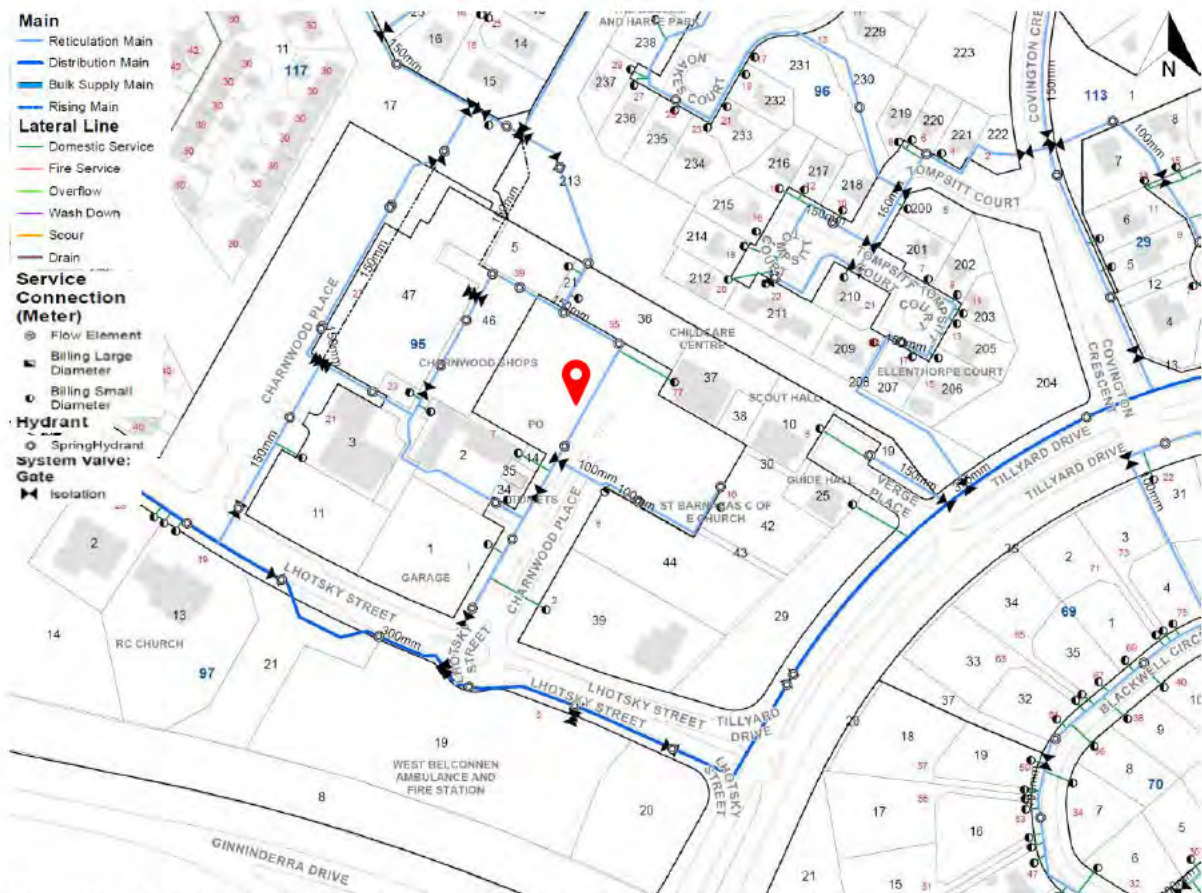
Figure 26 – Existing Water Infrastructure Near the Subject Site (Icon Water, 2024)

For further details on existing water infrastructure surrounding the subject site, refer to Figure 26, which is extracted from the Icon Water BYDA information.

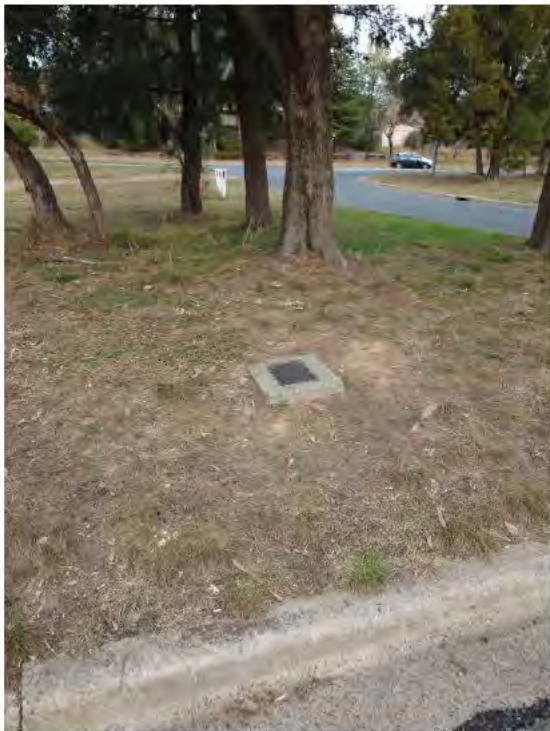
Figure 27 – Existing Fire Hydrant on Dead End DN150 in Verge Place

- A service connection to Block 25 Section 95 directly connects to the DN375 main.
- A DN150 main branches off the DN375 in the northern verge of Verge Place to provide service to Block 10 Section 95. This DN150 main terminates with a hydrant. See Figure 27 below for a photo of this hydrant in Verge Place.

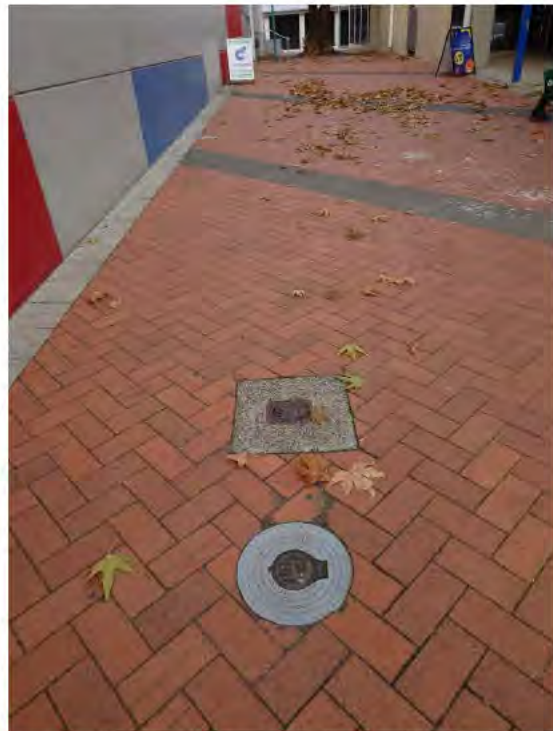
Figure 28 – Fire Hydrant and Stop Valve on DN150 Main Near Charwood Place (west)

- A DN150 main runs along the east verge of the west car park and Charnwood Place (west), connecting to a DN150 water network in the residential areas northwest of the site and to a DN300 distribution water main in the southern verge of Lhotsky Street. Two double hydrants are located on the DN150 main in Charnwood Place (west), with hydrant spacing between 35 and 60 metres along the main. Refer to Figure 28, Figure 29, Figure 30, and Figure 31 for photos of hydrants and stop valve on this DN150 main in Charnwood Place (west).

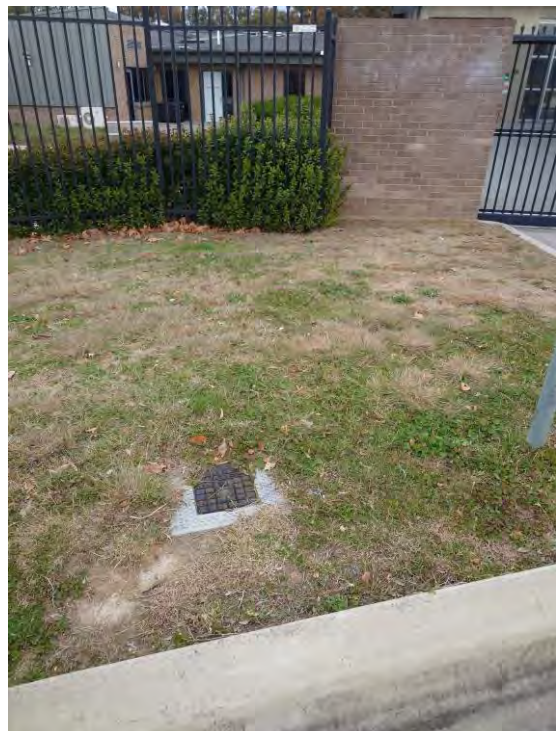
Figure 32 – Fire Hydrant on DN300 Main in Lhotsky Street

- The DN300 distribution main in the southern verge of Lhotsky Street is generally situated behind the kerb line, although it deflects and lowers adjacent to the Lhotsky Street underpass. Hydrant spacing on this trunk main ranges from 45 to 55 metres. The photos in Figure 32, Figure 33, and Figure 34 show hydrants and valves over this DN300 main.

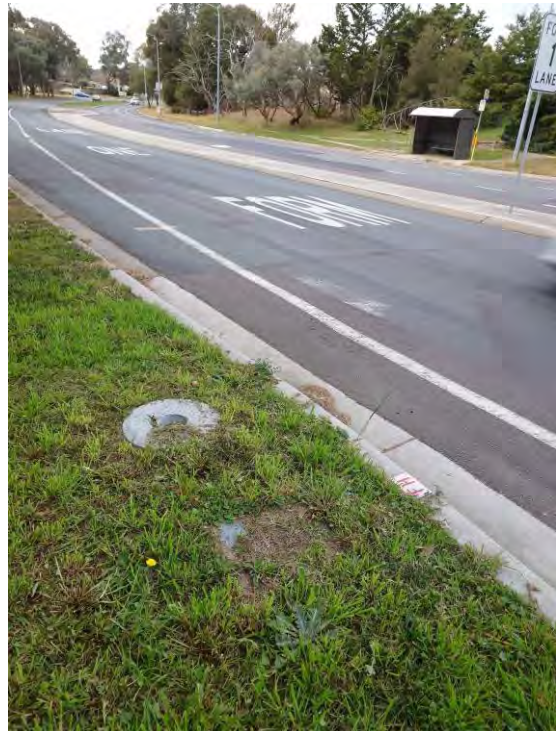
Figure 35 – Existing Fire Hydrant and Stop Valve on DN375 Main in Tillyard Drive

- A DN375 distribution water main is located within the west verge of Tillyard Drive, connecting at a 90 degree bend to the abovementioned DN300 main at the intersection of Tillyard Drive and Lhotsky Street. There is one set of double hydrants on this main adjacent to the subject site. The nearest hydrant to the north is approximately 170 metres away, and the nearest hydrant on Lhotsky Street is approximately 75 metres from these double hydrants. Figure 35 below shows a photo of the hydrant and valve arrangement on this DN375 main in Tillyard Drive.

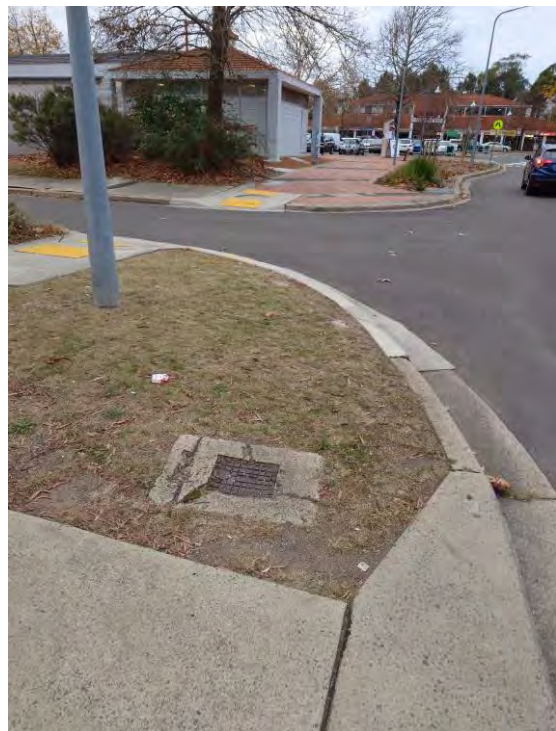
Figure 36 – Fire Hydrant in Charnwood Place (east)

- A DN100 and DN150 water main network loops around the central area of the group centre, with a connection to the DN300 main in Lhotsky Street. This main heads north in the west verge of Charnwood Place (east), then loops around the car park, connecting to the DN150 main in the western car park and north to the residential mains. Most blocks within the group centre have a service off this loop main. Hydrant spacing along this looped main ranges from approximately 15 to 85 metres, however, they are generally between 45 and 50 metres. Various hydrants and valves on this central looped main are provided in Figure 36 to Figure 42, below.

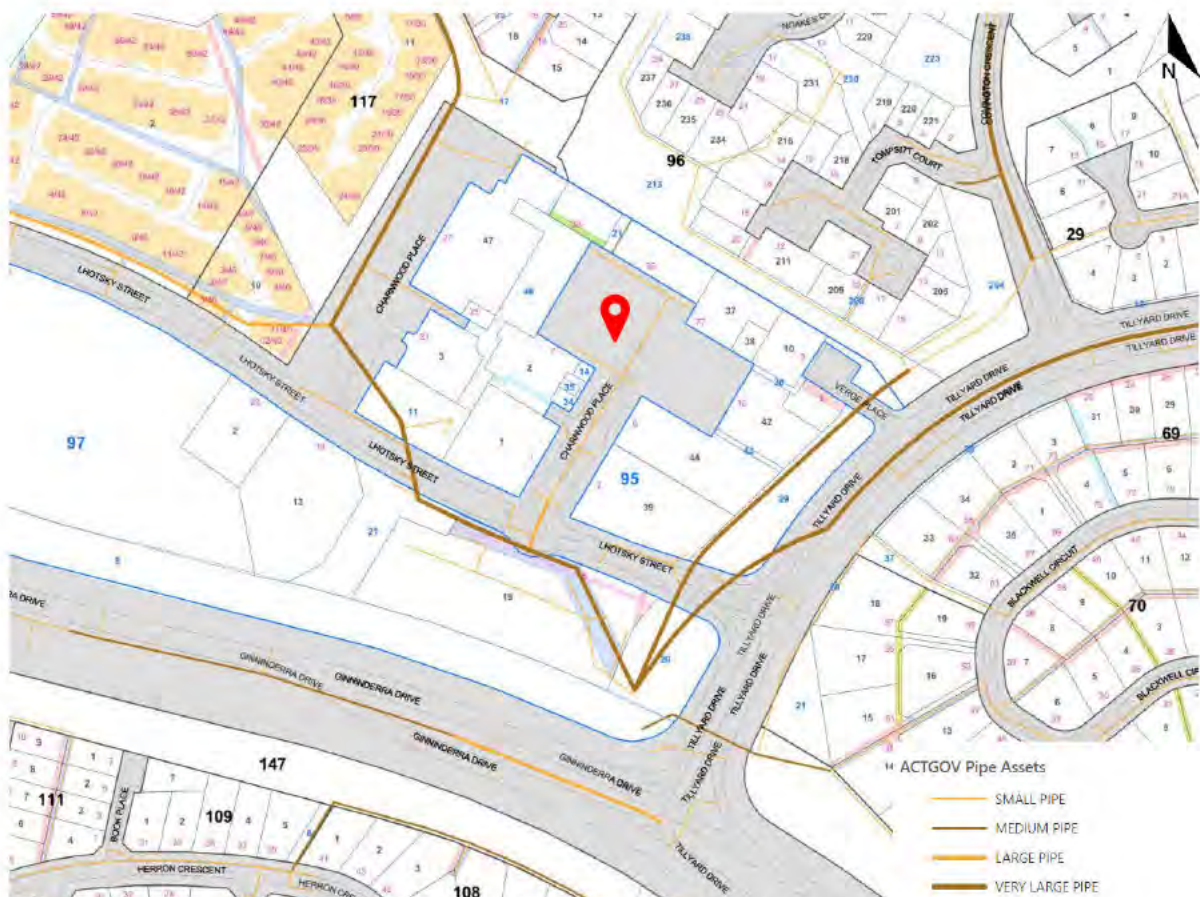
Figure 43 – Existing Stormwater Infrastructure in Proximity of the Site (ACTmapi, 2024)

This extensive stormwater infrastructure ensures effective drainage for the site and the surrounding areas, managing large volumes of stormwater from the contributing catchments. The northern catchment is directed into a series of plantation sumps, as observed during a site inspection. Some of these can be seen in Figure 44, Figure 46, and Figure 47, along the northern border of the subject site.

For visual reference, see ACTmapi map extract provided in Figure 43 below. This map displays the indicative positions of these stormwater pipes (depicted in orange and brown linework) and drainage easements in blue. The combination of these elements contributes to the existing stormwater infrastructure in the vicinity of the subject site.

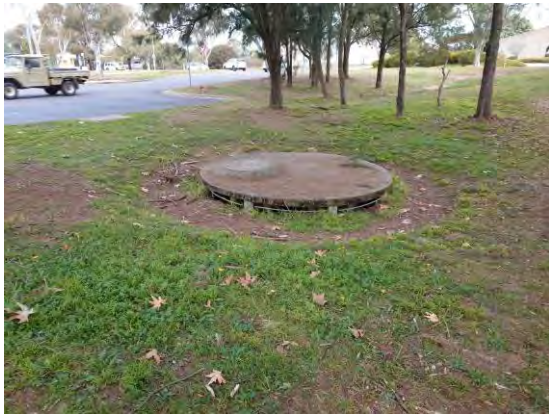
Figure 49 – Inlet/Surge Structure at Junction of DN1350 and DN1800 Pipes (west)

- A DN1350 stormwater pipe located in the west verge of Charnwood Place (west) drains a significant catchment to the northwest of the site. This DN1350 pipe crosses Charnwood Place (west) and passes through the open space block (Block 11 Section 95), where it upsizes to a DN1800 pipe. See Figure 49 below for a photo of an inlet/surcharge structure at the junction of the DN1350 and DN1800 pipes.

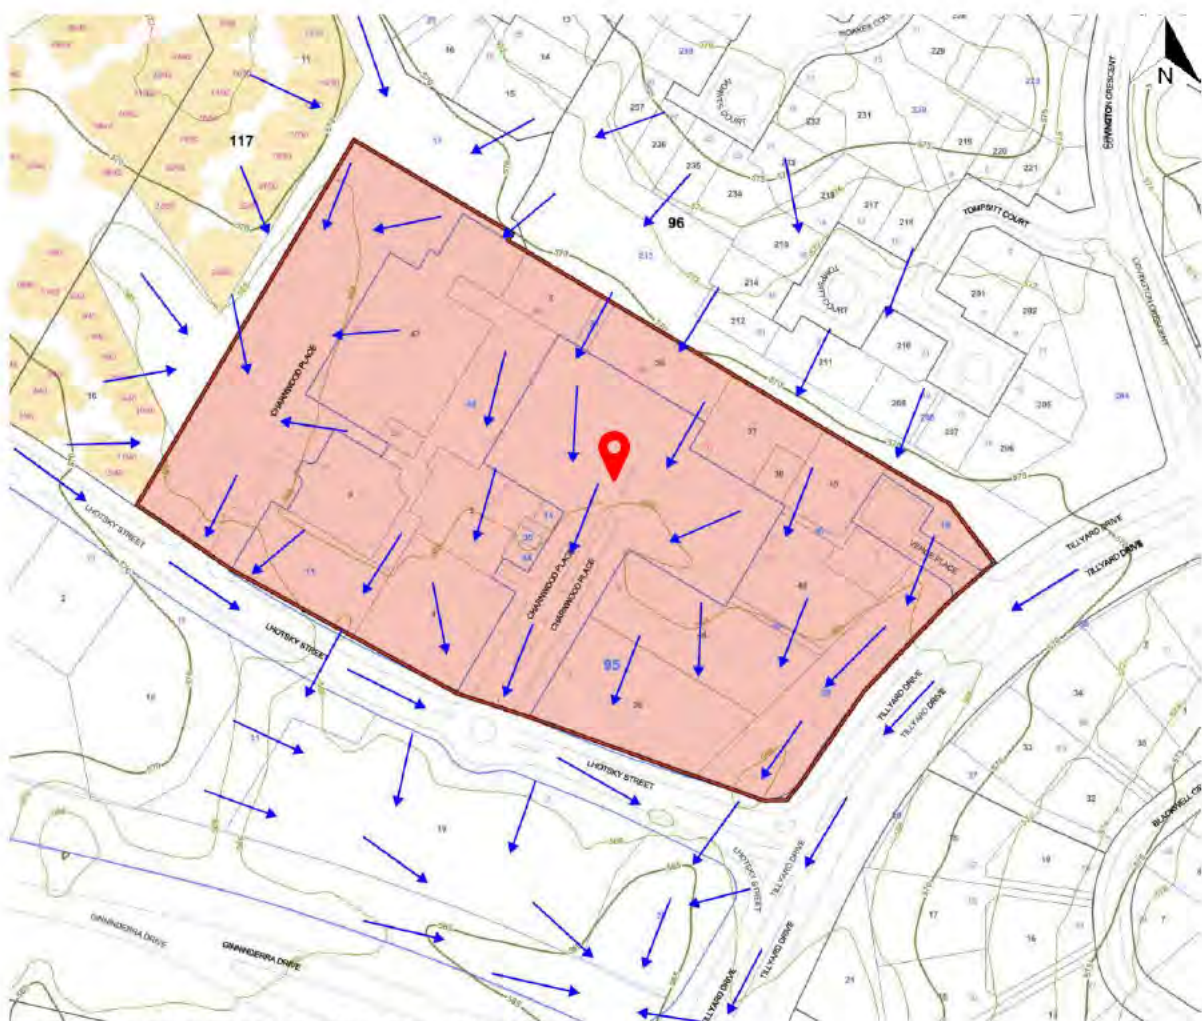
Figure 53 – Stormwater Overland Flow Diagram

Refer to Figure 53 for an indication of the stormwater overland flow directions within and surrounding the subject site depicted with blue arrows.

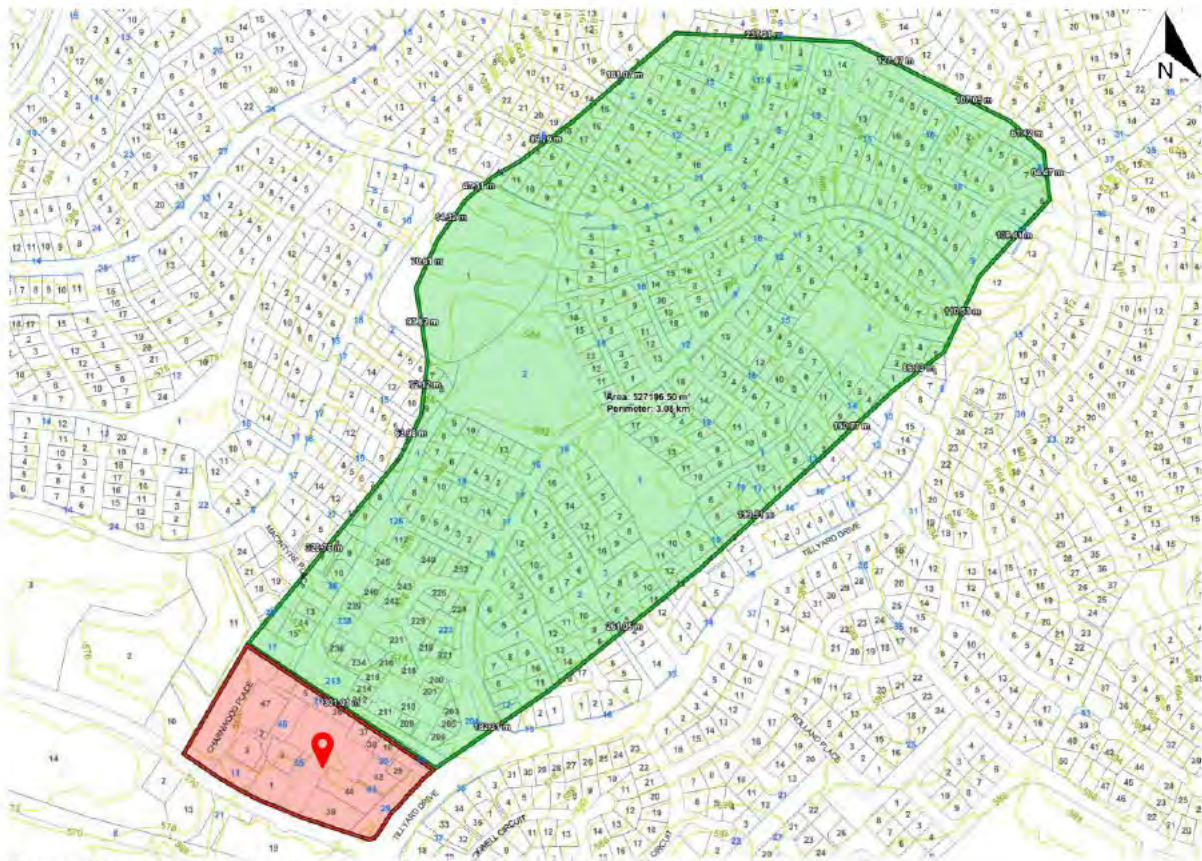
Figure 54 – Stormwater Catchment in Relation to Subject Site

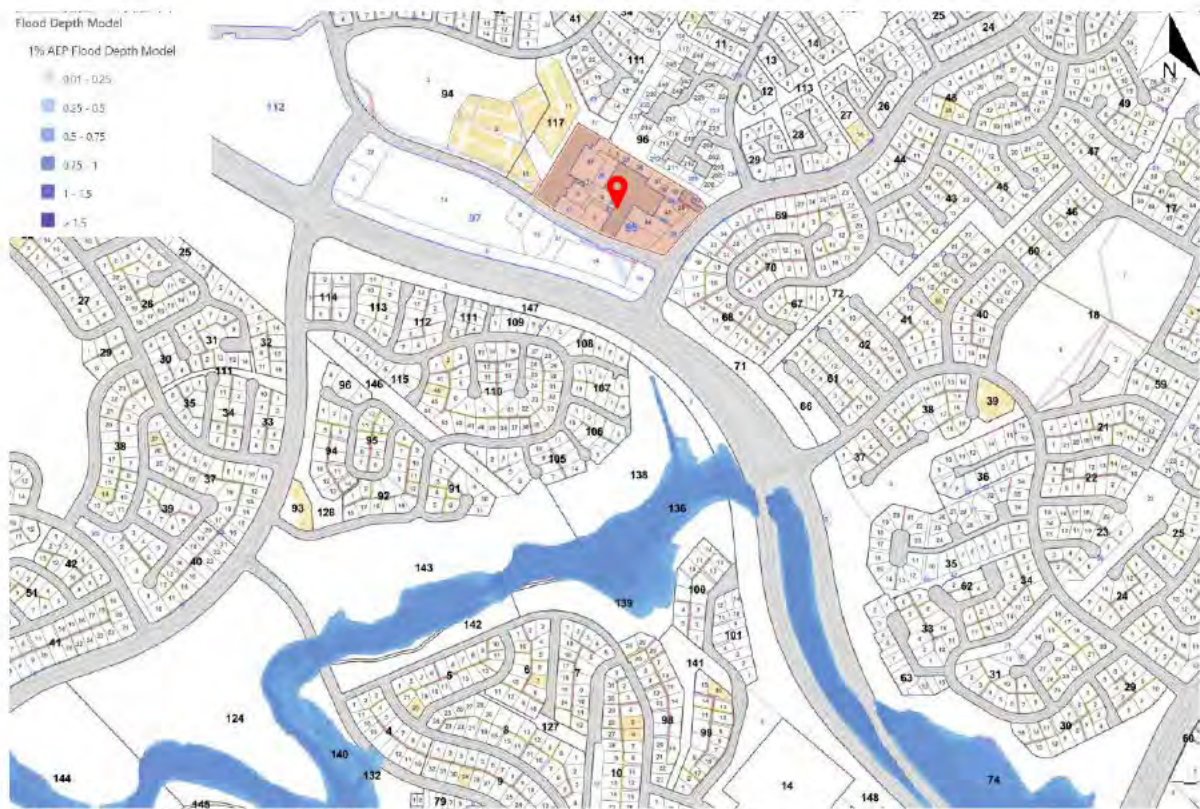
Figure 55 – 1% AEP Flood Extent and Waterways (ACTmapi, 2024)

The current flood mapping on ACTmapi indicates that the subject site is situated away from the 1% Annual Exceedance Probability (AEP) flood modelling footprint. Refer to Figure 55 for an image of the 1% AEP flood extent that is located to the south west in relation to the subject site's location, shown in red highlight and red place marker.

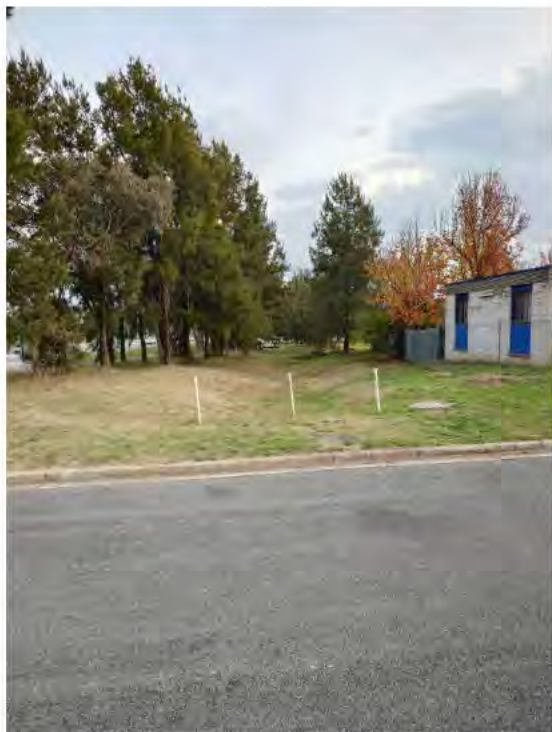
Figure 56 – Stormwater Swale through Block 29 Section 95 Looking South

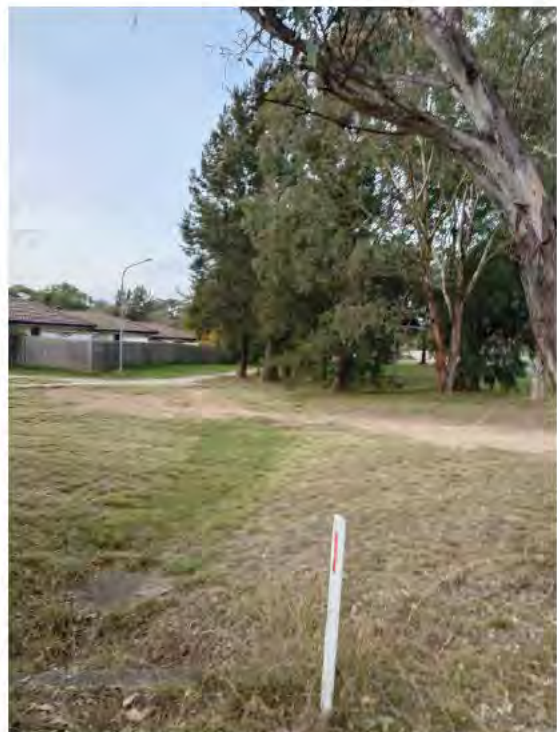
Figure 57 – Stormwater Swale and Plantation Sump North West of Site

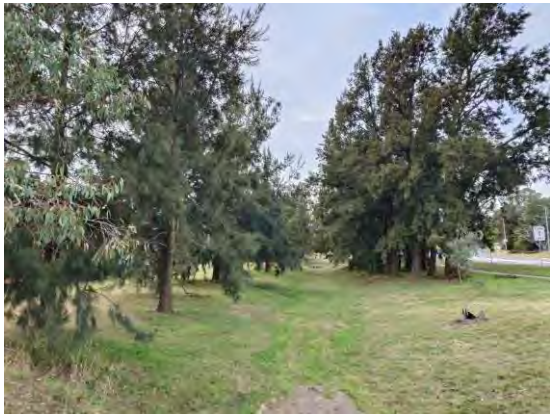
Figure 58 – Stormwater Swale in Block 29 Looking North

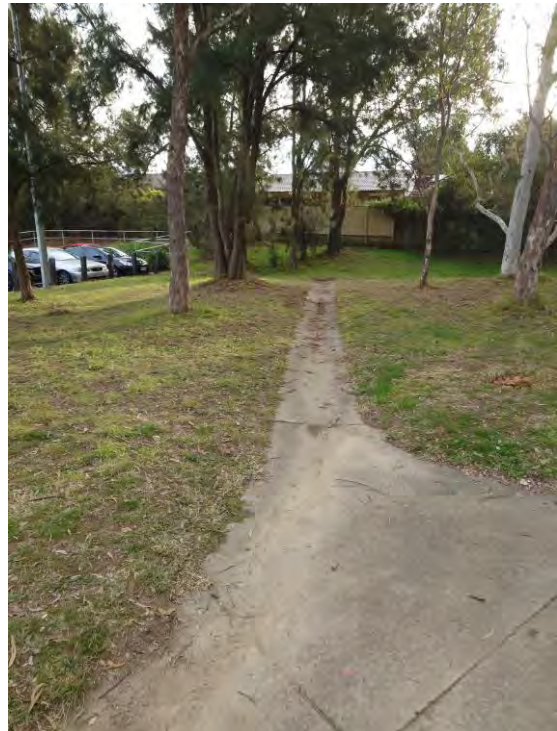
Figure 60 – Stormwater Swale and Concrete Invert North West of Site

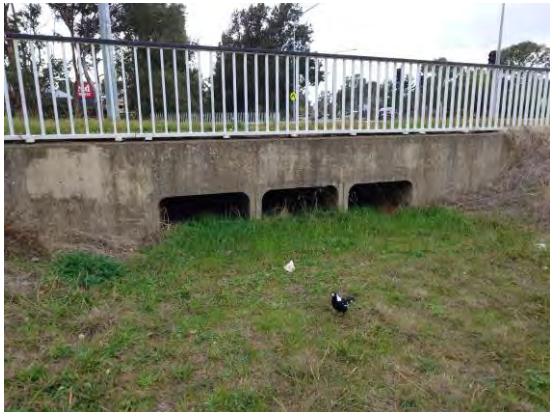
Figure 59 – Stormwater Box Culverts under Lhotsky Street

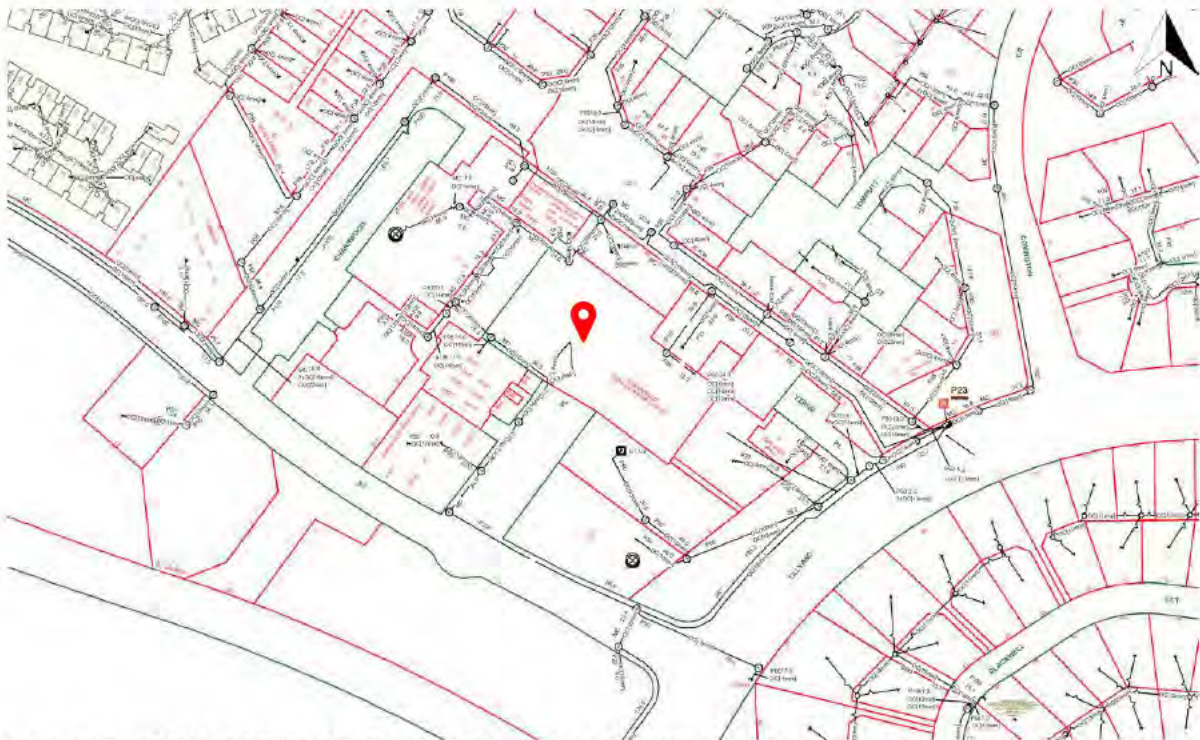
Figure 62 – Telstra BYDA Information in Proximity of the Subject Site (Telstra, 2024)

Refer to Telstra BYDA information that has been produced from digital data provided in Figure 62 below.

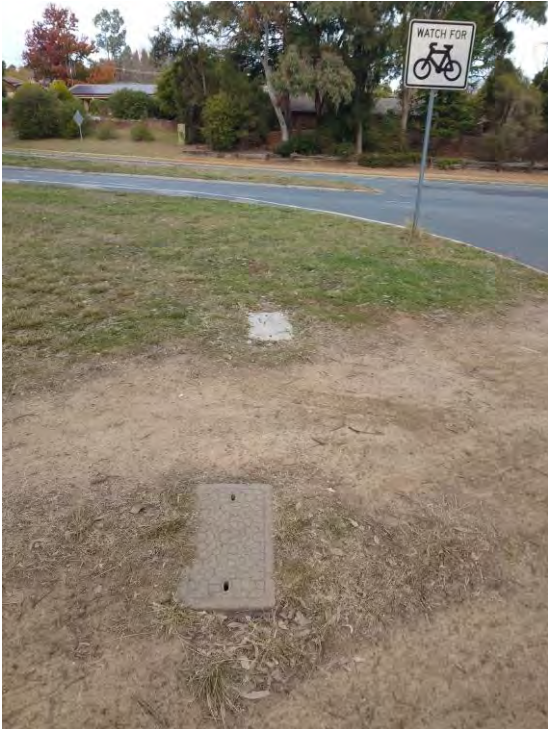
Figure 63 – Telstra Pit at Intersection of Tillyard Drive and Verge Place

Figure 63 and Figure 64 are photos of Telstra pits over the twin P50 runs near Tillyard Drive and Verge Place. Figure 70 to Figure 74 show Telstra pits observed in Lhotsky Street and in and around the central Charnwood Place (east) group centre fully paved verge.

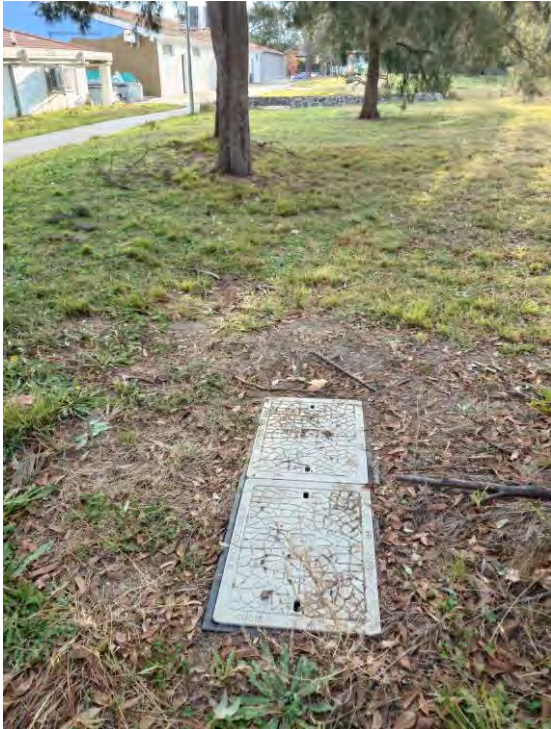
Figure 65 – Telstra Pit North of Subject Site Block 36 Section 95)

See below Figure 65, Figure 66, Figure 67, Figure 68, and Figure 69 for pits over these abovementioned A100 Telstra conduits in Charnwood Place (west), north of the site and between Blocks 3 and 47.

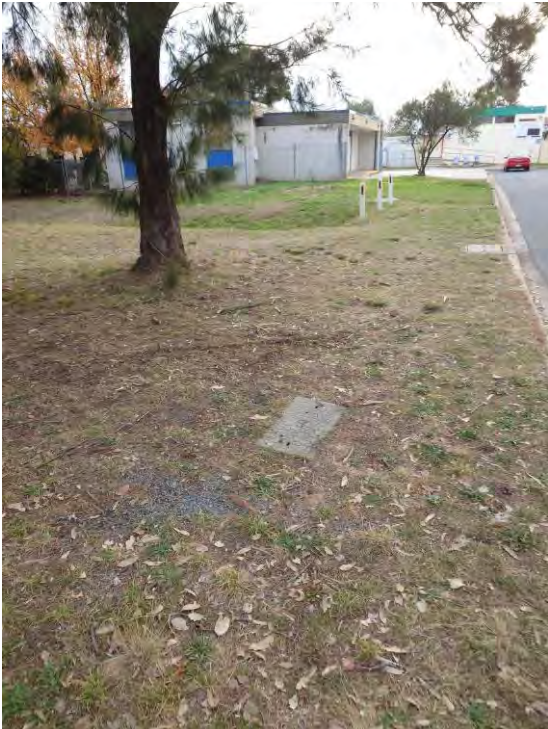
Figure 64 – Telstra Pit in Verge Place

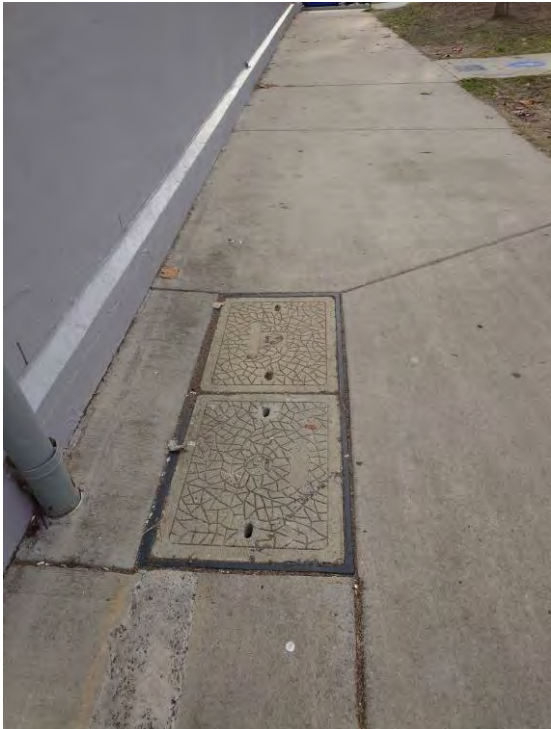
Figure 66 – Telstra Pit North of Site

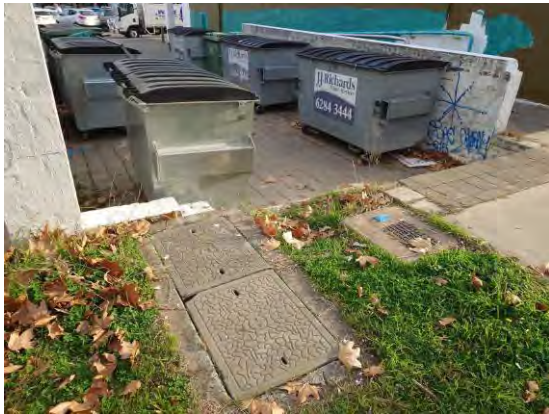
Figure 67 – Telstra Pit in Charnwood Place (west)

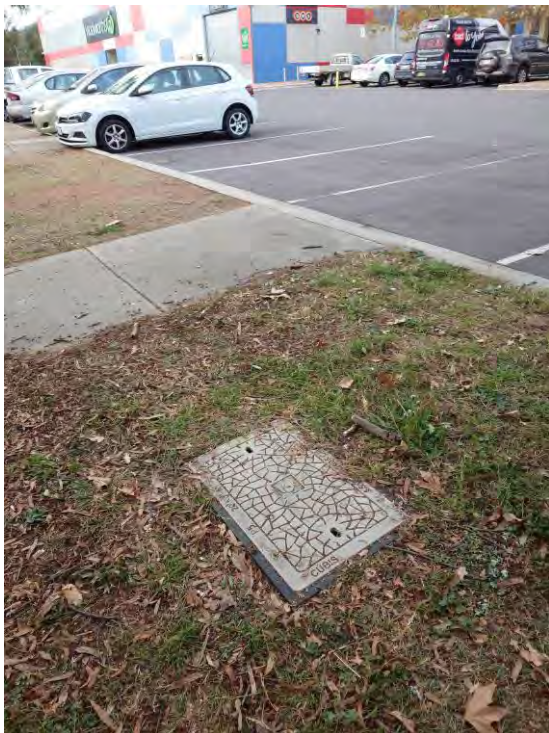
Figure 68 – Telstra Pit in Charnwood Place (west)

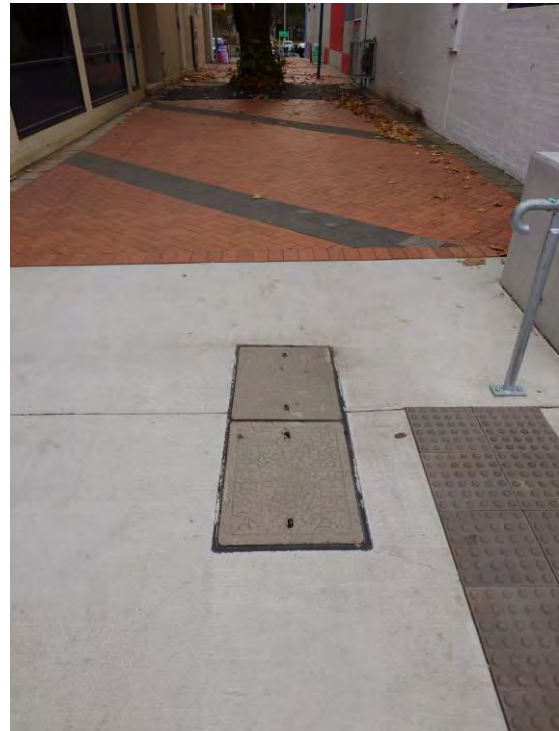
Figure 69 – Telstra Pit Between Block 3 and 47 Section 95

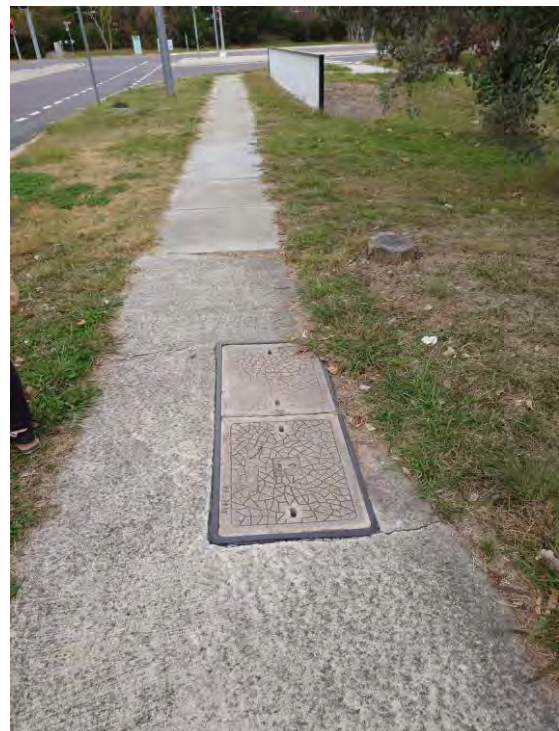
Figure 70 – Telstra Pit in Lhotsky Street South Verge

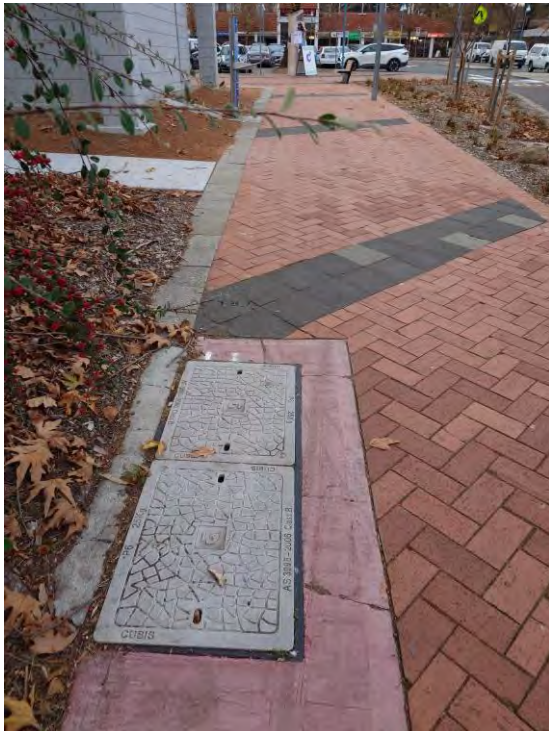
Figure 71 – Telstra Pit in Charnwood Place (east) West Verge

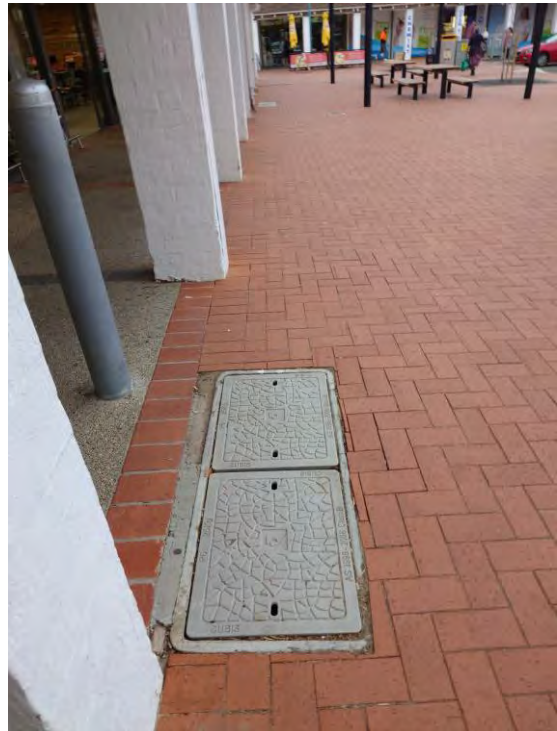
Figure 73 – Telstra Pits in South West Central Car Park

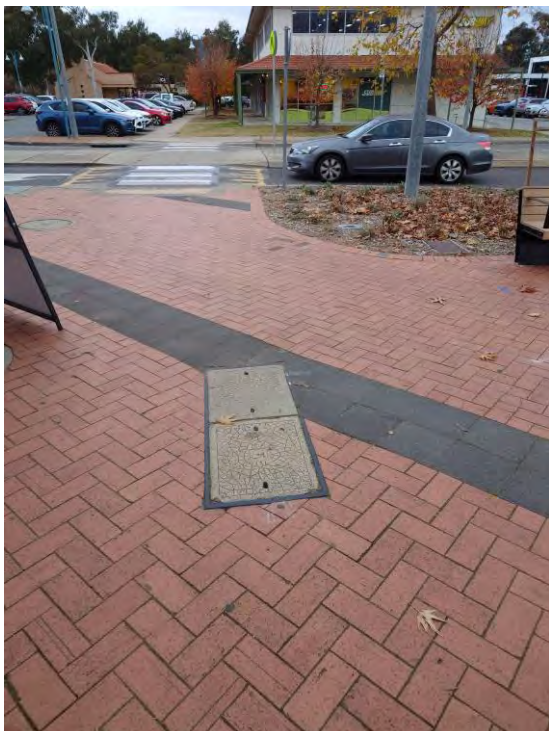
Figure 72 – Telstra Pit in South West Central Car Park

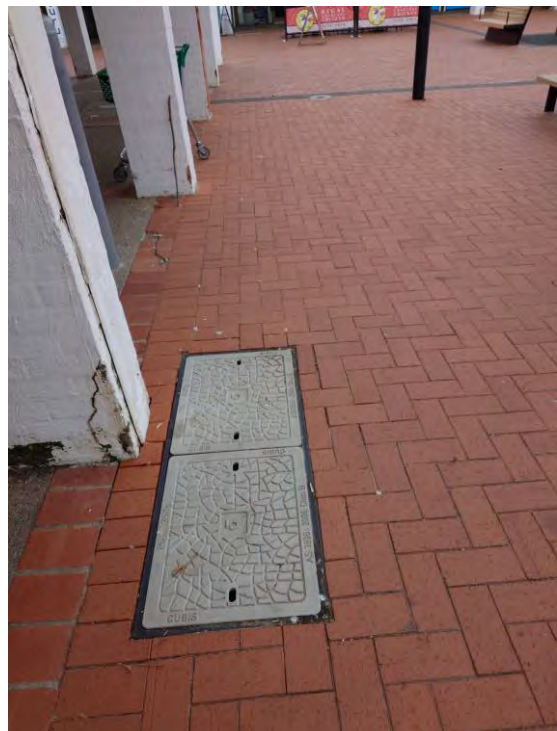
Figure 74 – Telstra Pit in West Central Car Park

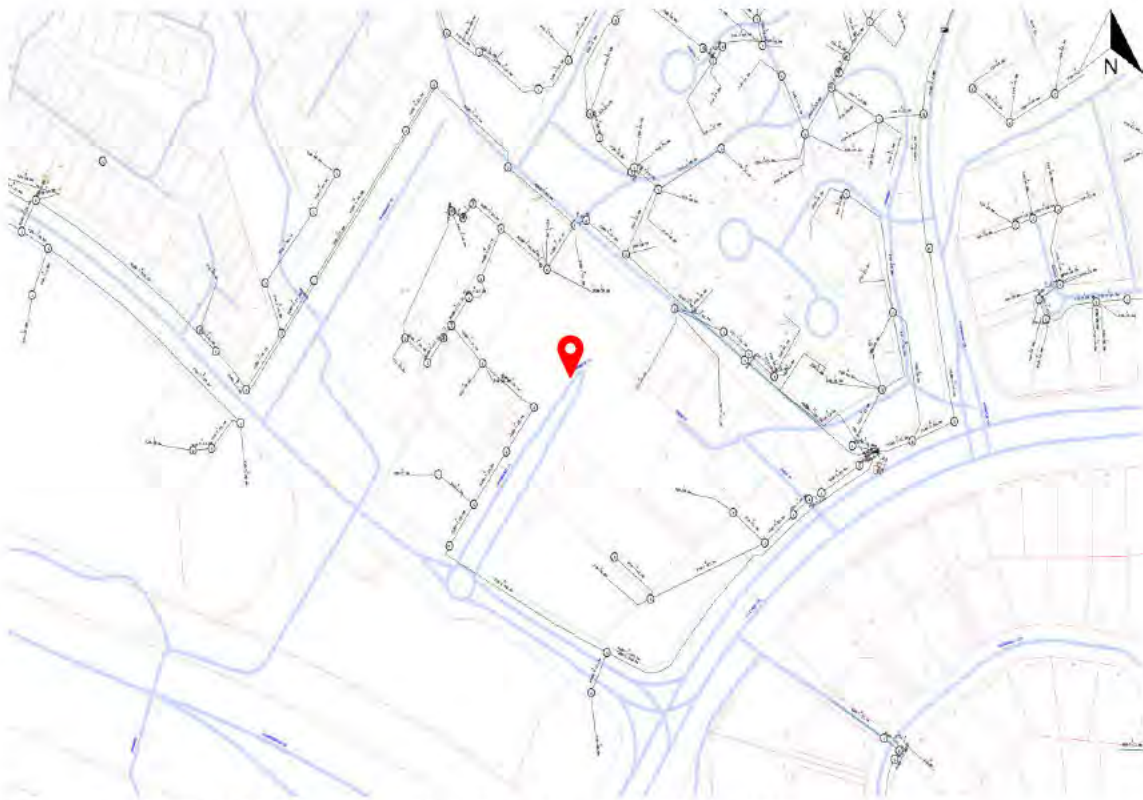
Figure 75 – NBN BYDA Information Near the Subject Site (NBN, 2024)

The BYDA information also shows that NBN services are currently installed independent of the Telstra conduits to Block 47 Section 95 (Woolworths).

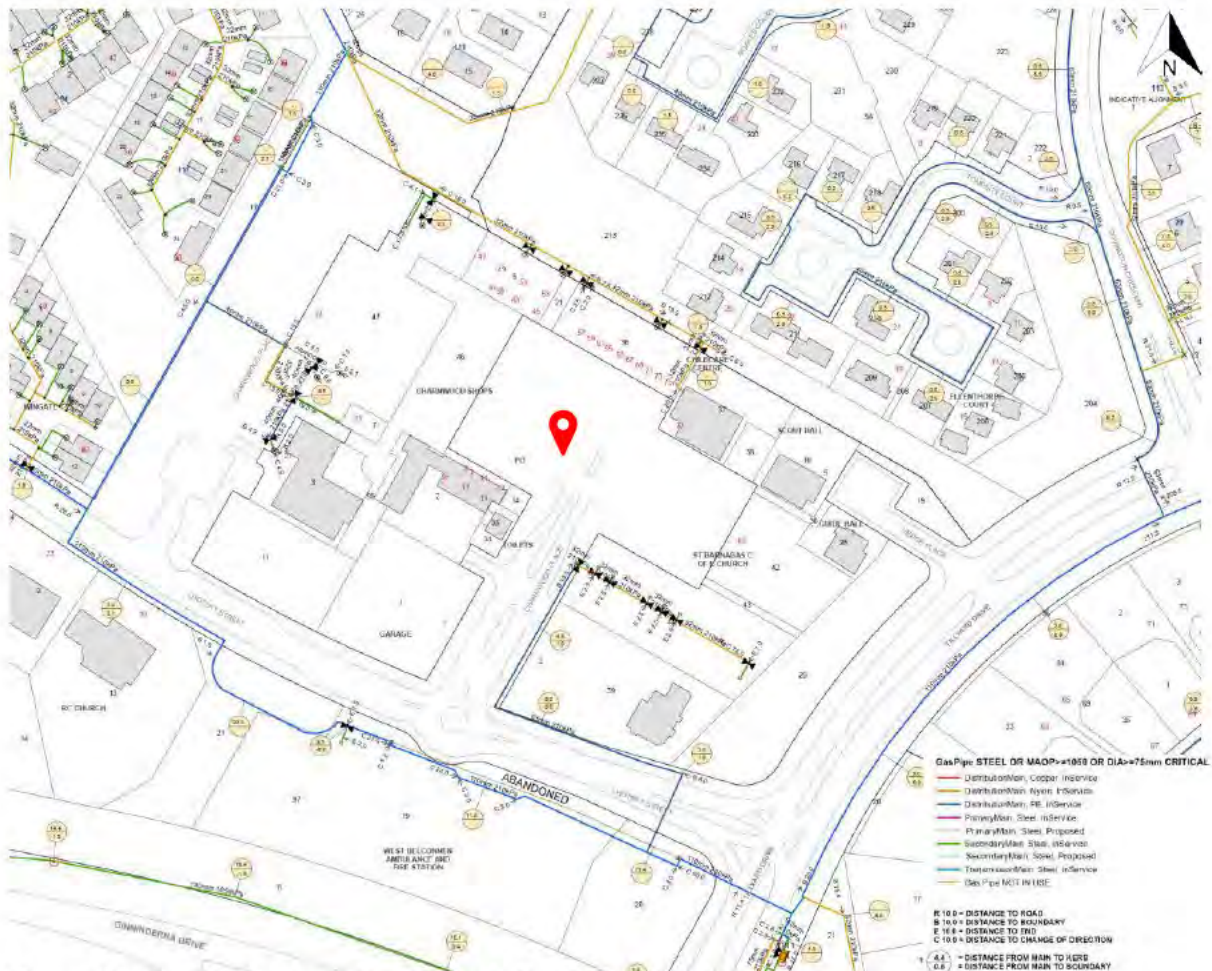
Figure 77 – Gas BYDA Information in Proximity of the Subject Site (Evoenergy, 2024)

For a visual representation of these gas main locations and their proximity to the subject site, refer to Figure 77 below, which is an excerpt from the BYDA information.

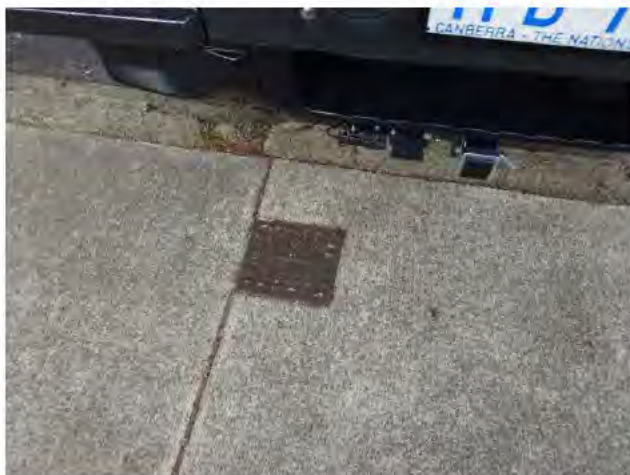
Figure 78 – Gas Marker in Charnwood Place (east)

- A DN63 210kPa polyethylene distribution gas main connects to the DN110 gas main in Lhotsky Street within Block 20 Section 97, then crosses Lhotsky Street and continues west in the northern verge of Lhotsky Street toward Charnwood Place (east). This DN63 main continues north in the east verge of Charnwood Place (east) and provides services to commercial developments in Block 44 Section 95 via a DN32 210kPa nylon gas main and service ties. A photo of a gas marker over the main that is within Charnwood Place (east) near Block 44, is given in Figure 78 below.

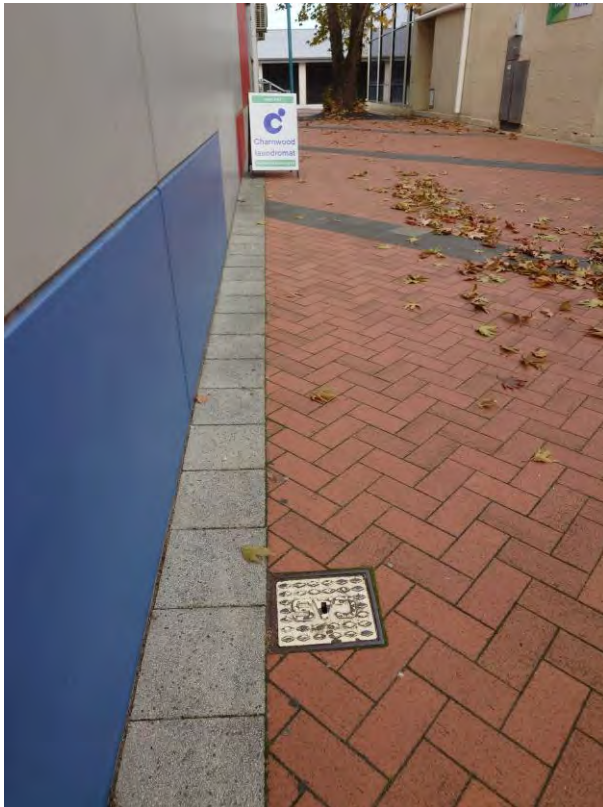
Figure 79 – Gas Isolation Valve Between Block 3 and Block 47 Section 95

- A DN110 210kPa polyethylene distribution gas main runs along the west verge of Charnwood Place (west) and the car park.
- A DN40 210kPa polyethylene distribution gas main runs across the car park in Charnwood Place (west) to the east, providing service to Block 47 Section 95. An isolation valve over the DN40 gas branch main can be seen in Figure 79 below.
