Charnwood Group Centre Stage 1 Site Investigation Report

**Environment, Planning and
Sustainable Development
Directorate (EPSDD)**

14 August 2024

JPS Engineering Consultants

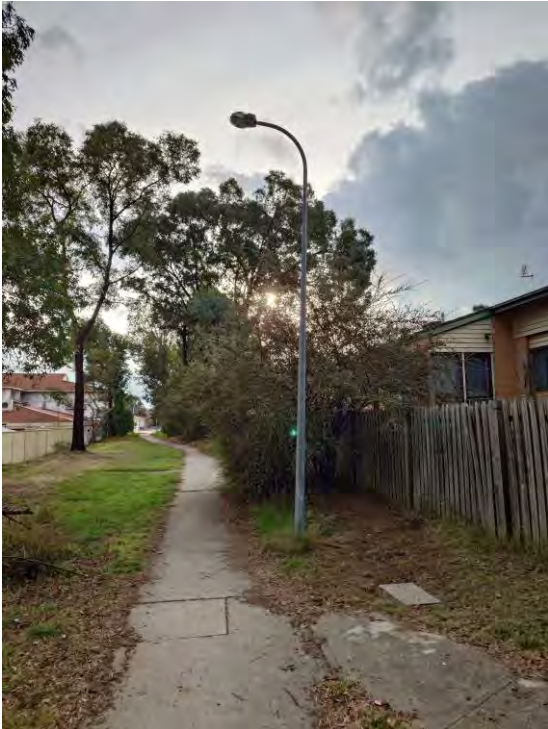
Figure 81 – TCCS Streetlights in Block 213 Section 96 North of Site

- The east and west verges of Tillyard Drive. See Figure 84 below for a general photo of lights on Tillyard Drive.
- In the open space corridor north of the subject site, in Block 213 Section 96 and Block 17 Section 117, as can be seen in Figure 81.

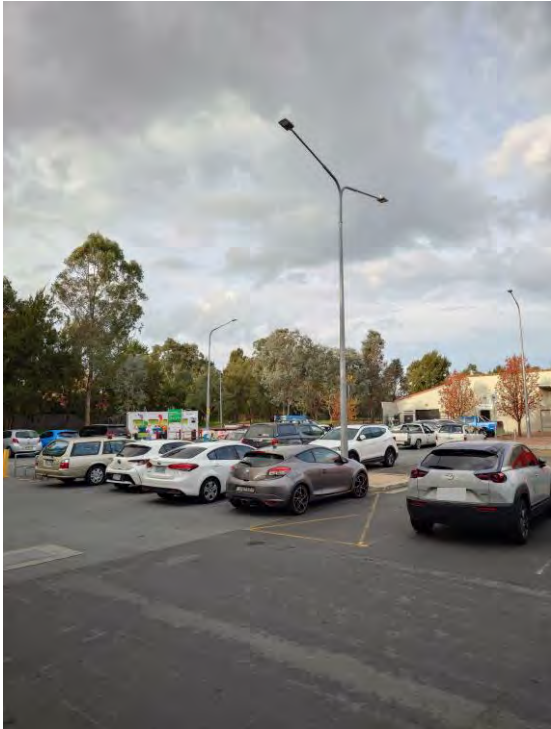
Figure 83 – TCCS Streetlights in Charnwood Place (west)

- The west and east verges and centrally in the car park in Charnwood Place (west). A photo of some streetlights in this location can be seen in Figure 83 below.

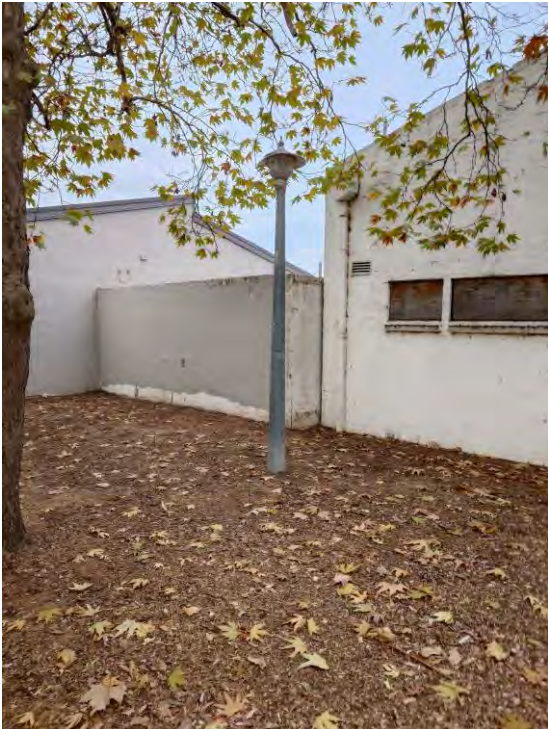
Figure 82 – TCCS Streetlight in South West Portion of Site (Block 46 Section 95)

Some of the streetlight columns within the group centre and in open space areas are older custom unidirectional lights. See Figure 82 for an example of one of these streetlights within the subject site.

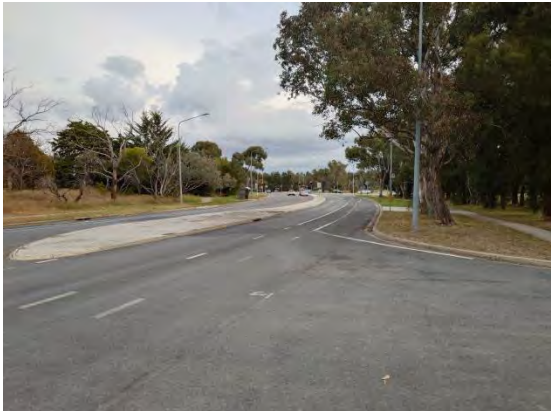
Figure 84 – TCCS Streetlights on Tillyard Drive

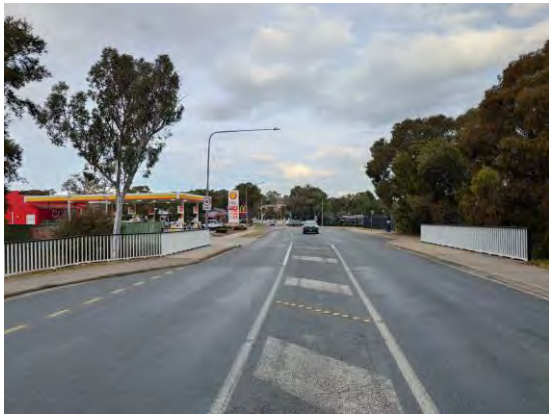
Figure 85 – TCCS Streetlights on Lhotsky Street Looking East

- The southern and northern verges of Lhotsky Street. Figure 85 and Figure 86 show the streetlights on Lhotsky Street and those at the intersection with Tillyard Drive.

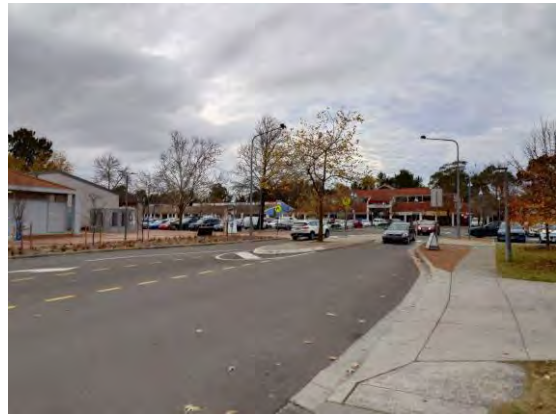
Figure 87 – Streetlights in Charnwood Place (east)

- Both the east and west verges of Charnwood Place (east). Refer to Figure 87 below for a general photo of streetlights in this location.
- Surrounding the central car park in the group centre and within the centre medians of the car park. Most of these streetlights are bespoke poles and fittings, as shown in Figure 88 below.

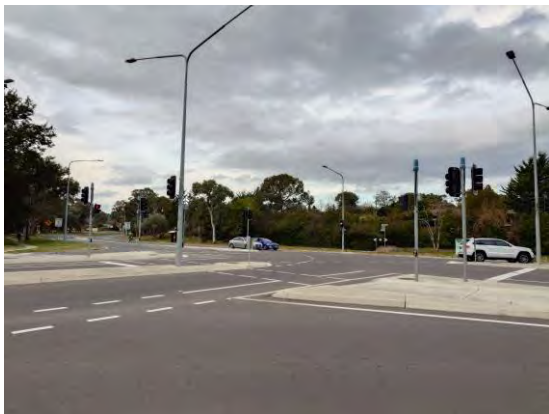
Figure 86 – TCCS Streetlights at Intersection of Lhotsky Street and Tillyard Drive

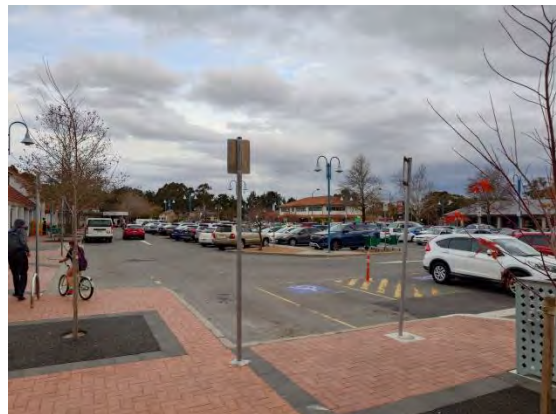
Figure 88 – TCCS Streetlights in Charnwood Place (east) Car Park

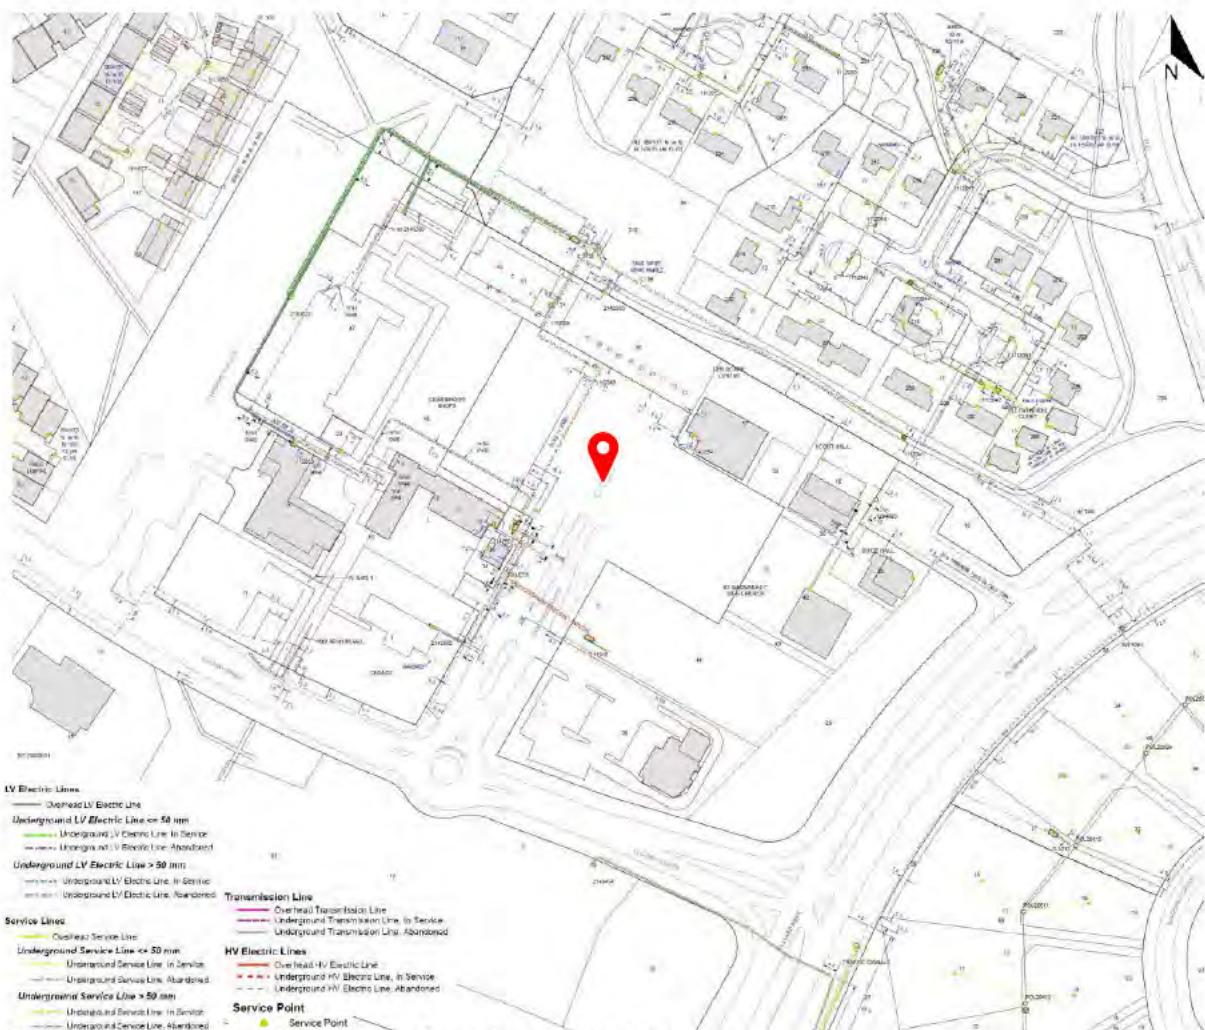
Figure 89 – Electrical BYDA Information (Evoenergy, 2024)

Refer to Figure 89 for the electrical BYDA information, depicting HV lines in red dashed lines and service lines shown in lighter green dashed or solid lines for underground and overhead lines, respectively.

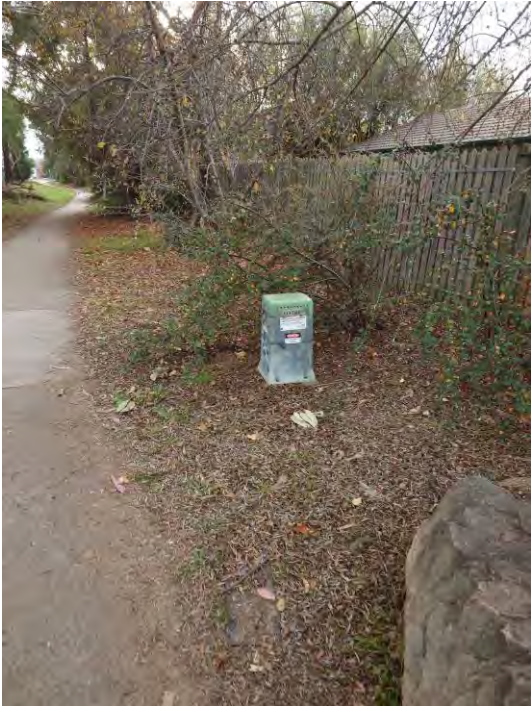
Figure 90 – Electrical Minipillar in Block 213 Section 96 North of Site

- HV lines from substation S 2721 extend across Charnwood Place (east) to another substation located within Block 44 Section 95 (S 11010). This substation was located on site and can be seen in Figure 93 below.
- Several electrical service lines branch from the abovementioned infrastructure, providing service to all blocks within the subject site and surrounding residential and community facility areas. Some electrical minipillars within and near the subject site can be seen in Figure 90 and Figure 91.

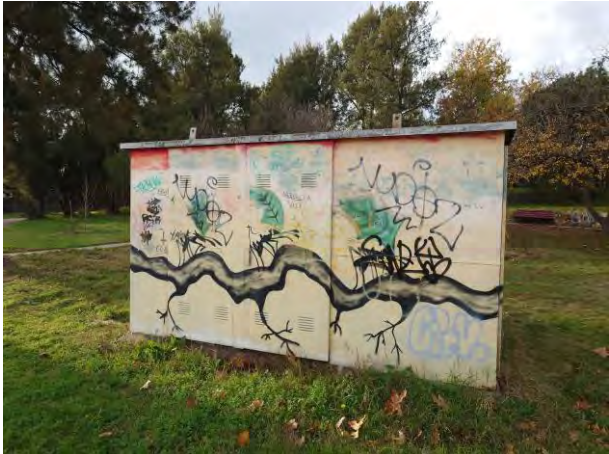
Figure 92 – Electrical Substation S 2720 North of Block 5 Section 95

- Underground HV lines branch from the abovementioned lines in Tillyard Drive near Verge Place and continue west along the open space corridor north of the site (Block 213 Section 96). These lines connect to another substation (S 2720) located in Block 213 Section 96, north of Block 5 Section 95. See Figure 92 below for a photo of this substation.

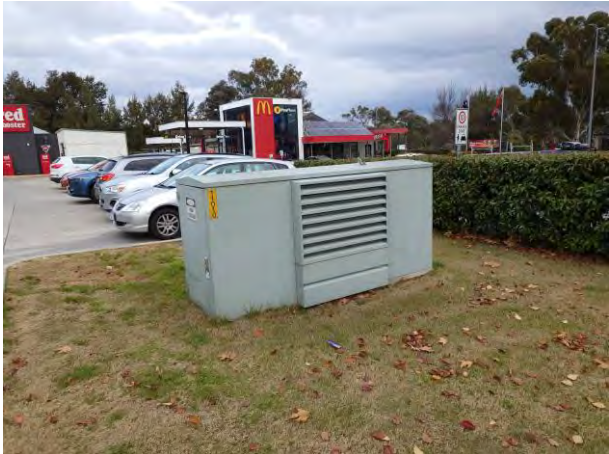
Figure 93 – Electrical Substation S 11010 in Block 44 Section 95

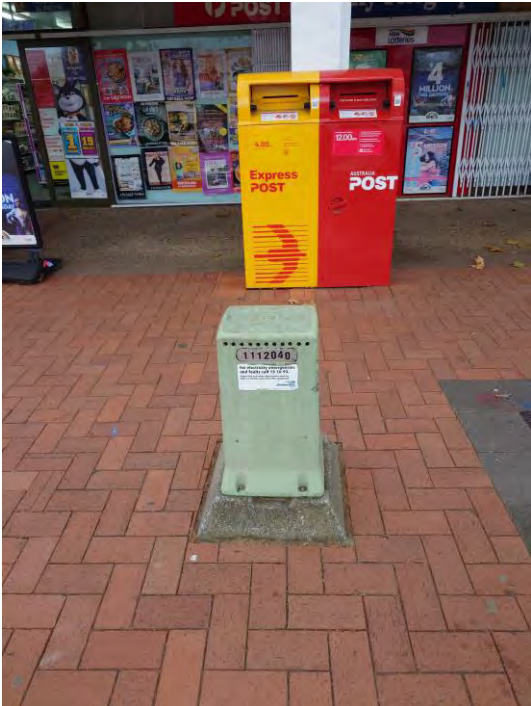
Figure 91 – Electrical Minipillar in North Central Group Centre

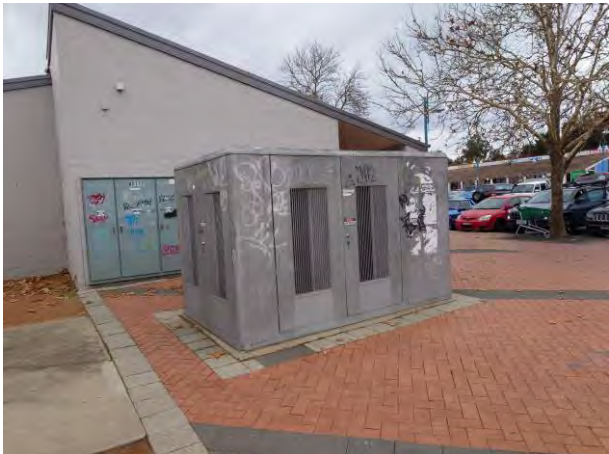
Figure 94 – Electrical Substation S 2721 in Charnwood Place (east)

- Underground low voltage (LV) lines extend from substation S 2720 to the east along the open space corridor, south into the group centre, and west toward the car park and Charnwood Place (west). The LV lines in the west car park run adjacent to Block 47, where they turn east into the plaza area between Block 3 and Block 47 and continue east to a substation (S 2721) located in the west verge of Charnwood Place (east). A photo of this substation is provided in Figure 94 below.

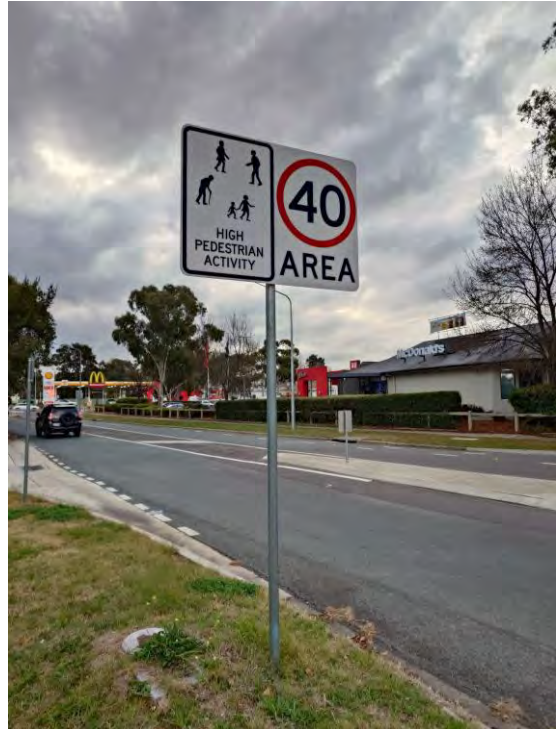
Figure 102 – Lhotsky Street Speed Restriction
Sign

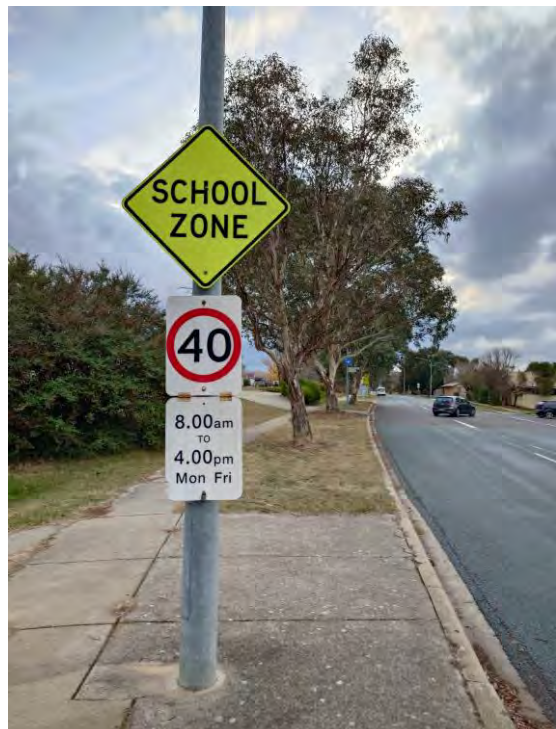
Figure 103 – School Zone sign on Lhotsky
Street

The subject site comprises the Charnwood Group Centre, which is adjacent to Tillyard Drive and in close proximity to Ginninderra Drive. Also south of the site is Lhotsky Street that provides access via Charnwood Place and car parks that provide ease of accessibility to the commercial area. Refer to Figure 97 and Figure 104 for general perspective views of Tillyard Drive. Also see below Figure 98, Figure 99, Figure 100, Figure 101 and Figure 102 for photos of Lhotsky Street, including intersections with Charnwood Place (east) and Tillyard Drive. Lhotsky Street has been reduced to 40km/h in the vicinity of the group centre, indicating a high pedestrian activity area. Further to this, a 40km/h school zone is imposed on Lhotsky Street to the west of the group centre to cater for St. Thomas Aquinas Primary School and the Edge Early Learning Centre to the south west. See Figure 103 for a photo of sign on Lhotsky Street delineating the school speed zone.

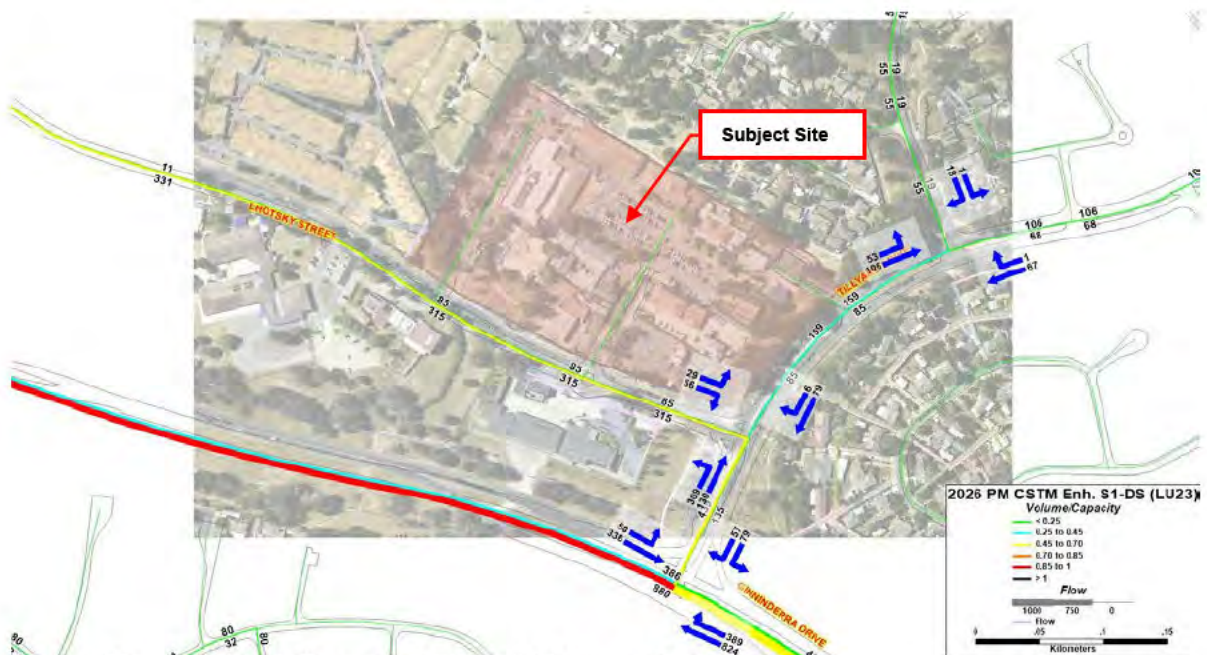
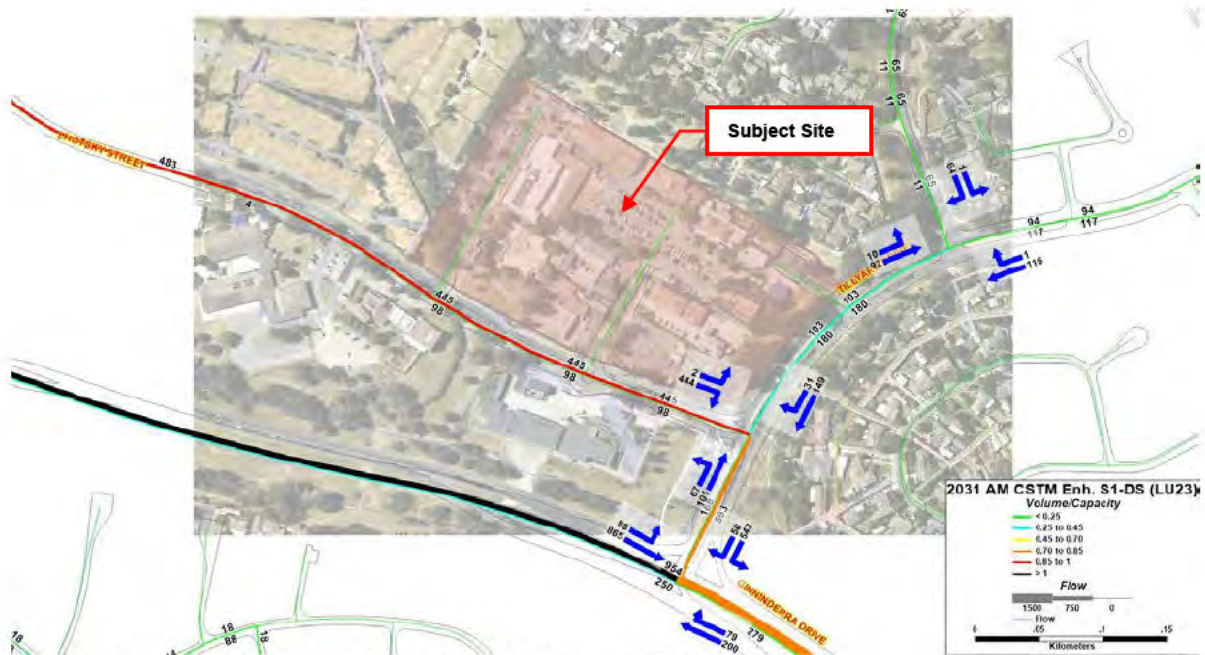
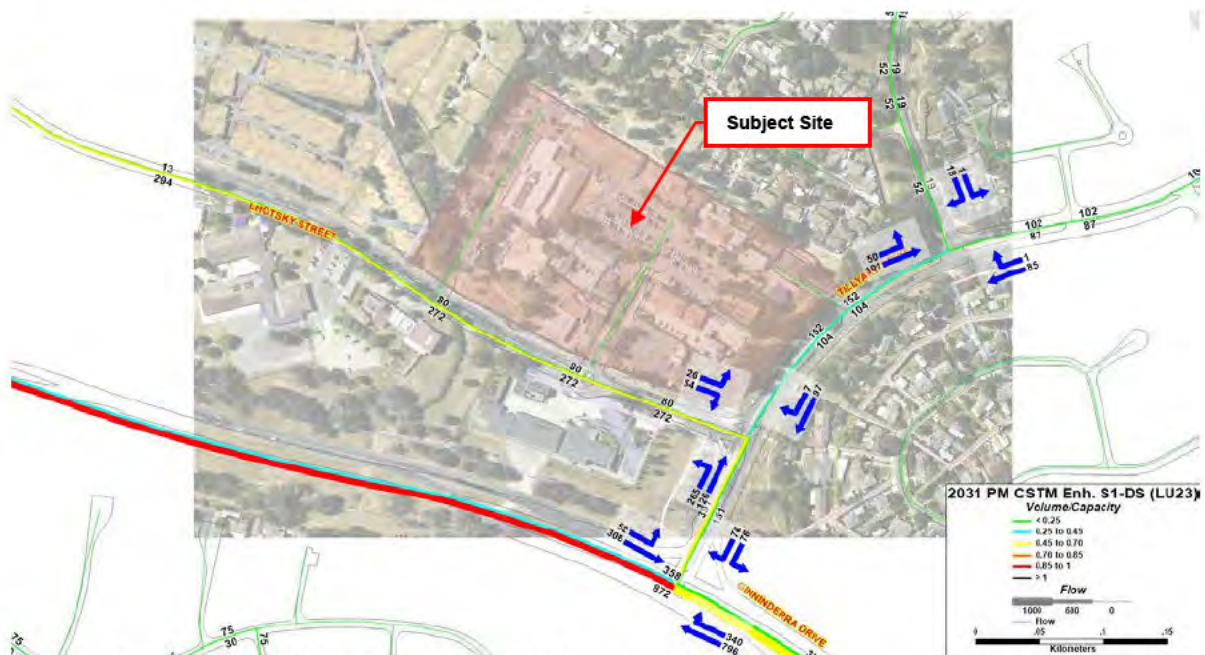
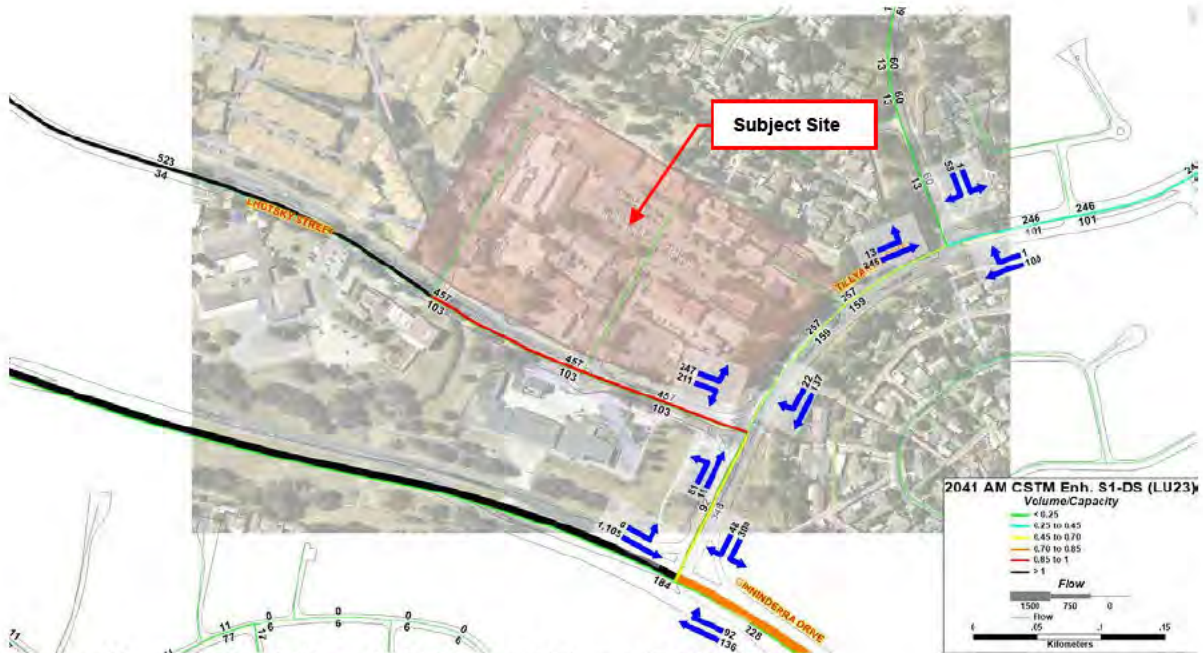
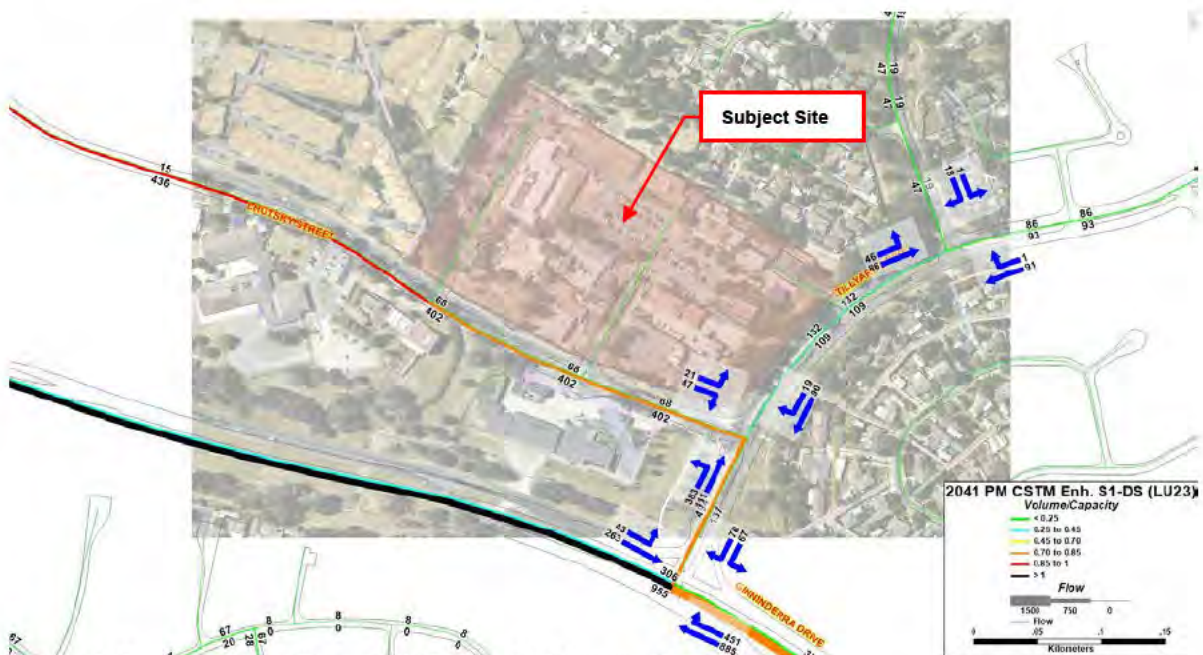
Charnwood Place and Verge Place do not have projected traffic volumes in the CSTM output, due to their relatively low traffic compared to surrounding roads. However, it can be safely assumed that both roads fall within the Access Street B threshold of 1,000 vpd for commercial zones, as stipulated in MIS 01.

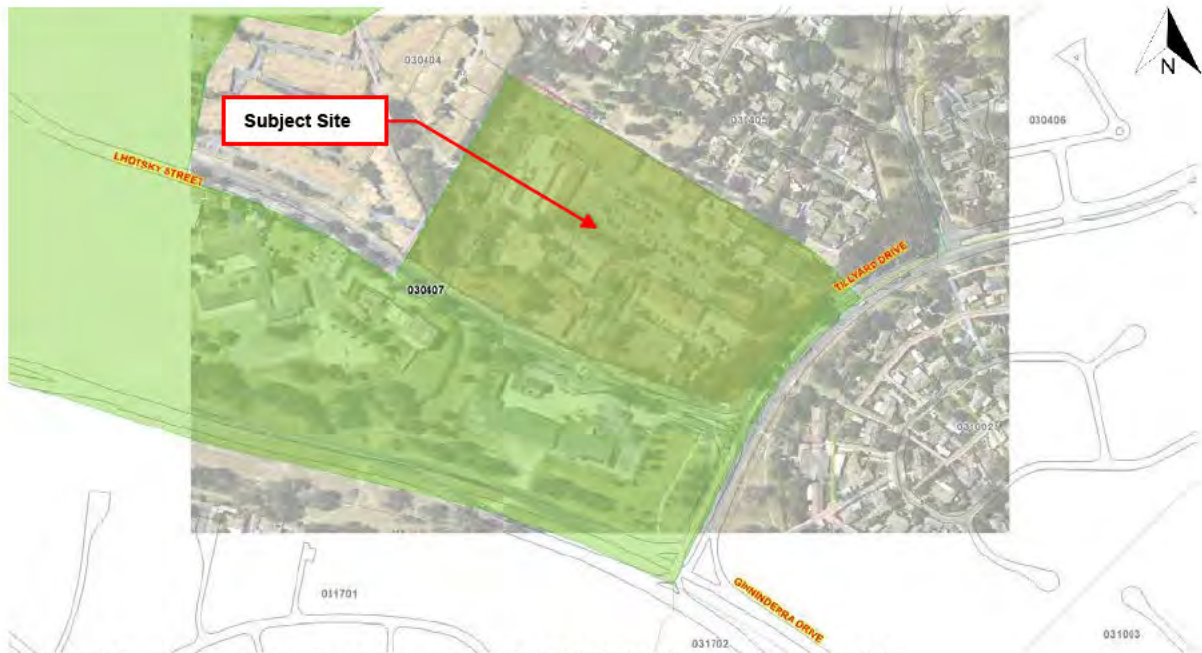
Figure 115 – Canberra Strategic Transport Model (CSTM) Zone ID (TCCS, 2024)

The demographics and associated populations assumed for the group centre area that is applied to the Canberra Strategic Transport Model (CSTM) was provided by ACT Government TCCS and is detailed in Figure 115 and Table 3 below. The data confirms that the site is located in an area (CSTM Zone 030407) that is a mix of employment, retail space and schools. There is a small decrease in employment over the projected year of 2026 by approximately 14% and 2041 by approximately 8%, whilst numbers rise slightly by 2051 (3%). The retail space, measured in square meters, is projected to increase over the years, stabilising by 2051. Likewise, school enrolments are projected to significantly increase by 2026, with an approximate 20% uptake, and then is relatively maintained until 2051.

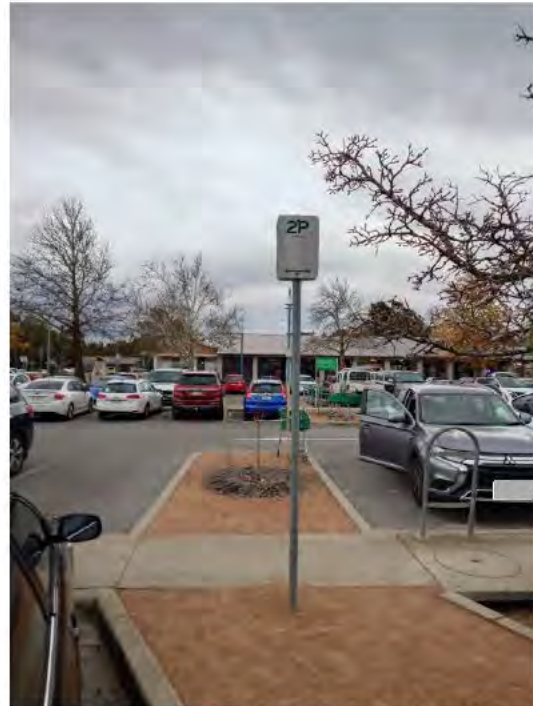
Figure 122 – Parking Sign in Charnwood Place (east)

Photos in Figure 116 to Figure 126 show existing car parking bays and associated infrastructure, whilst Figure 122 and Figure 123 show existing parking signs within and surrounding the site. Also see Figure 124 below for a signposted park and ride facility in the Charnwood Place (east) car park.

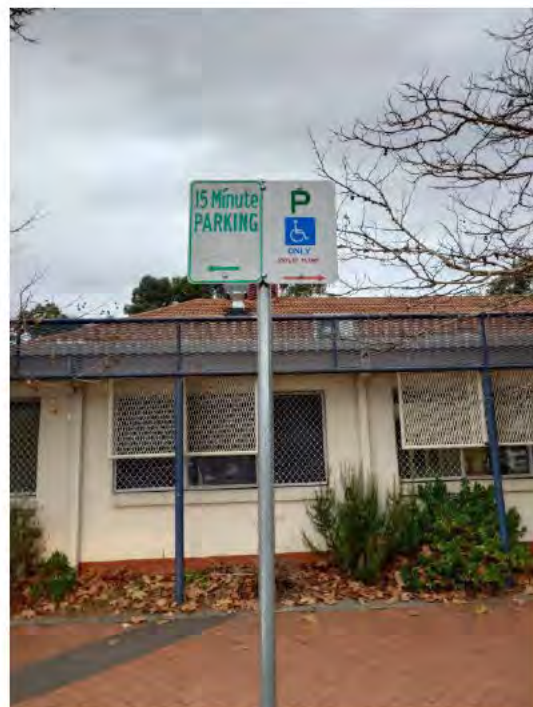
Figure 123 – Parking Sign in Charnwood Place (east)

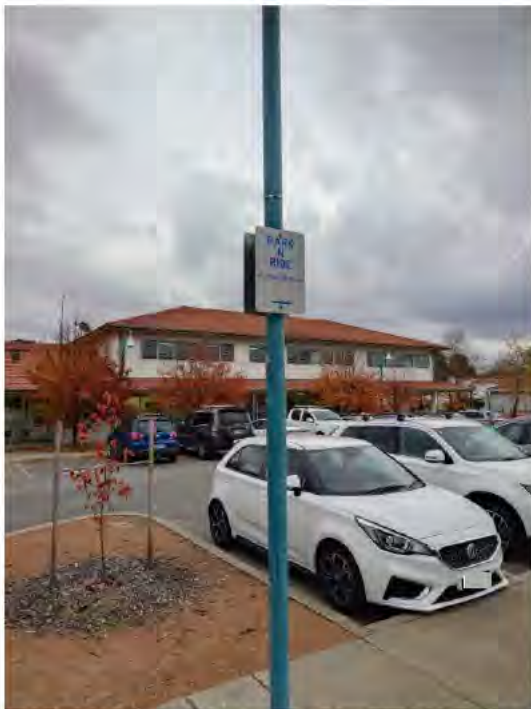
Figure 124 – Park and Ride Area in Charnwood Place (east)

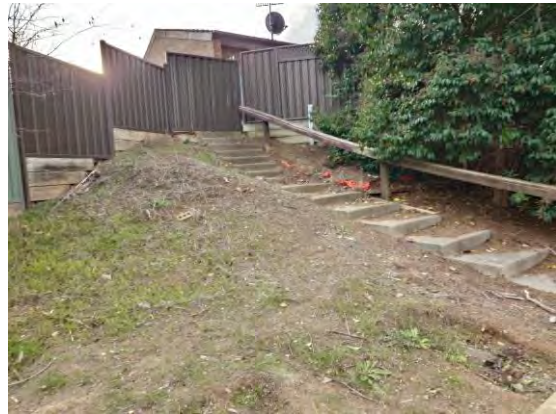
Figure 138 – Stairs Access from Residential Areas West of Charnwood Place (west)

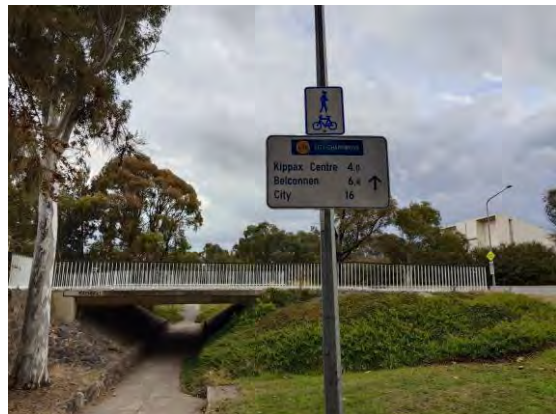
Figure 139 – C3 Principal Route Designation Near Lhotsky Street Underpass

An excerpt from the CBR Cycle Routes map in Figure 127, published by ACT Government Transport Canberra, illustrates that a principal route is available commencing from Charnwood Place (west) to Belconnen Town Centre (Route C3). This route is connected to by main routes along Lhotsky Street further west and north of Charnwood Place (west) through the residential area of Charnwood. The principal route continues on Tillyard Drive and east on Ginninderra Drive. The principal route is also shown to be connected with local routes, which interconnect with the previously mentioned paths near the subject site.

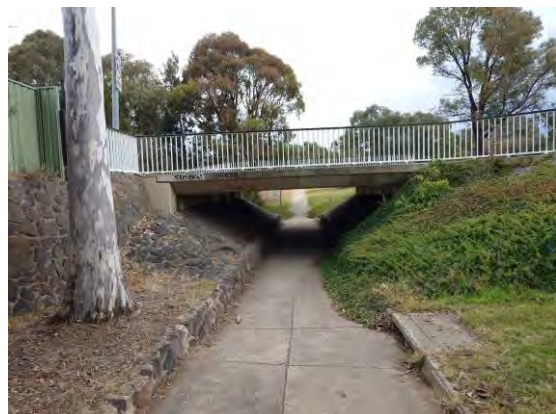
Figure 140 – Lhotsky Street Underpass

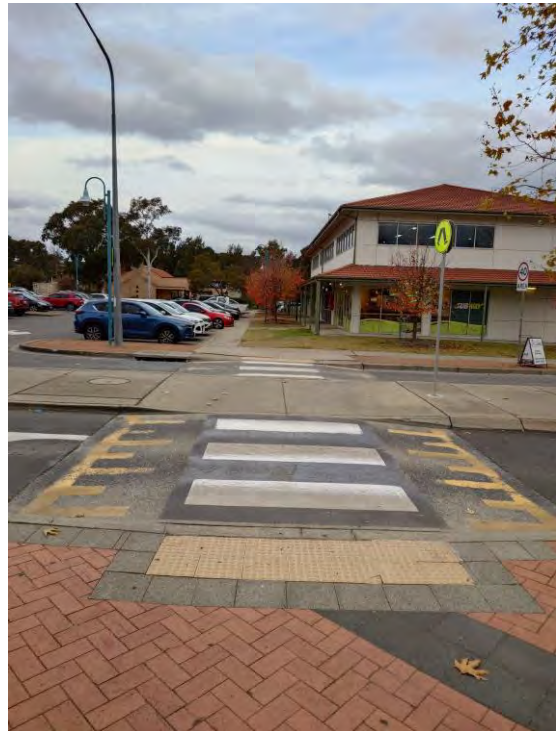
Figure 143 – Raised Pedestrian Crossing in Charnwood Place (east)

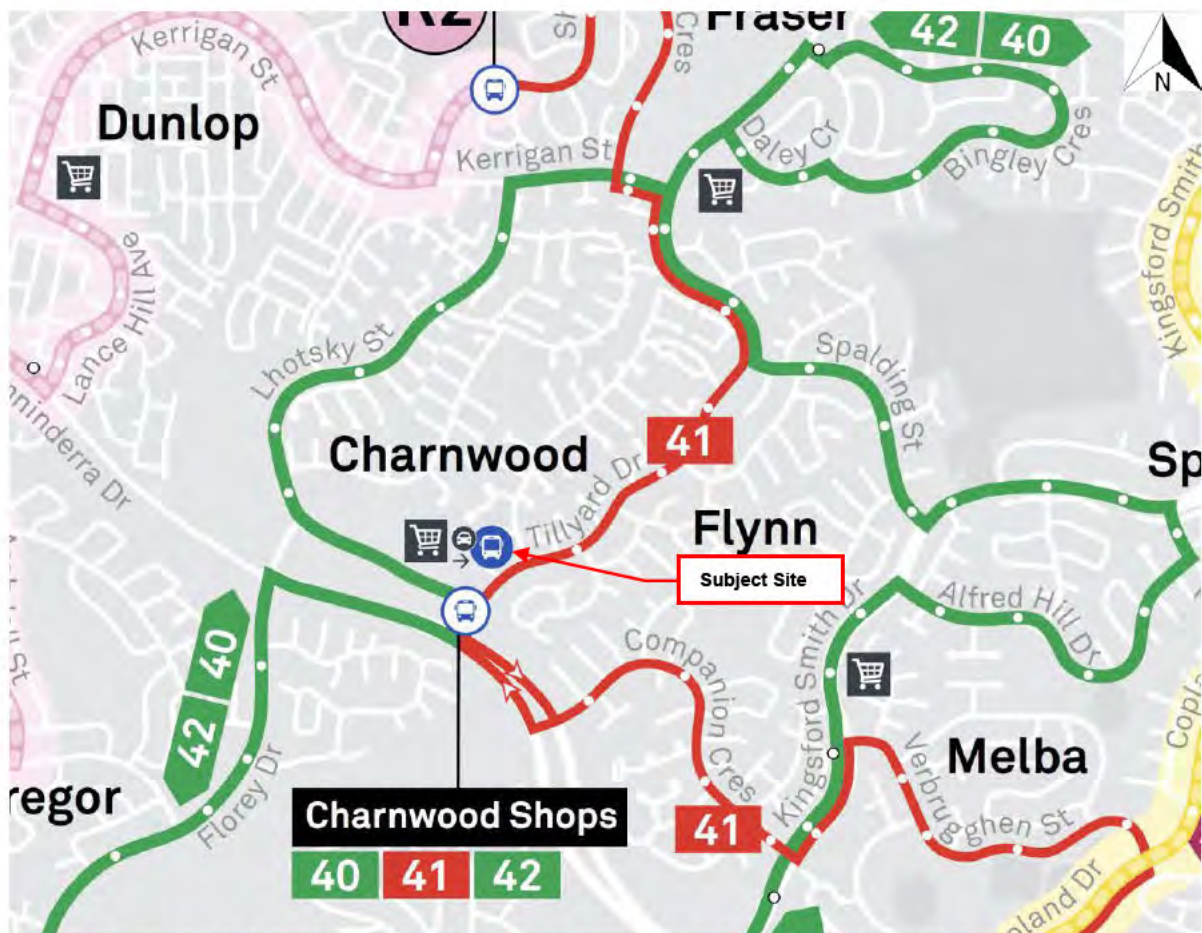
Figure 147 – Bus Routes Adjacent the Subject Site – Extracted from Transport Canberra (2024)

Refer to Figure 147 for an excerpt from the Transport Canberra bus route map showing these bus routes in relation to the subject site.

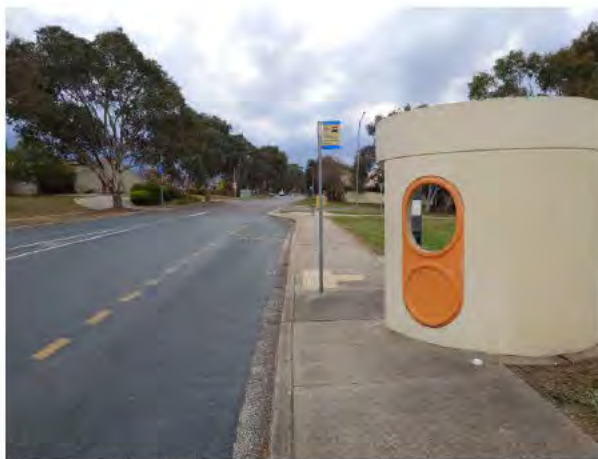
Figure 148 – Bus Stop on Lhotsky Street Near Charnwood Place (west)

The subject site is situated in a location where two bus routes runs adjacent the group centre on Lhotsky Street and Tillyard Drive. Bus stops serving both directions on Lhotsky Street is available at the main entrance to the group centre near the intersection of Charnwood Place (east). See Figure 148 and Figure 151 below for photos of these bus stops in both eastbound and westbound carriageways.

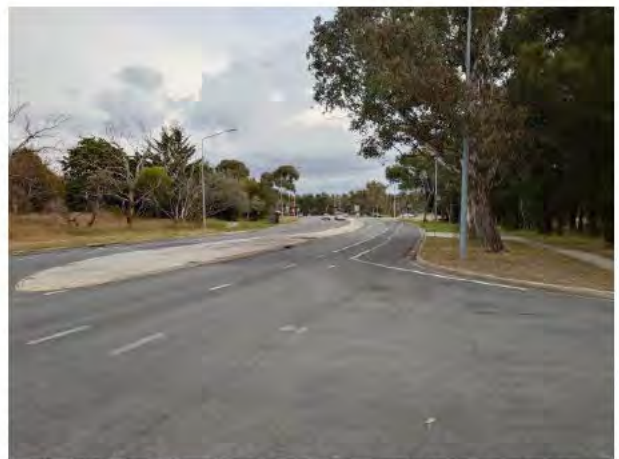
Figure 149 – Bus Stops on Tillyard Drive East of Site

Additionally, another bus route passes the site on Tillyard Drive, with bus stops directly east of the subject site. Refer to Figure 149 for a photo of Tillyard Drive and the bus stops in both carriageways.

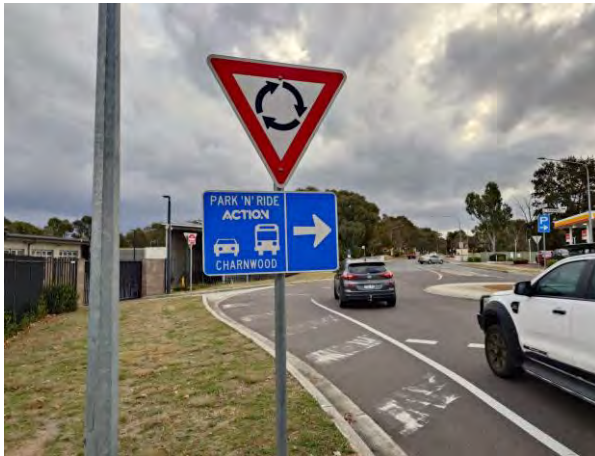
Figure 150 – Park ‘n’ Ride Sign Near Charnwood Place (east)

A park and ride sign was also noticed on site to be at the intersection of Lhotsky Street and Charnwood Place (east) as can be seen in Figure 150 below.

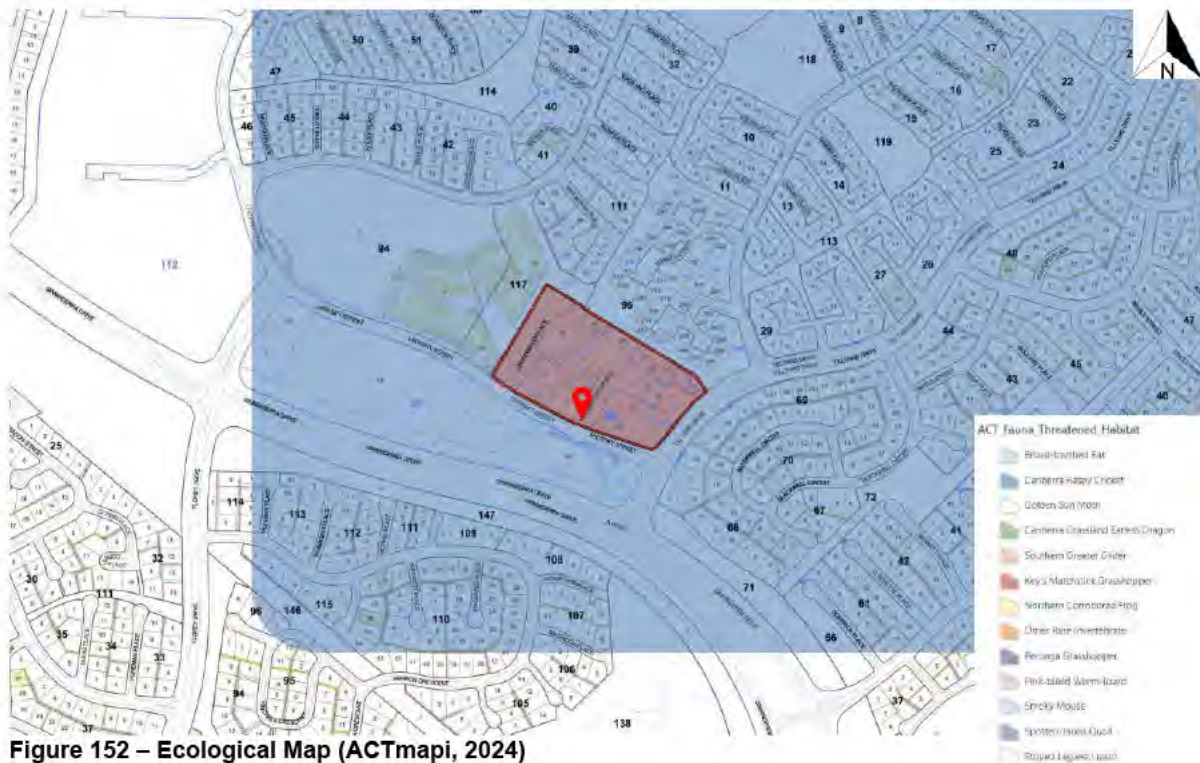
Figure 152 – Ecological Map (ACTmapi, 2024)

Reviewing ACTmapi data indicates that the subject site contains ecologically sensitive habitat areas. The mapping shows that within and surrounding the site, there is potential for Spotted-tailed Quoll habitat areas. Refer to Figure 152, which provides a depiction of the area that incorporates this threatened fauna habitat area in proximity of the site, taken from ACTmapi. Figure 153 also shows ecologically sensitive vegetation mapping from ACTmapi, that correspond with the location of mature large trees.

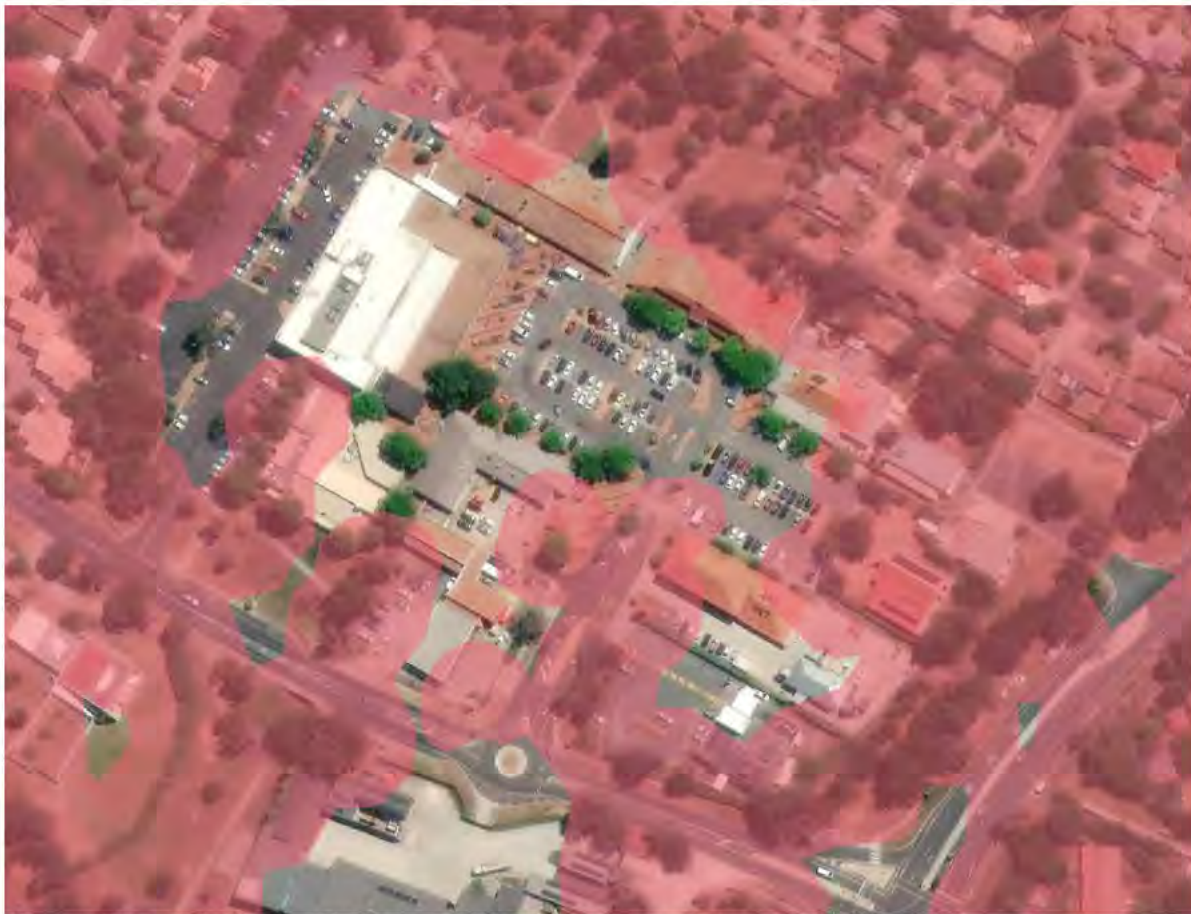
Figure 154 – Ecological Habitat Connectivity (Conservator of Flora and Fauna, 2024)

- The Conservator noted that at least two trees on the site may provide significant habitat value. The assessment should determine if these trees meet the criteria for registration on the ACT Tree Register.

If any development is proposed within the subject site, it is recommended to engage with the ACT Conservator of Flora and Fauna during the project's design phase, which will lead to the need for a full ecological and tree assessment of the site and its immediate surrounds.

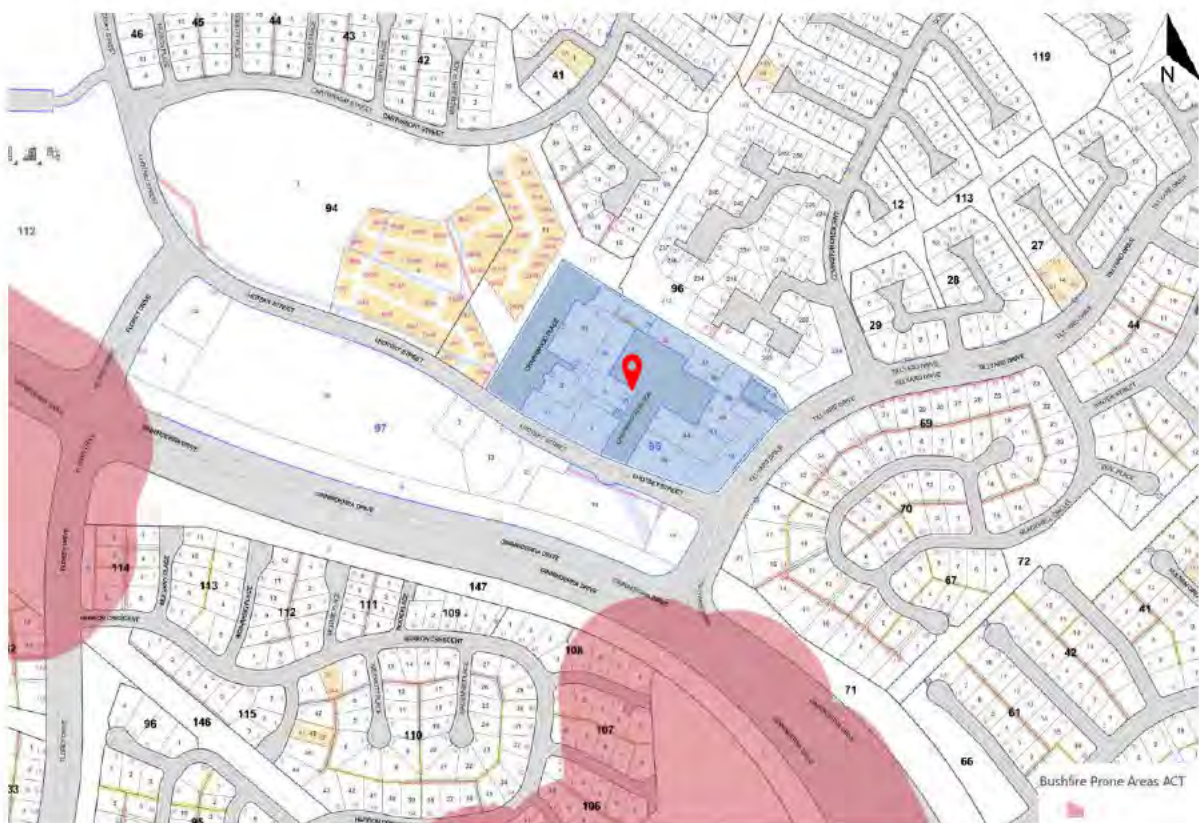
Figure 155 – ACTmapi Bushfire Map (ACTmapi, 2024)

The current bushfire mapping listed on ACTmapi demonstrates that the subject site is relatively near a recorded Bushfire Prone Zone, to the south east, beyond Ginninderra Drive. The site however is within proximity of a Strategic Bushfire Management Zone, shown in mapping to include the open space area in the south east portion of the site (Block 29 Section 95). Refer to Figure 155 and Figure 156 for a bushfire prone area map and strategic bushfire management zone map, respectively, reproduced from ACTmapi. These include the subject site and broader area to provide context.

Additional advice from ACT Fire & Rescue suggests that the verification of the fire risk rating can be conducted during the development application stage, with particular consideration given to the size and type of development.

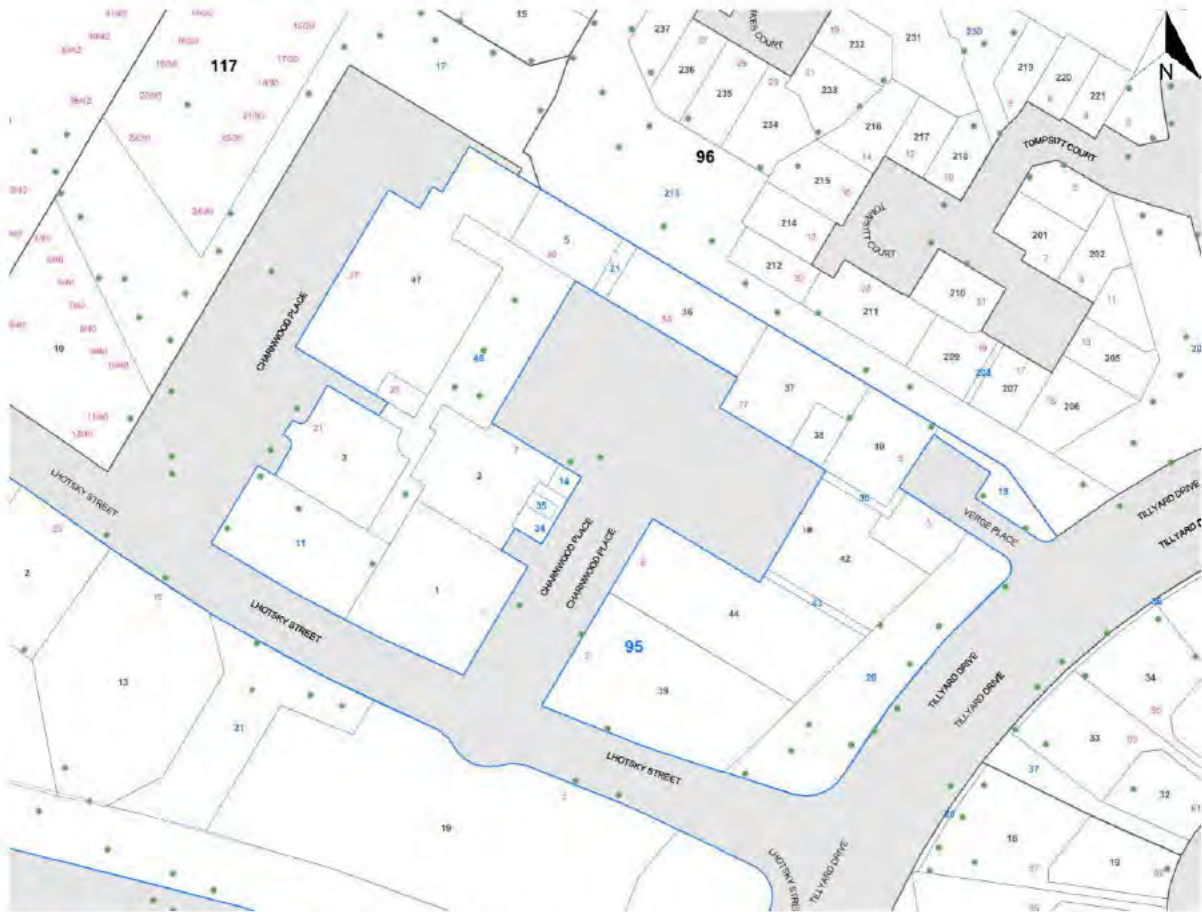
Figure 157 – Mature Trees Map (ACTmapi, 2024)

- Based on ACTmapi information, none of these trees present on and in close proximity to the site are registered trees. However, mature trees are shown in ACTmapi mapping, as can be seen in Figure 157 below.

A tree assessment has not been undertaken on the site, however, it is recommended that one is carried out by an accredited arborist in conjunction with a tree survey, to provide detailed information

on the location and status of trees within the site. This information would aid in the development or redevelopment of any portion of the site by identifying and assessing trees that are Protected and Regulated, as covered by the Urban Forest Act 2023. Following a tree assessment, the findings should be provided to the ACT Tree Protection Unit for comment/validation.

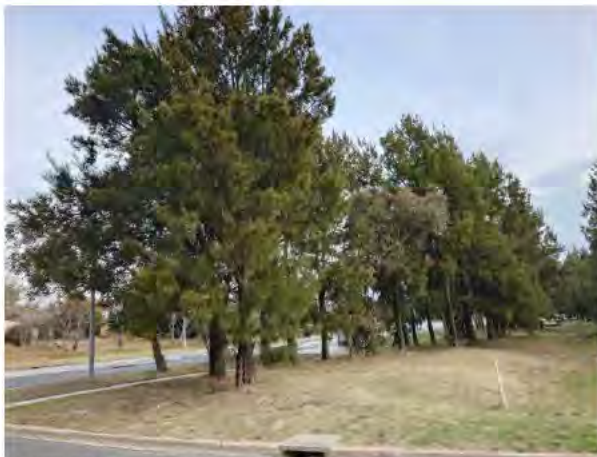
Figure 158 – Large Mature Trees Adjacent Tillyard Drive

- There are also some large mature trees that are located in the open space of Block 29 Section 95, adjacent Tillyard Drive. See Figure 158 and Figure 162 for a photo of these trees.

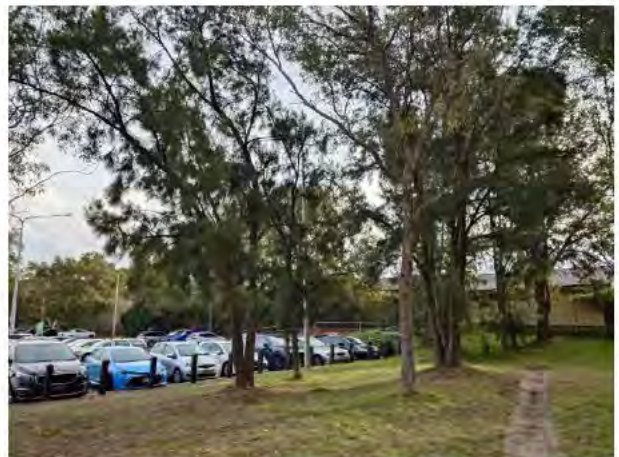
Figure 159 – Large Mature Trees North West of Site

Refer to Figure 158 to Figure 168 for site photographs of some of the potentially regulated trees and newly planted trees identified during the site inspection.
