Charnwood Group Centre Stage 1 Site Investigation Report

**Environment, Planning and
Sustainable Development
Directorate (EPSDD)**

14 August 2024

JPS Engineering Consultants

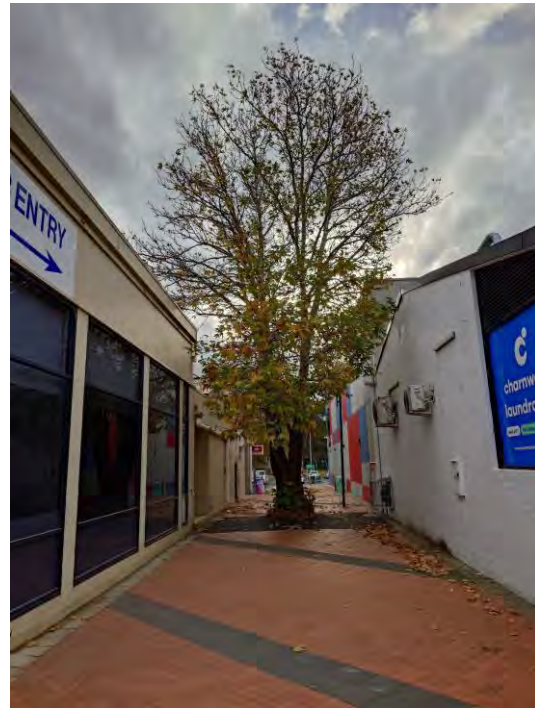
Figure 166 – Mature Tree Between Block 3 and Block 47

- Some very large isolated and grouped mature trees are present within the car parks on site and in the group centre's road verges. A large mature tree was observed in the passageway between Block 3 and Block 47, as can be seen in Figure 166 below.

A tree assessment has not been undertaken on the site, however, it is recommended that one is carried out by an accredited arborist in conjunction with a tree survey, to provide detailed information

on the location and status of trees within the site. This information would aid in the development or redevelopment of any portion of the site by identifying and assessing trees that are Protected and Regulated, as covered by the Urban Forest Act 2023. Following a tree assessment, the findings should be provided to the ACT Tree Protection Unit for comment/validation.

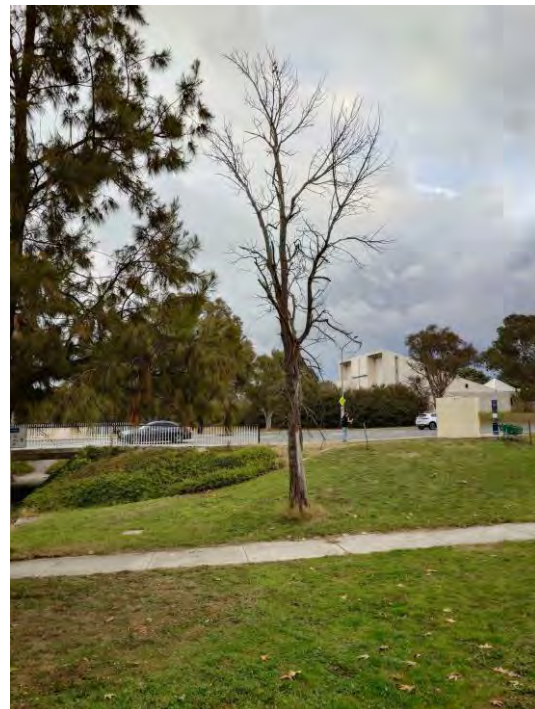
Figure 167 – Dead Tree in Block 11 Open Space Area

- Some dead trees were also observed within the site's open space block (Block 11 Section 95), an example of which is shown in Figure 167 below.
- Some small relatively newly planted trees were observed during the site inspection within the Charnwood Place (east) west verge. See Figure 168 for an example of these newly planted trees observed within the subject site.

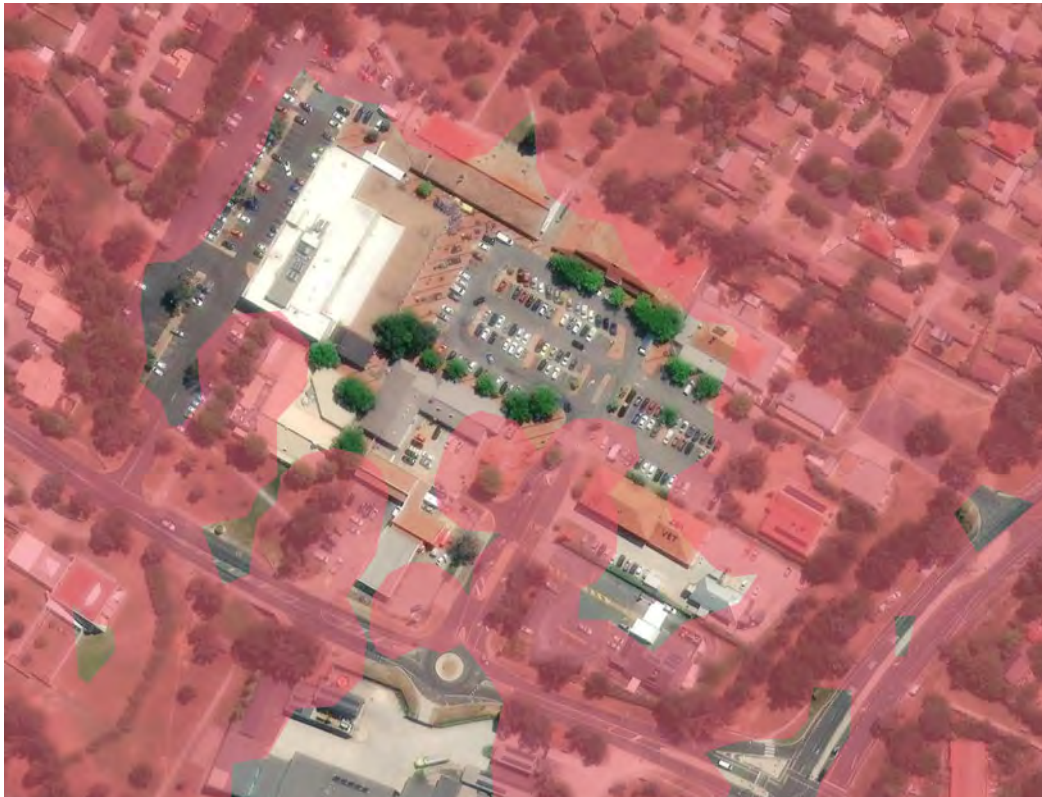
- Maintaining connectivity for small woodland birds. The red shaded areas in the map below indicate areas that provide connectivity values. At a site scale the connectivity values are concentrated on the tree lines in the green space on the northern, eastern and western edges of the site., it will be important to maintain this connectivity.
