Why can't fish cross the road? Barriers to fish passage in the national park and reserves of the ACT.

Research Report
Conservation Research
September 2019

Conservation Research
Environment, Planning and Sustainable Development Directorate

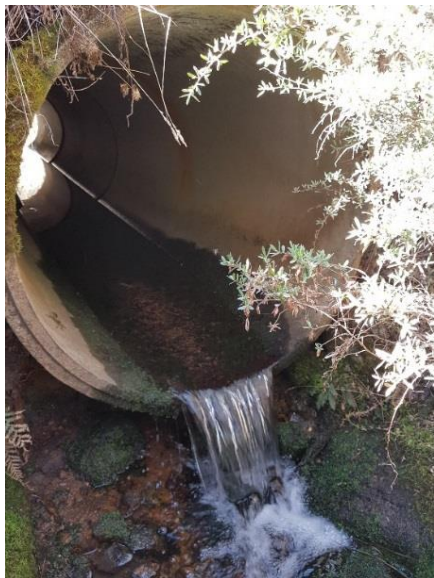
Vertical drops are most commonly associated with culverts (Figure 8 and Figure 9). When culverts are placed above the water level a lip is created; while water can flow through, fish cannot pass. All culverts that were recorded as a barrier to fish movement were placed too high above the river bed for fish to swim through.

Figure 9. A vertical drop from a pipe culvert on Smokers trail crossing Sawpit Creek, Namadgi National Park.

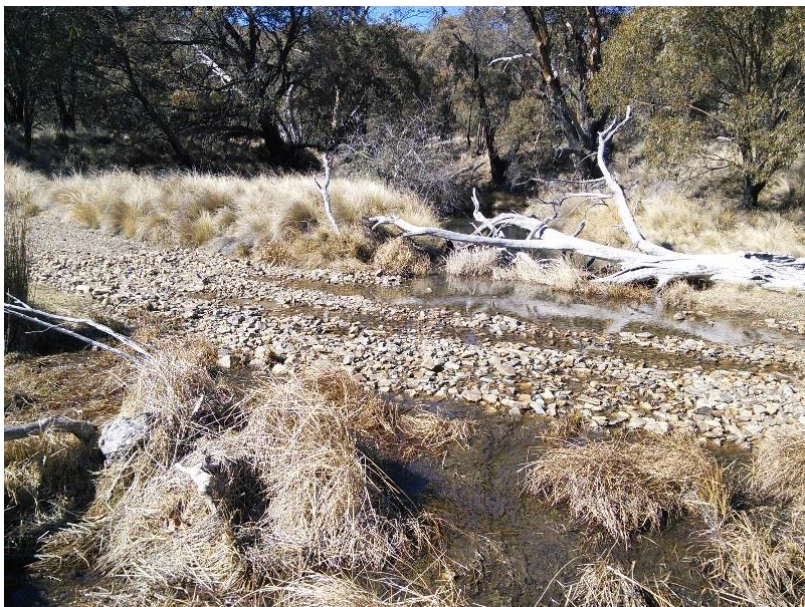
Shallow flow depth (water too shallow for fish to pass) are most commonly associated with ford crossings (Figure 10 and Figure 11). Raised ford crossings, which are made by piling rocks or gravel to create a dry vehicle crossing, block fish passage by creating a shallow water depth. In some instances, the flow of water is blocked entirely.

Figure 11. Shallow flow depth caused by a ford over a tributary to Naas Creek crossing on Naas Fire Trail.

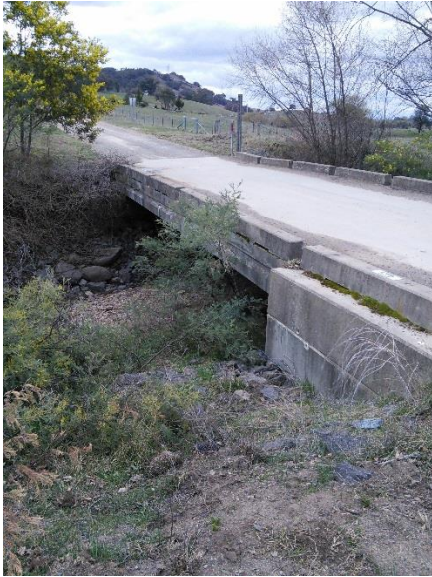
Type of crossing	Attributes that allow fish passage
Bridges (Figure 13 A)	Open span: width matches width of stream channel Uninterrupted water flow and natural base: water velocity matches the velocity in the stream channel
Culverts (Figure 13 B)	Wide culverts: width matches width of stream channel Deep culverts: depth matches depth of stream channel
Fords (Figure 13 C)	Deep ford: depth matches depth of stream channel
Causeways	Wide pipes: width matches width of stream channel and water velocity matches that of stream channel Deep pipes: depth matches depth of stream channel

A. Bridge on Mountain creek Road crossing Swamp Creek.

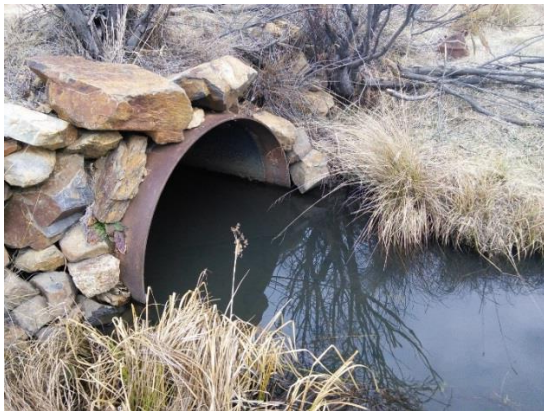
B. Low culvert on Bogong Flat fire trail crossing Bogong Creek.

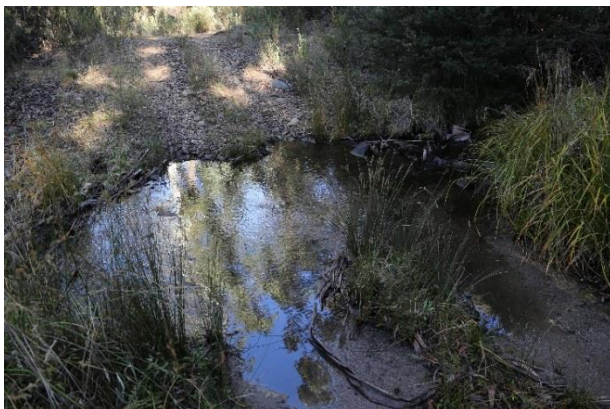
C. Deep ford on Lickhole track crossing Gingera Creek.

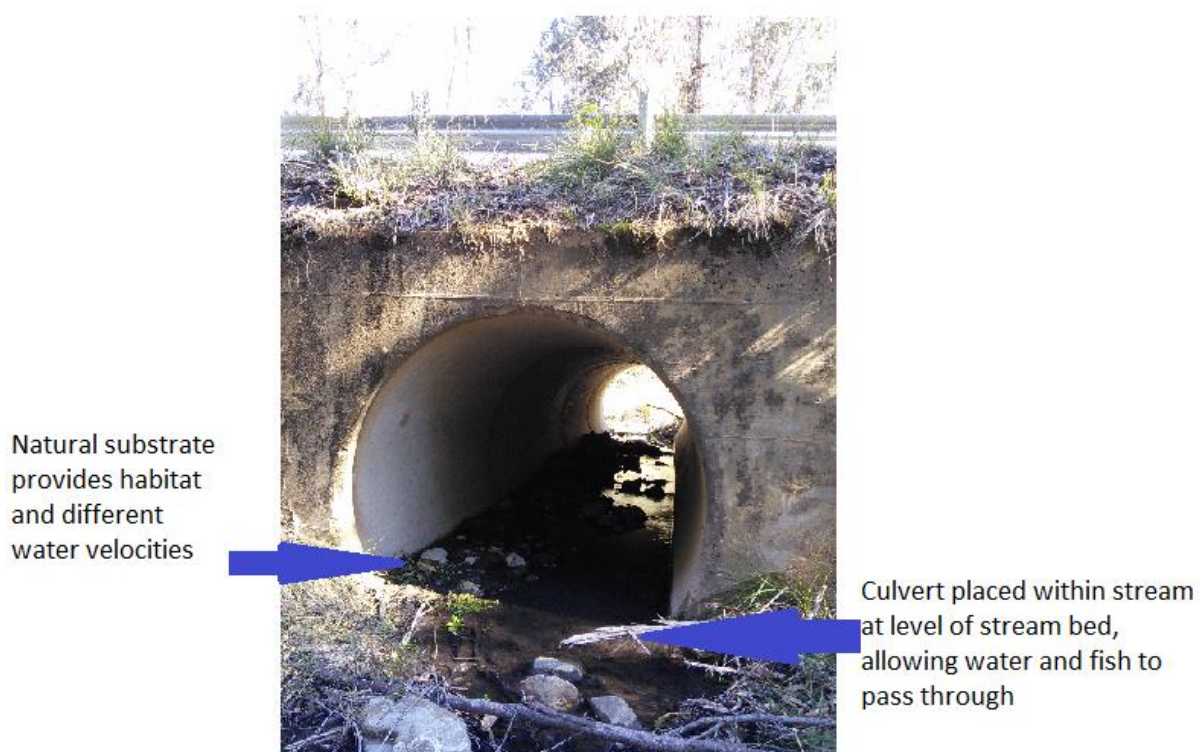
Figure 14. Culvert construction of crossing along Tidbinbilla Ring Road that allows fish passage. Note the wide pipe placed in the stream bed with natural substrate.

Details of several examples of crossings with effective fish passage are illustrated in Figures 14, 15 and 16.

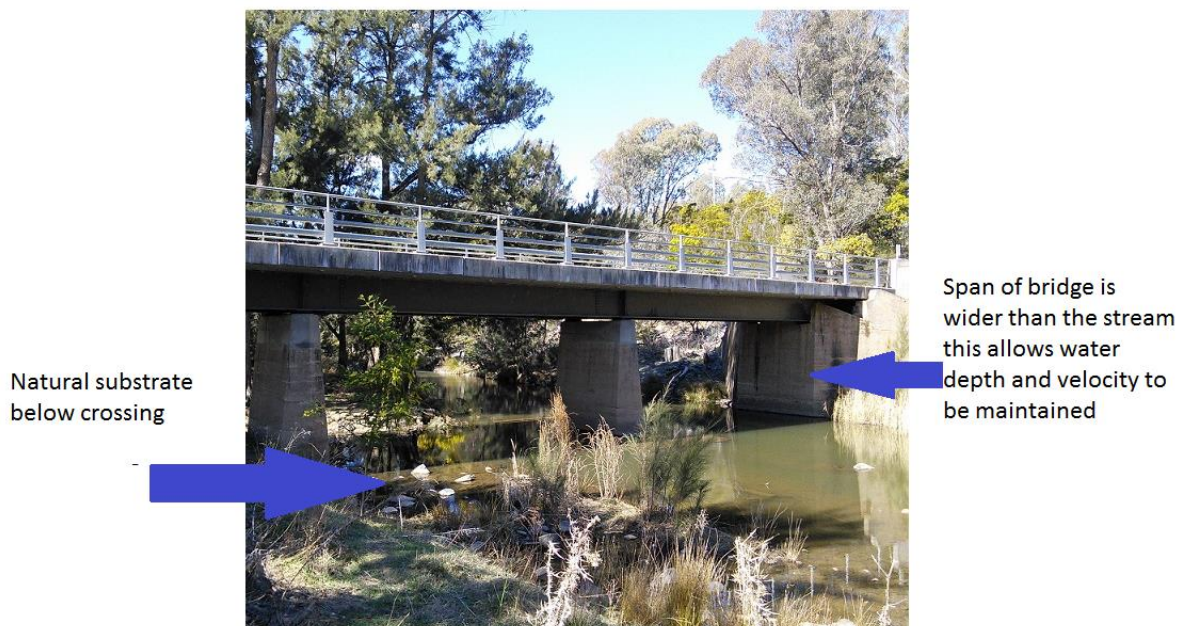
Figure 15. Cotter Road bridge that allows fish passage in the Cotter River, note the wide span and natural stream base that allows adequate water depth and velocity to be maintained.

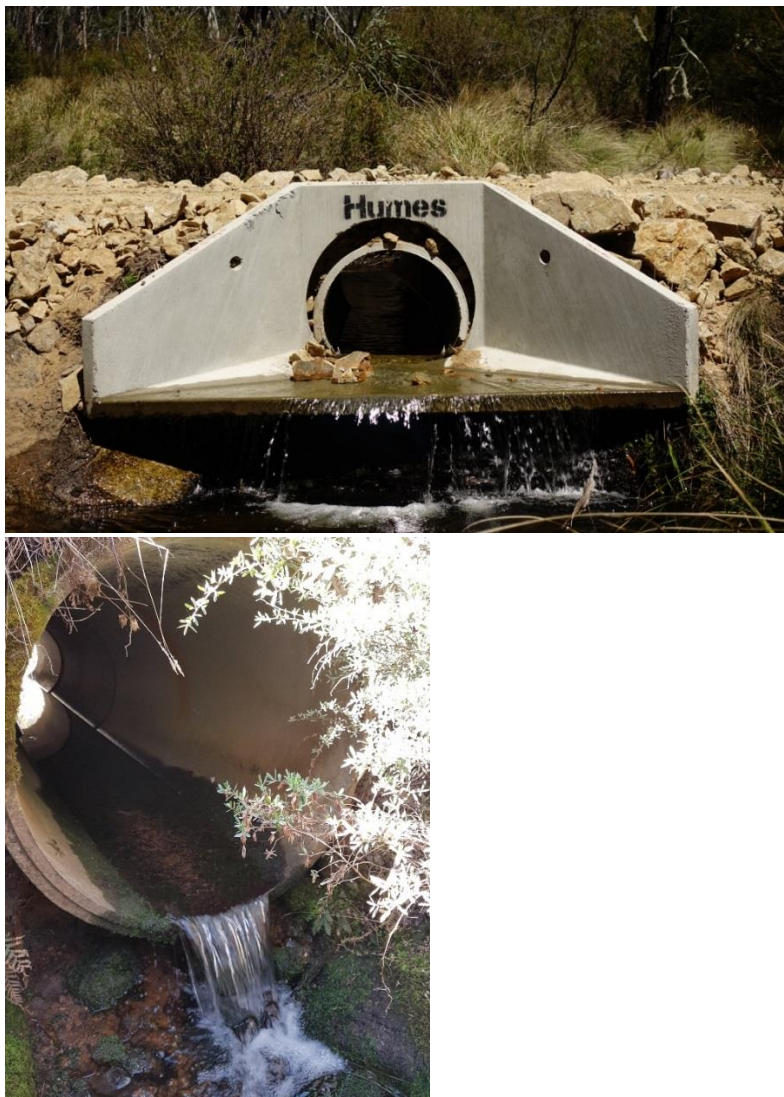
This distance between the natural channel base water and the structure creates a vertical obstacle to fish and usually a higher velocity at the outlet. A vertical drop can be present at the upstream and /or downstream end of the structure. The vertical distance between the water and structure may be created by a culvert placed above water level, or over time through erosion of the stream bed (Figure 17).

Figure 17. Pipe culvert in Bimberi Creek along Yaouk Fire Trail, and pipe culvert in Sawpit Creek fire trail, Namadgi National Park, both showing a significant lip between the culvert and stream.

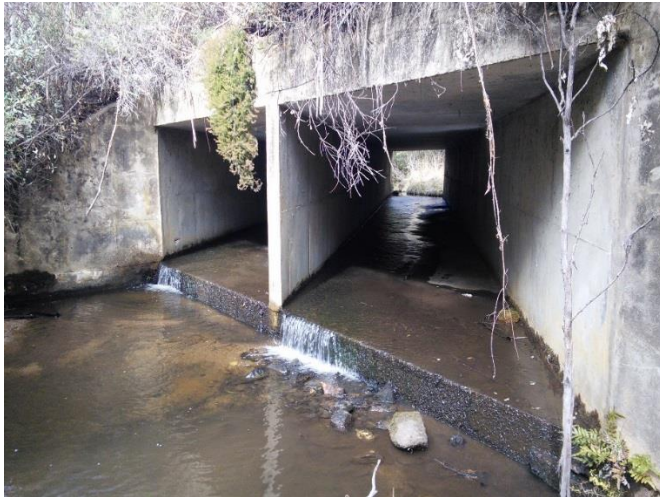
When the base of a crossing is raised above the level of the stream bed the shallow water prevents the movement of fish that need a minimum depth of water to move thorough. In shallow water fish are prevented from swimming, gills are not saturated (resulting in lack of oxygen) and with body designs requiring emersion in water, movement is impaired (Webb 1975). In addition the crossing can dry out completely in times of low stream flow, creating a complete barrier for all fish (Figure 18).

Figure 18. Gibraltar Creek and Corin Road crossing, demonstrating barrier to fish with shallow flow depth in the crossing, this crossing also has a downstream drop.

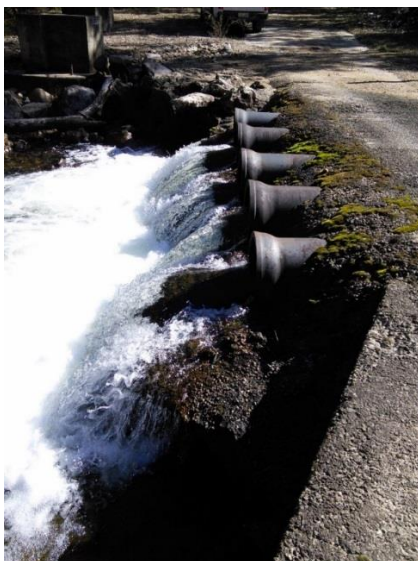
The pressure of water flowing through pipes creates high velocity that acts as a physical barrier which fish are unable to swim through. In sites where water turbulence exceeds the swimming capability of the fish in the area these sites of high velocity are barriers to fish passage (Webb 1975). In the ACT only trout are able to swim through such strong flows (Figure 19).

Figure 19. Crossing of the Cotter River below Bendora Dam showing high velocity of water from pipes and downstream drop.

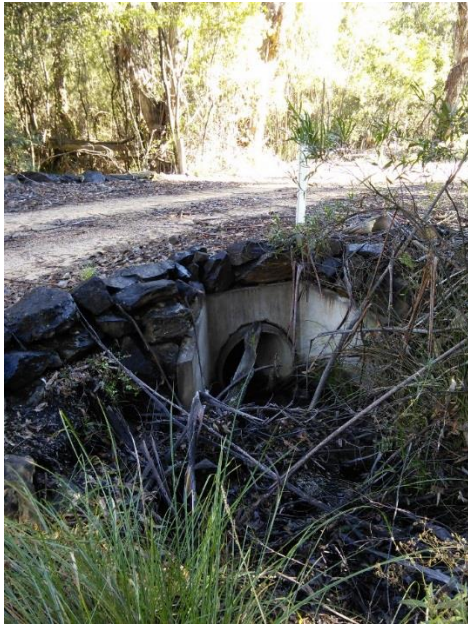
Debris and sediment block fish passage by creating a wall or bank that fish cannot pass. Narrow culverts for example more easily clog up with debris than wider culverts, where the water flow pushes the debris through (Figure 20).

Figure 20. Debris caught at the outlet of a culvert, blocking upstream fish movement, on Warks Road crossing Lees Creek.
