Braddon Place - Block 4 Section 60 Braddon Review of Potential Impacts on adjacent Heritage Places

HEALTH AND CONDITION TREE AUDIT

Arboricultural Impact Assessment

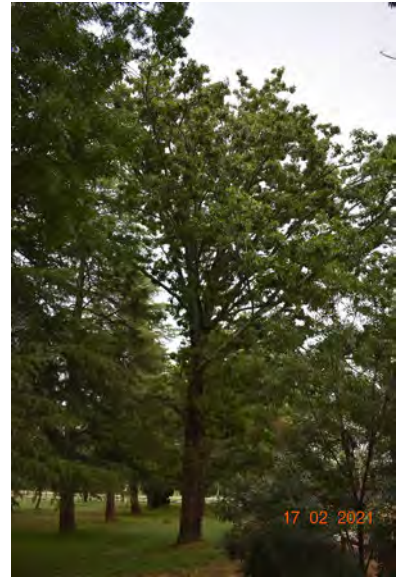
Tree Number: 5 **Botanical Name:** *Cedrus deodara*
Common Name: Deodar Cedar
Origin: Exotic
Height & Width (m): 20 x 9
DBH (cm) 68
TPZ Radius (m): 8.16 **TPZ Impact:** 0%
Health: Fair **TPZ Enchroachment**
Structure: Good **(AS 4970):** No impact
ULE: 10 to 20 years
Landscape Contribution: High
Individual Significance: Valuable
Retention Value: Third party ownership
Comments:

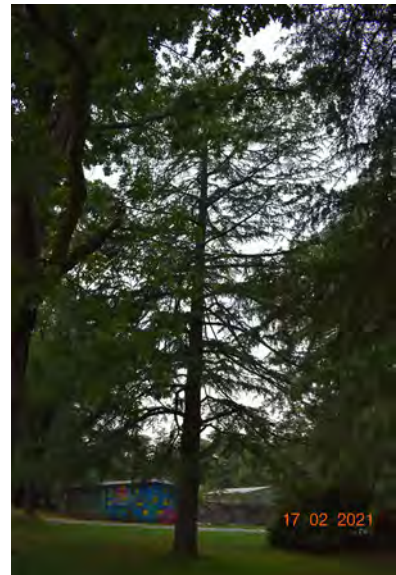
Tree Number: 6 **Botanical Name:** *Cedrus deodara*
Common Name: Deodar Cedar
Origin: Exotic
Height & Width (m): 18 x 13
DBH (cm) 69
TPZ Radius (m): 8.28 **TPZ Impact:** 0%
Health: Fair **TPZ Enchroachment**
Structure: Good **(AS 4970):** No impact
ULE: 10 to 20 years
Landscape Contribution: High
Individual Significance: Valuable
Retention Value: Third party ownership
Comments:

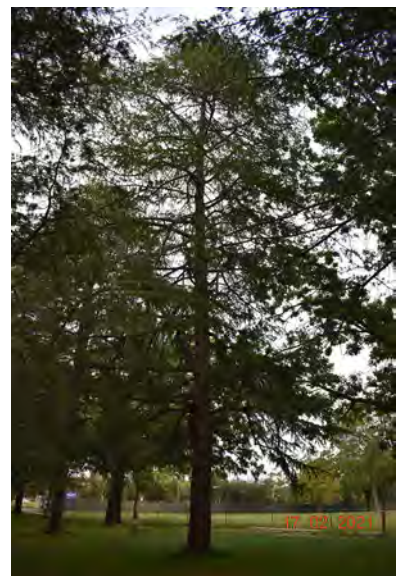
Tree Number: 7 **Botanical Name:** *Cedrus deodara*
Common Name: Deodar Cedar
Origin: Exotic
Height & Width (m): 17 x 10
DBH (cm) 60
TPZ Radius (m): 7.2 **TPZ Impact:** 0%
Health: Fair **TPZ Enchroachment**
Structure: Fair **(AS 4970):** No impact
ULE: 10 to 20 years
Landscape Contribution: High
Individual Significance: Valuable
Retention Value: Third party ownership
Comments:

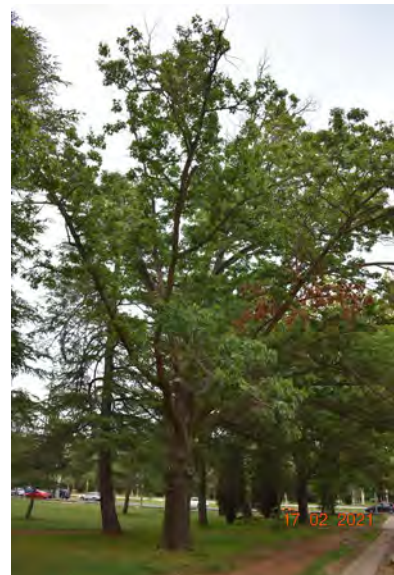
Tree Number: 9 **Botanical Name:** *Cedrus deodara*
Common Name: Deodar Cedar
Origin: Exotic
Height & Width (m): 20 x 13
DBH (cm) 72
TPZ Radius (m): 8.64 **TPZ Impact:** 0%
Health: Fair **TPZ Enchroachment**
Structure: Good **(AS 4970):** No impact
ULE: 10 to 20 years
Landscape Contribution: High
Individual Significance: Valuable
Retention Value: Third party ownership
Comments:

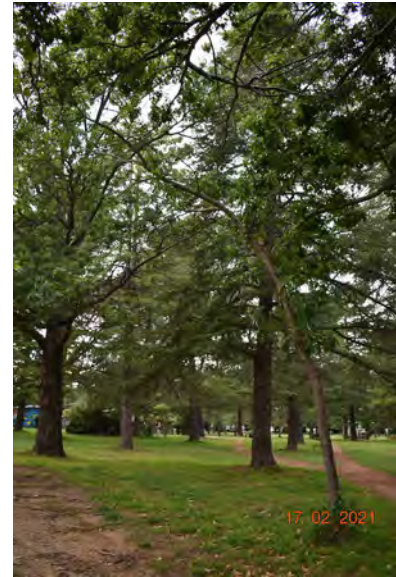
Tree Number: 11 **Botanical Name:** *Cedrus deodara*
Common Name: Deodar Cedar
Origin: Exotic
Height & Width (m): 19 x 10
DBH (cm) 59
TPZ Radius (m): 7.08 **TPZ Impact:** 0%
Health: Fair **TPZ Enchroachment**
Structure: Good **(AS 4970):** No impact
ULE: 10 to 20 years
Landscape Contribution: High
Individual Significance: Valuable
Retention Value: Third party ownership
Comments:

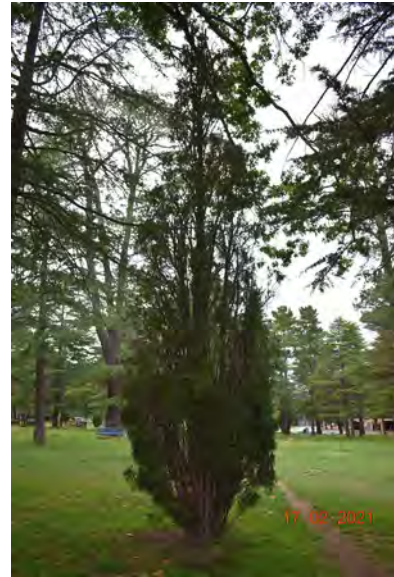
Tree Number: 14 **Botanical Name:** *Cedrus deodara*
Common Name: Deodar Cedar
Origin: Exotic
Height & Width (m): 17 x 12
DBH (cm) 81
TPZ Radius (m): 9.72 **TPZ Impact:** 0%
Health: Fair **TPZ Enchroachment**
Structure: Good **(AS 4970):** No impact
ULE: 10 to 20 years
Landscape Contribution: High
Individual Significance: Valuable
Retention Value: **Third party ownership**
Comments:
