# **SURVEY OF VEGETATION AND HABITAT IN KEY RIPARIAN ZONES OF TRIBUTARIES OF THE MURRUMBIDGEE RIVER IN THE ACT: Naas, Gudgenby, Paddys, Cotter and Molonglo Rivers**

Technical Report 23

November 2011

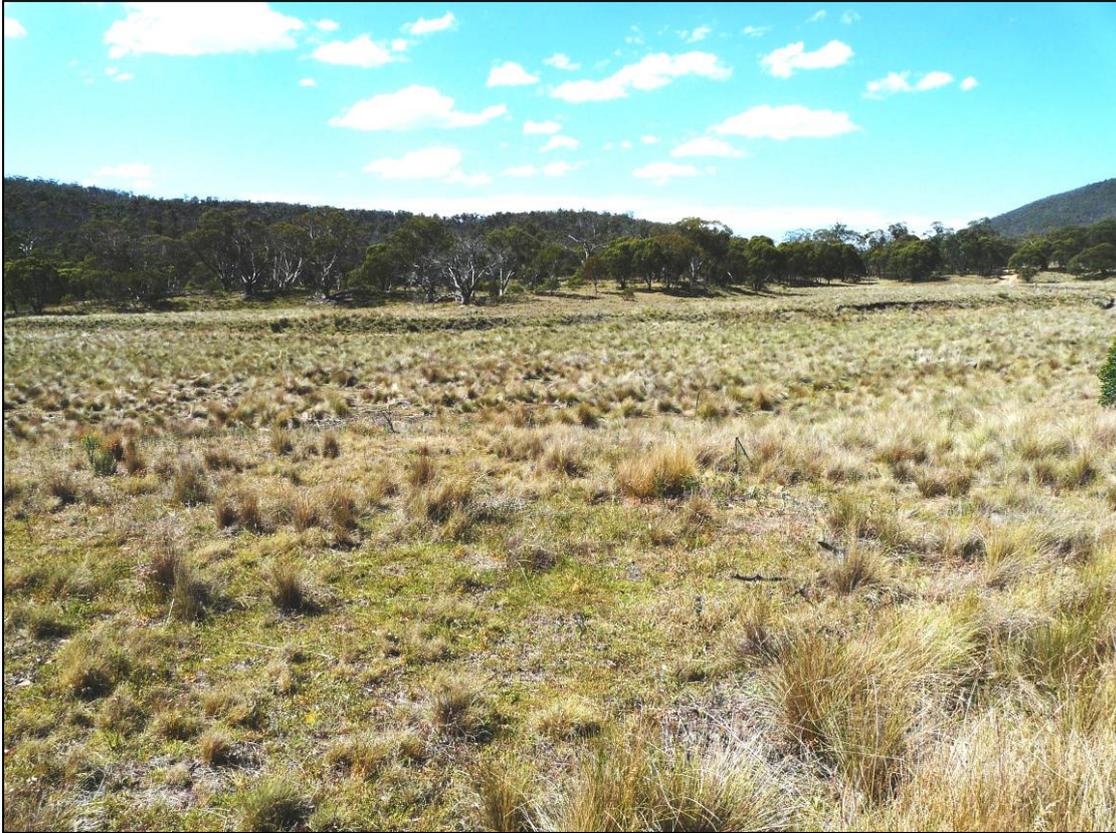
The river rises in Tableland Wet Tussock Grassland surrounded by Snow Gum Montane Woodland (Plate 3.1; Maps 3.1a, 3.2a, 3.3a). The riparian vegetation has a high condition ranking (see Appendix 3A). The river flows through alternating sections of open tussock grassland in the valley floor and Snow Gum Montane Woodland. Where the river passes through woodland, the riparian zone is dominated by *E. stellulata* with *E. pauciflora* and scattered *E. rubida* on the hillslope.

**Plate 3.1: Tableland Wet Tussock Grassland in the upper Naas Valley**

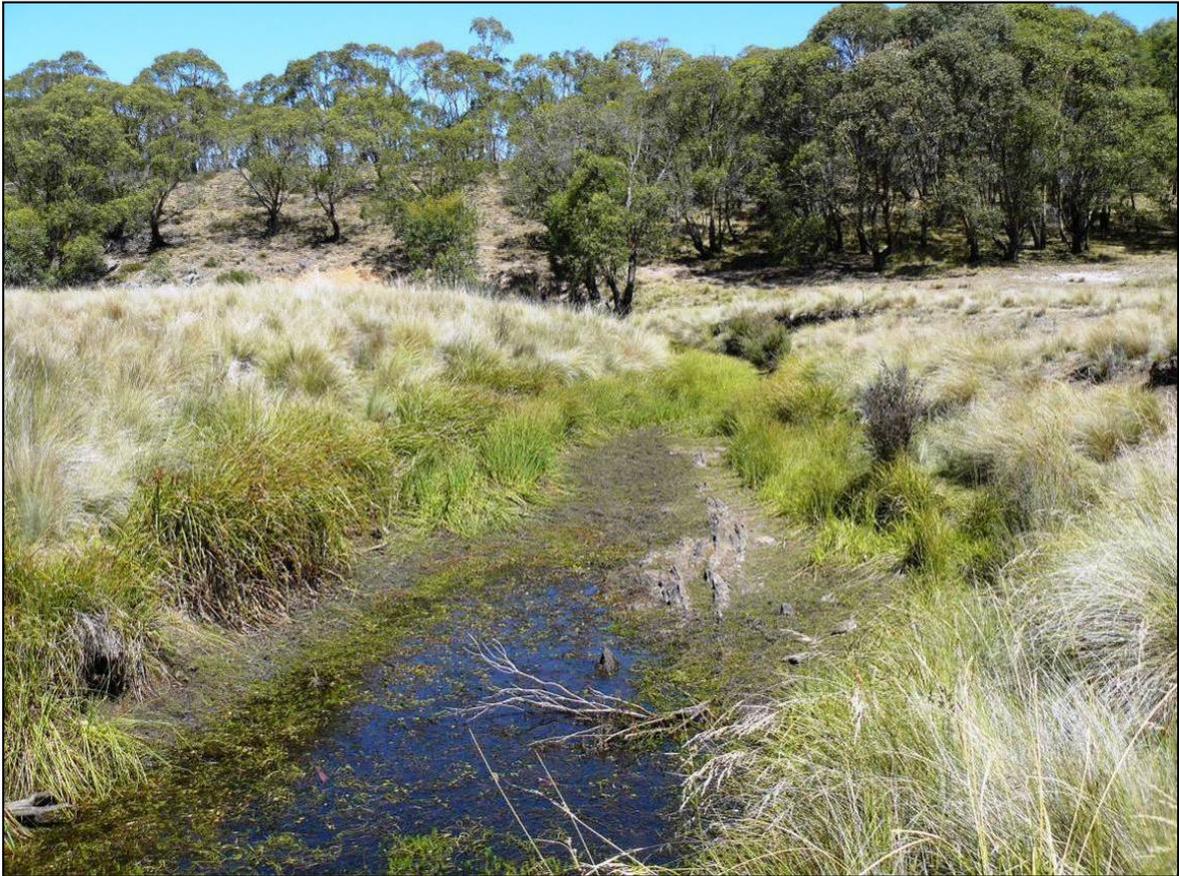
**Plate 3.2: Tableland Aquatic and Fringing Vegetation Complex in the upper section of Naas Creek**

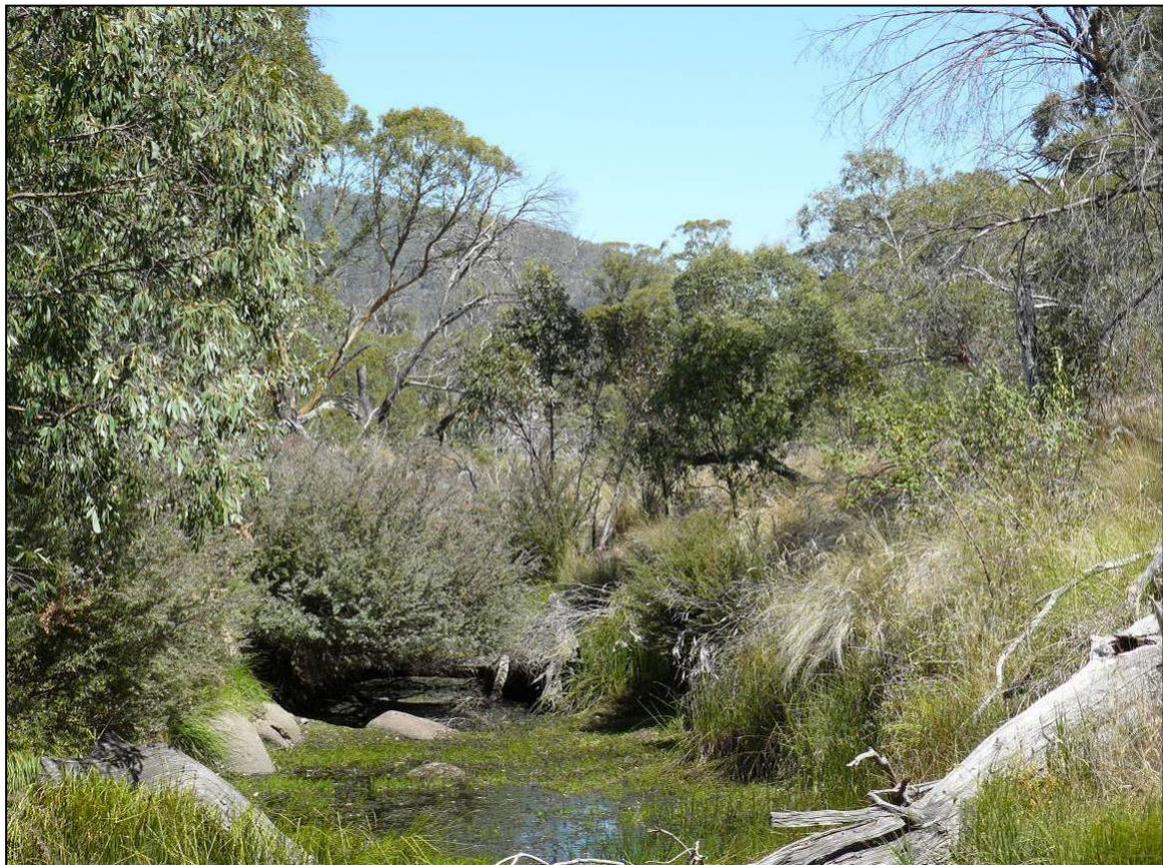
**Plate 3.3: Tableland Aquatic and Fringing Vegetation Complex in Naas Creek at Mt Clear**

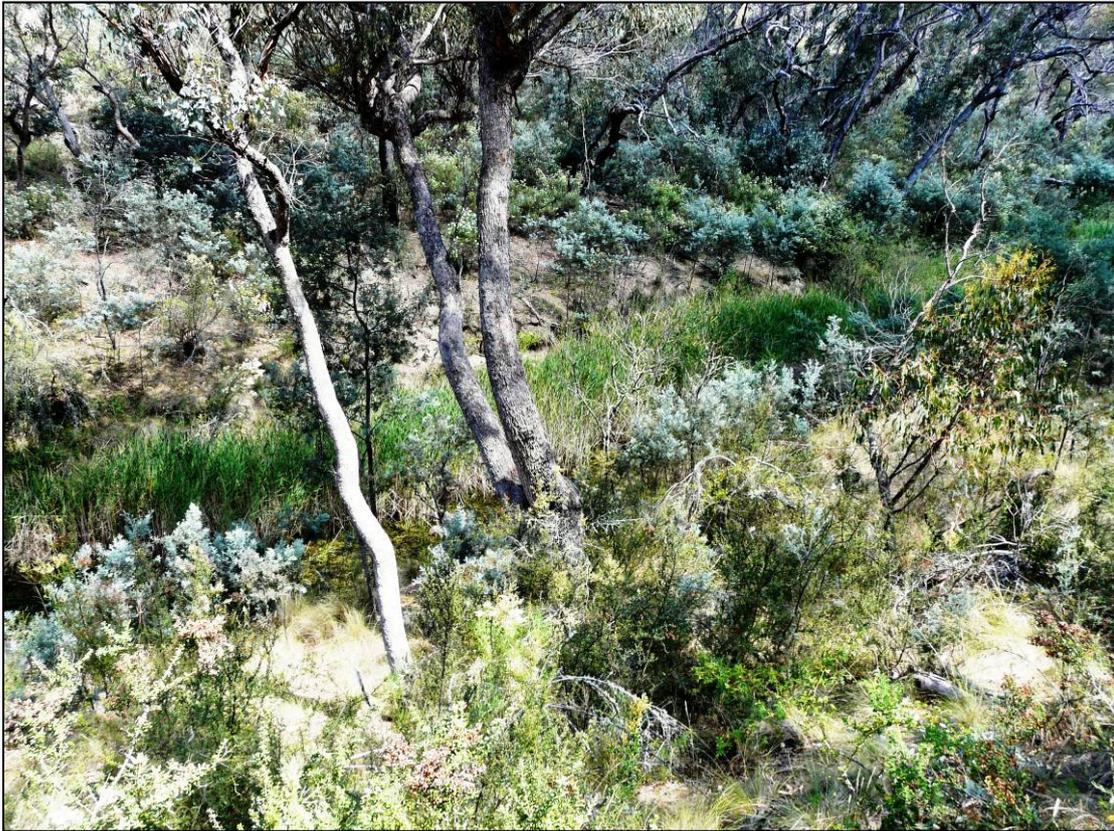
Fringing Vegetation Complex) (Plates 3.2, 3.3). A section of river near Mt Clear also has patches of fringing *Phragmites australis* (Plate 3.4). The only weeds in the open valley appear to be the occasional *Rosa rubiginosa* and *Verbascum thapsus*. The area achieves a high condition ranking, having no visible disturbance and a high density of native vegetation cover.

**Plate 3.4: Tableland Aquatic and Fringing Vegetation Complex dominated by *Phragmites australis***

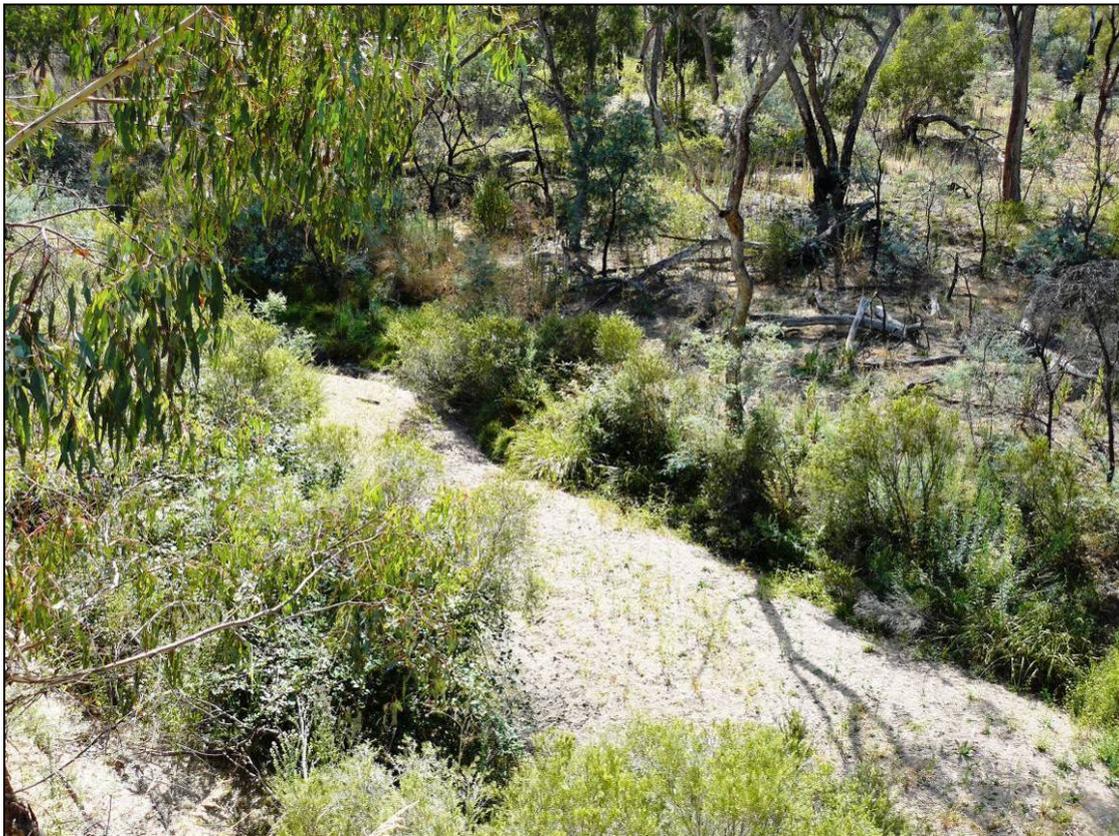
Shrubs in the riparian River Bottlebrush – Burgan Tableland Riparian Shrubland include *A. melanoxylon*, *C. sieberi*, *A. dealbata*, *L. obovatum*, *G. pulchella* (Plate 3.5). On the hillslope the vegetation community remains Broad-leaved Peppermint – Apple Box Tableland Woodland but many *E. blakelyi* seedlings are visible on the hillslope (regenerating post-2003 fire). *Bothriochloa macra* is present in parts and the occasional *E. stellulata*. As in areas upstream, the riparian zone is still in excellent condition with only minor occurrences of weeds such as *V. thapsus*, *Portulaca* sp. and *H. incana* at river crossings and along roadsides.

**Plate 3.5: River Bottlebrush – Burgan Tableland Riparian Shrubland**

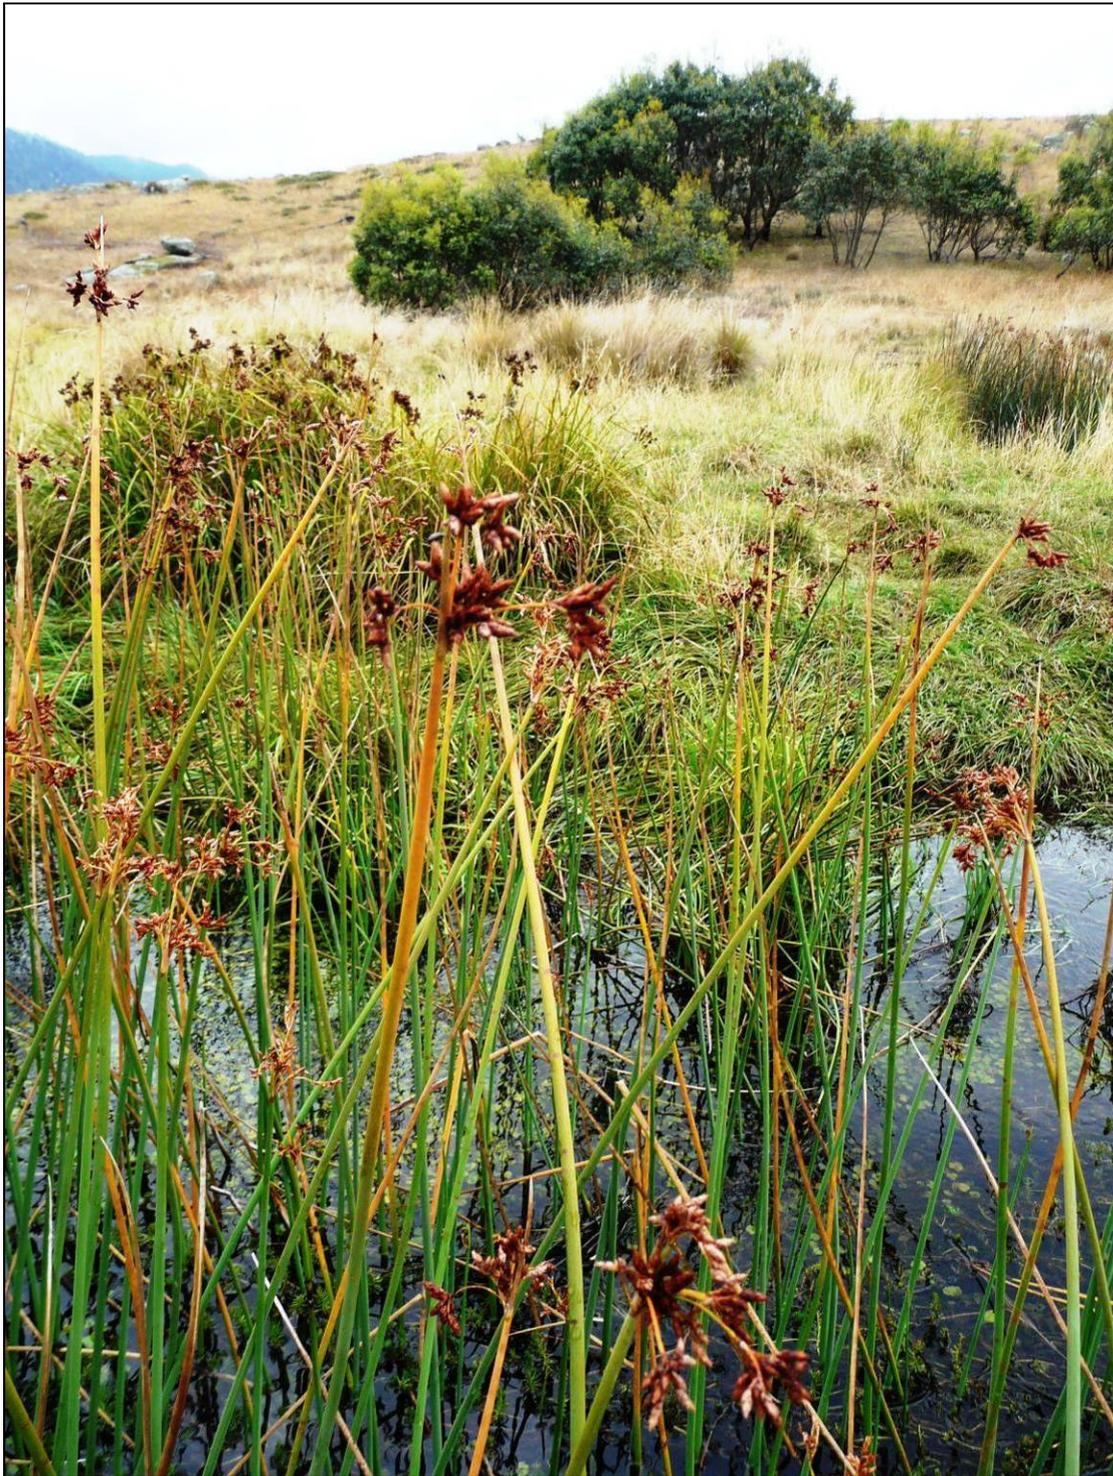
**Plate 4.1: *Schoenoplectus validus* at the confluence of Bogong and Middle creeks, upper Gudgenby River**

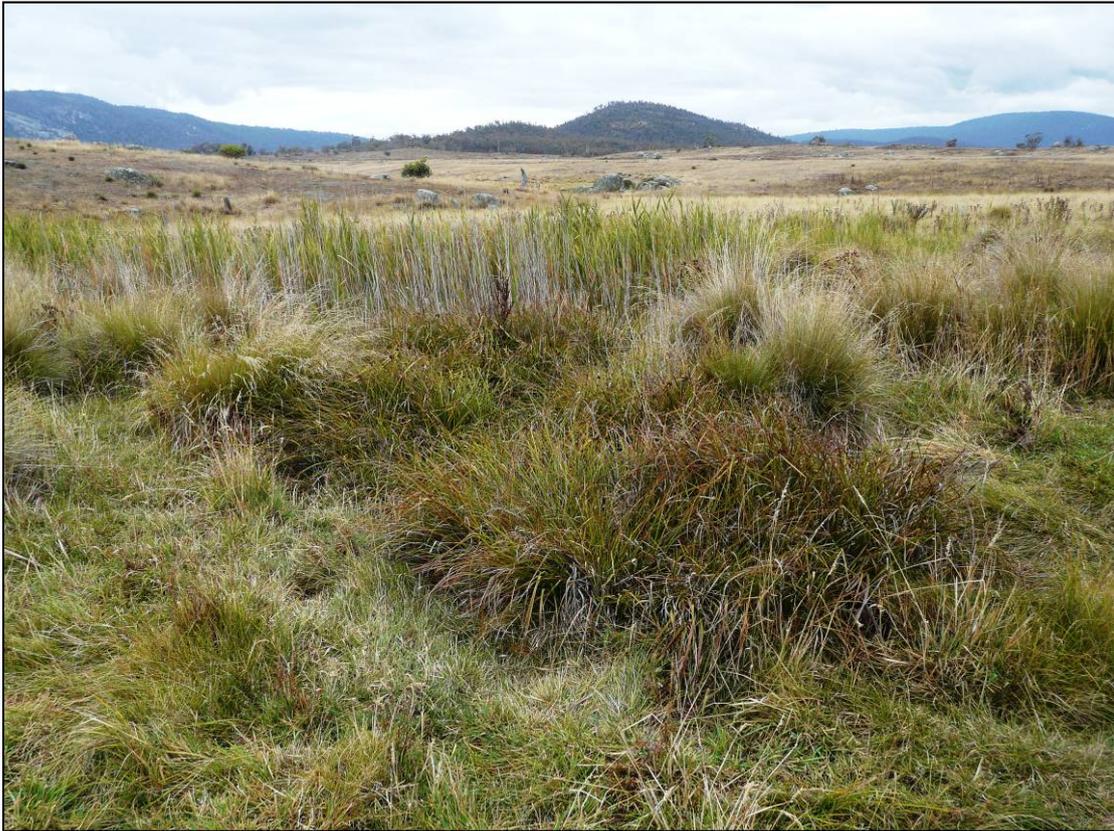
**Plate 4.2: *Bolboschoenus* sp., upper Gudgenby River**

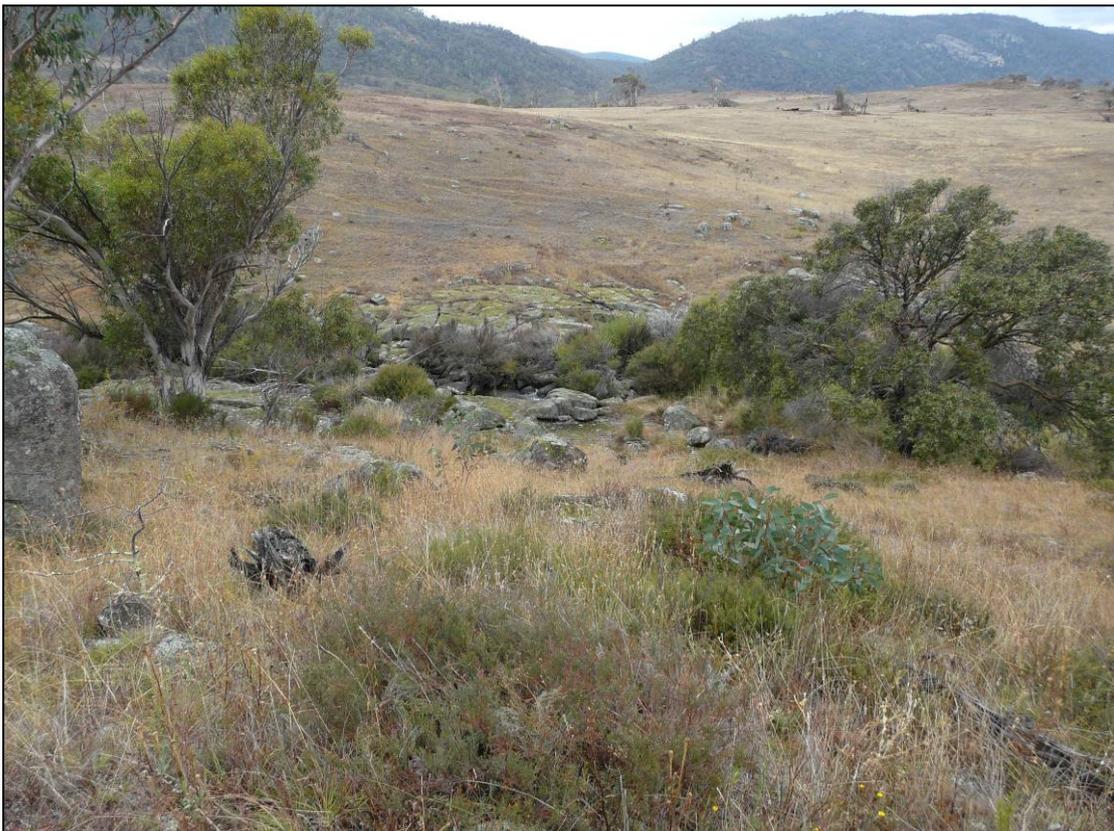
The adjacent hillslope vegetation community is Snow Gum Montane Woodland with *E. stellulata* closest to the river and *E. pauciflora* and *E. rubida* further up the slopes. Shrubs and grasses include *T. triandra*, *Cratageous monogyna*, and *Hakea* sp. (Plate 4.3).

**Plate 4.3: Snow Gum Montane Woodland near the source of the Gudgenby River**

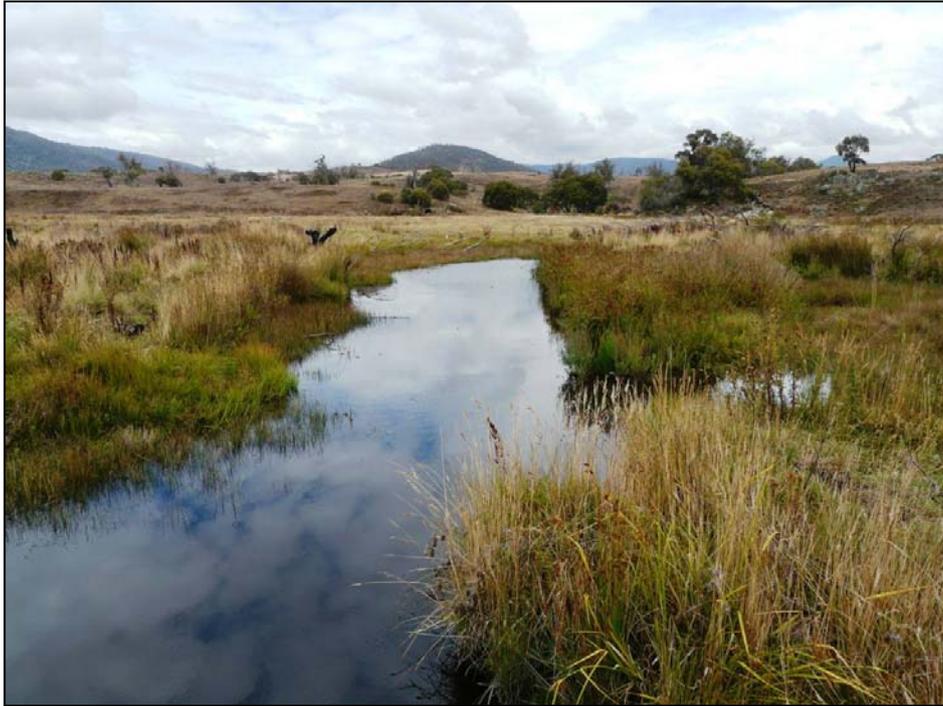
**Plate 4.4: Submerged and Emergent Herbland sub-community at Hospital Creek, Gudgenby River**

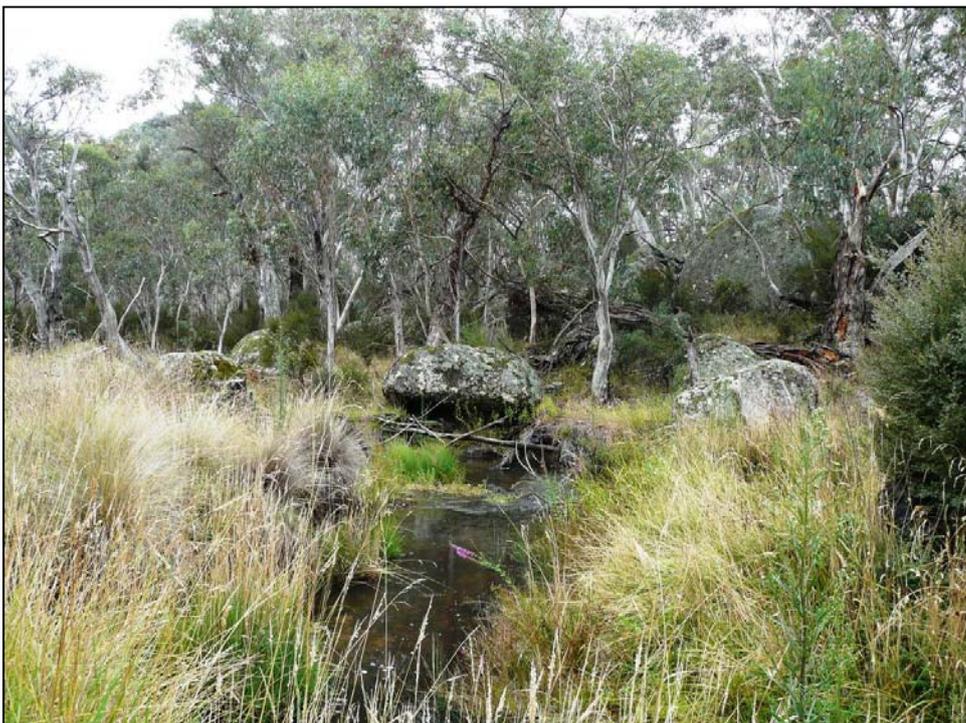
Snow Gum Montane Woodland persists, with *E. stellulata* on the flats closest to the river and *E. pauciflora* and *E. rubida* up the hillslope (Plate 4.5). Excluding the few old willows resprouting along the river and on the flats, willow management has been successful along this section. Although the area was heavily impacted by the 2003 bushfire, the trees are regenerating well and should recover to pre-fire condition with time. There is no sign of fire effects in the grass and shrub layer.

**Plate 4.5: Snow Gum Montane Woodland, Gudgenby River near Gudgenby homestead**

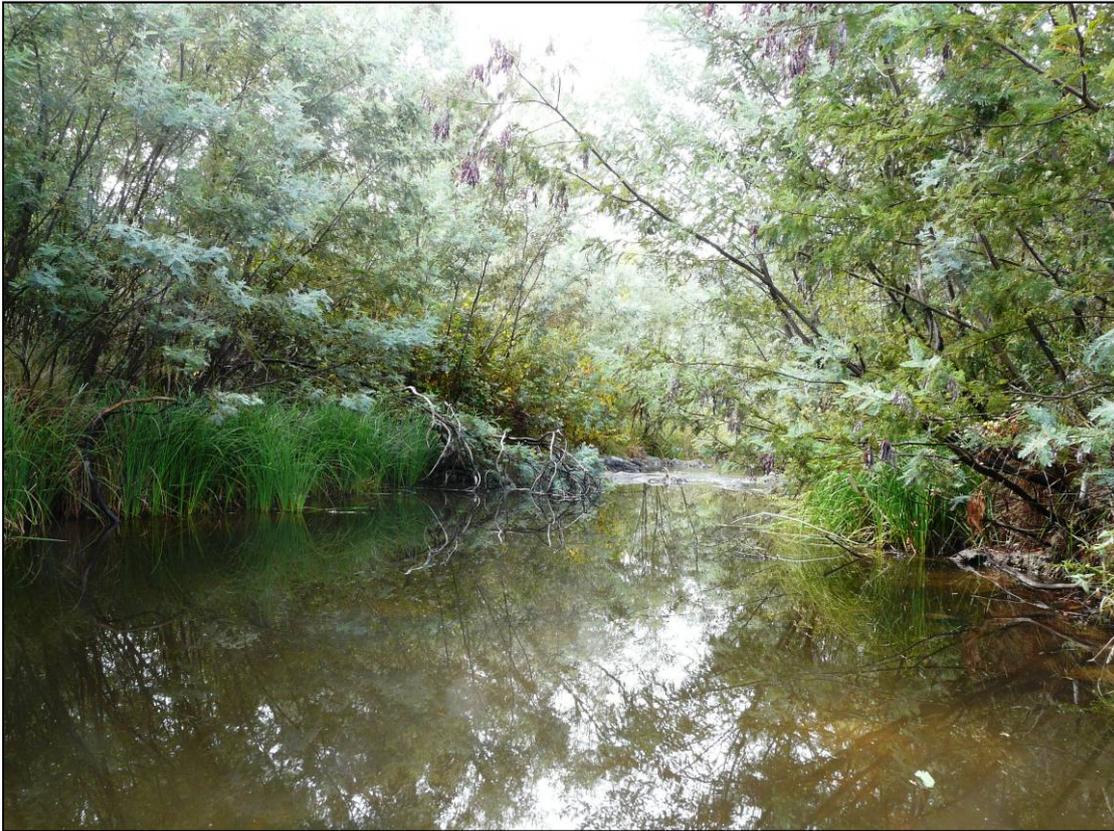
The riparian vegetation above Glendale Depot (Namadgi National Park) changes to River Bottlebrush – Burgan Tableland Riparian Shrubland, dominated by an *A. dealbata* fringe on the river (Plate 4.7). The hillslope community changes to Broad-leaved Peppermint – Apple Box Tableland Woodland, although *E. pauciflora* and scattered *E. rubida* still occur.

Plate 4.7: *Acacia dealbata* shrubland on the Gudgenby River, near Glendale Depot

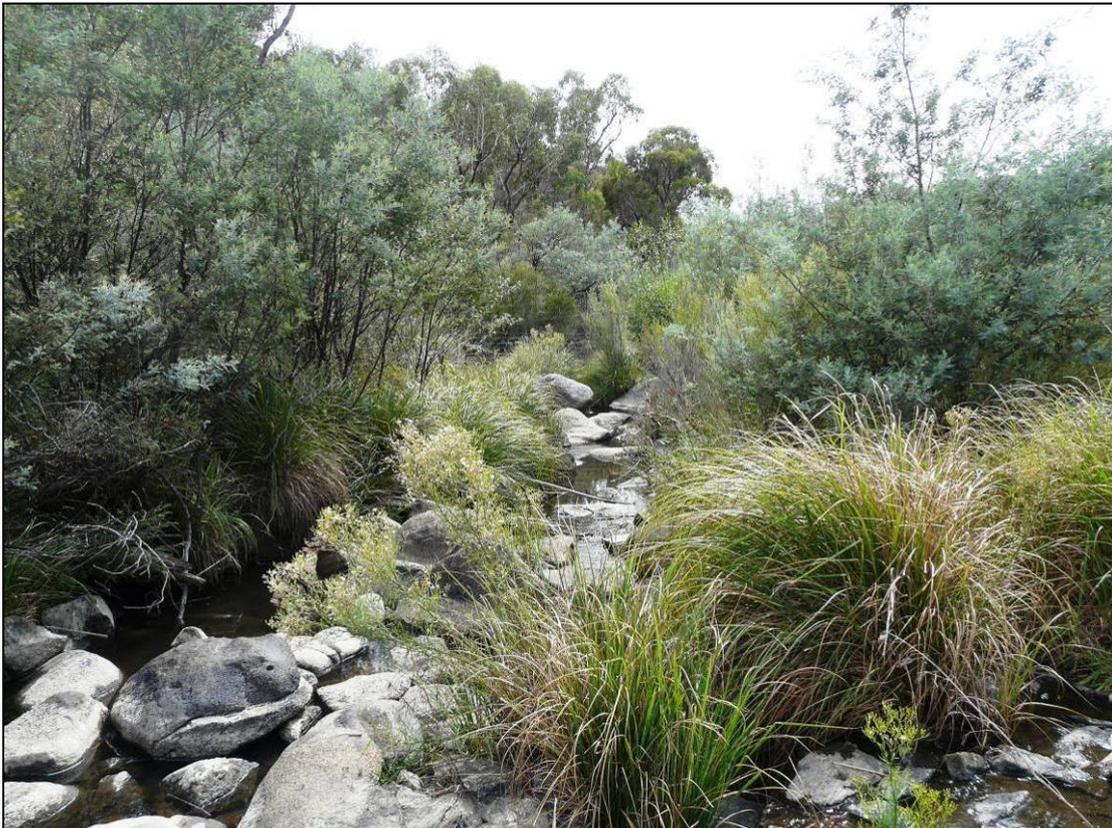
At the Orroral Road causeway the river becomes an artificially wide pool with a constructed boulder stream below. *Salix babylonica* is growing in the upstream section with the pasture grass, *Phalaris sp.*, understorey and native fringing species including *P. australis*, *C. sieberi* and *Bolboschoenus sp.* The adjacent shrubland includes *A. dealbata*, *G. pulchella*, *L. obovatum*, *Lomatia sp.*, *R. parvifolius*, *C. longifolia*, *K. ericoides* and *P. labillardierei* with the occasional *E. bridgesiana*, *E. dives* and *E. dalrympleana* on the slopes. Valley slope species (especially on the gentler western side) include *E. pauciflora* and or *E. dives* woodland with rich shrub diversity (Plate 4.8).

**Plate 4.8: River Bottlebrush – Burgan Tableland Riparian Shrubland (dominated by *Acacia dealbata*) below causeway on Orroral Road**

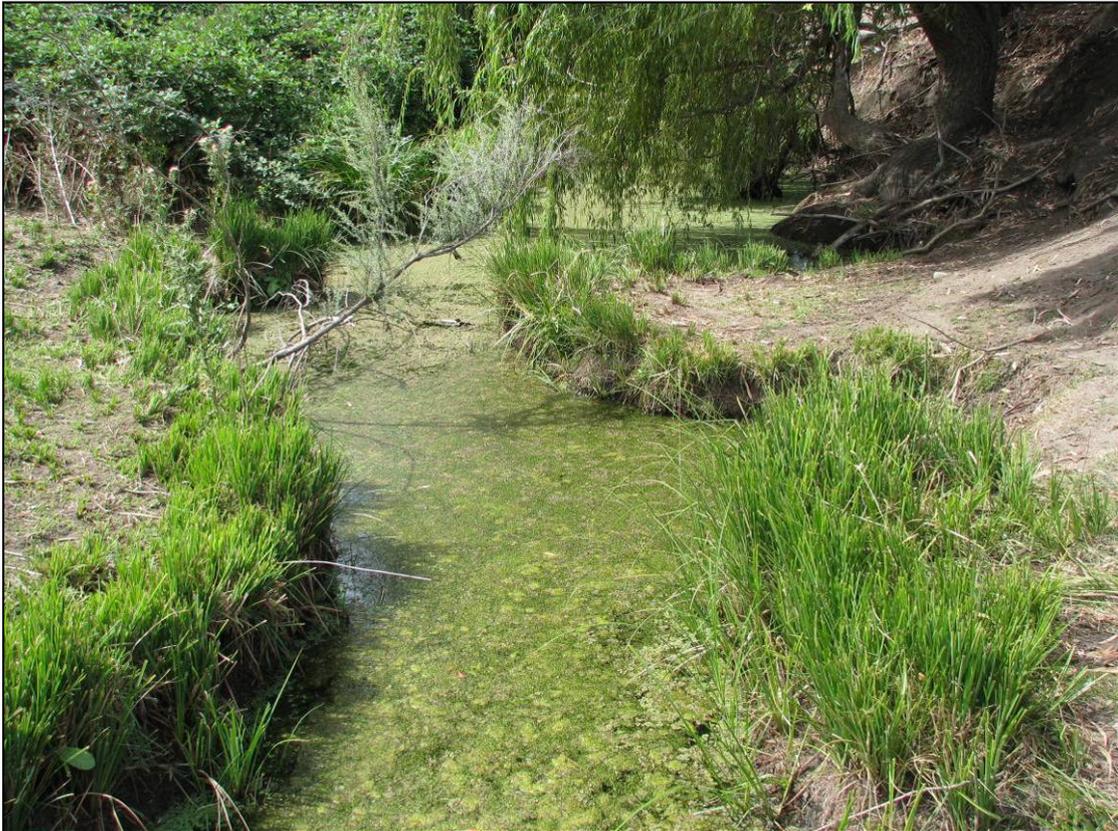
**Plate 4.10: Tableland Aquatic and Fringing Vegetation Complex surrounding offstream wetland Gudgenby River**

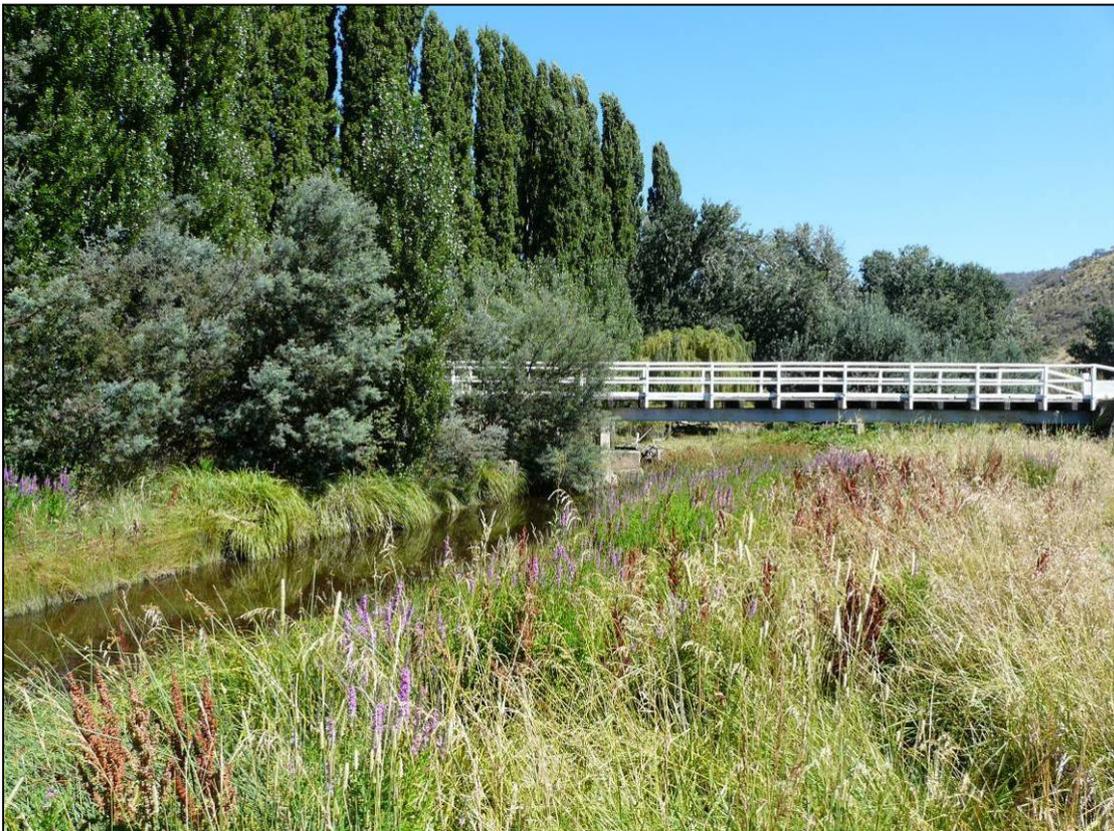
**Plate 4.13: Poplars along the Gudgenby River at Naas Bridge upstream of Naas River confluence**

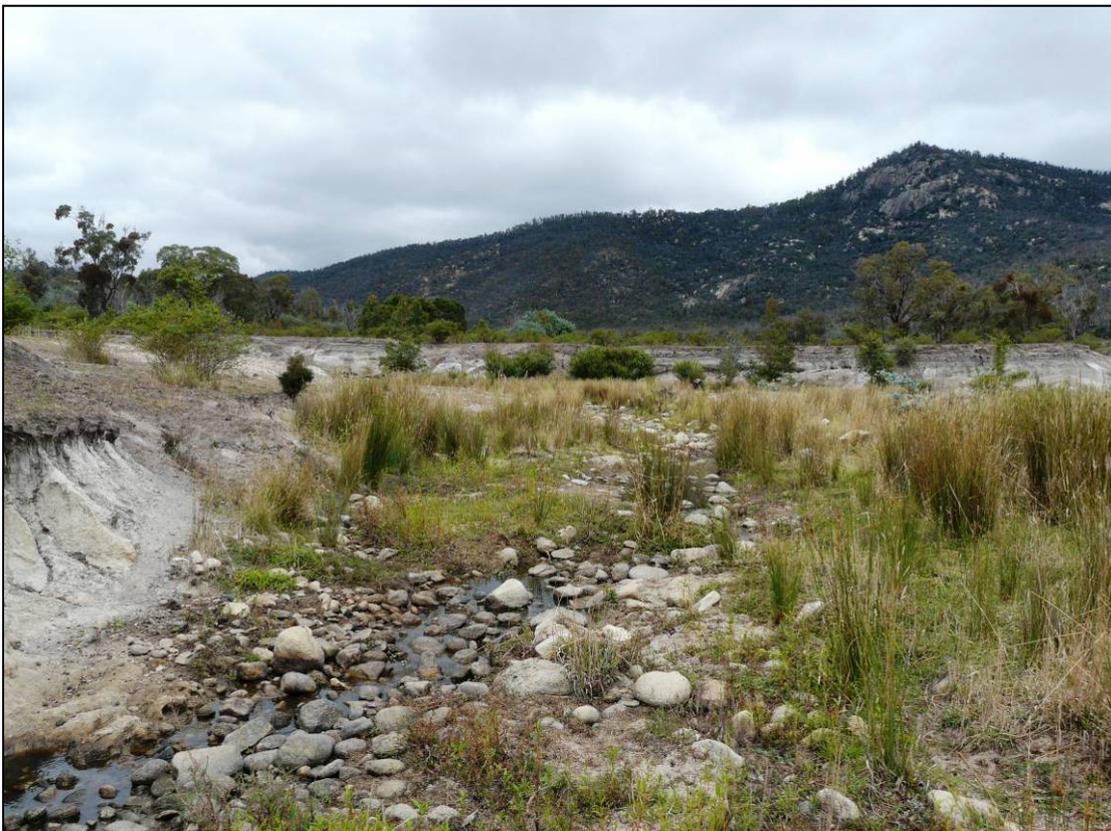
This reach is approximately 7.3 km in length and occurs entirely within rural land (Appendix 5A Maps 5.1a, 5.2a). The Paddys River rises at the confluence of Blue Gum and Punchbowl creeks in a sparsely timbered, wide valley of Fen/Sedge Montane Wet Tussock Grassland. The river bed itself is deeply incised, wide and heavily eroded by past flood events, land modification and grazing pressure. This erosion has caused exposure and dessication of the sedgeland and created a new riparian zone within the incised river bed (Plate 5.1).

**Plate 5.1: Paddys River, broadening of the channel below confluence of Blue Gum and Punchbowl creeks**

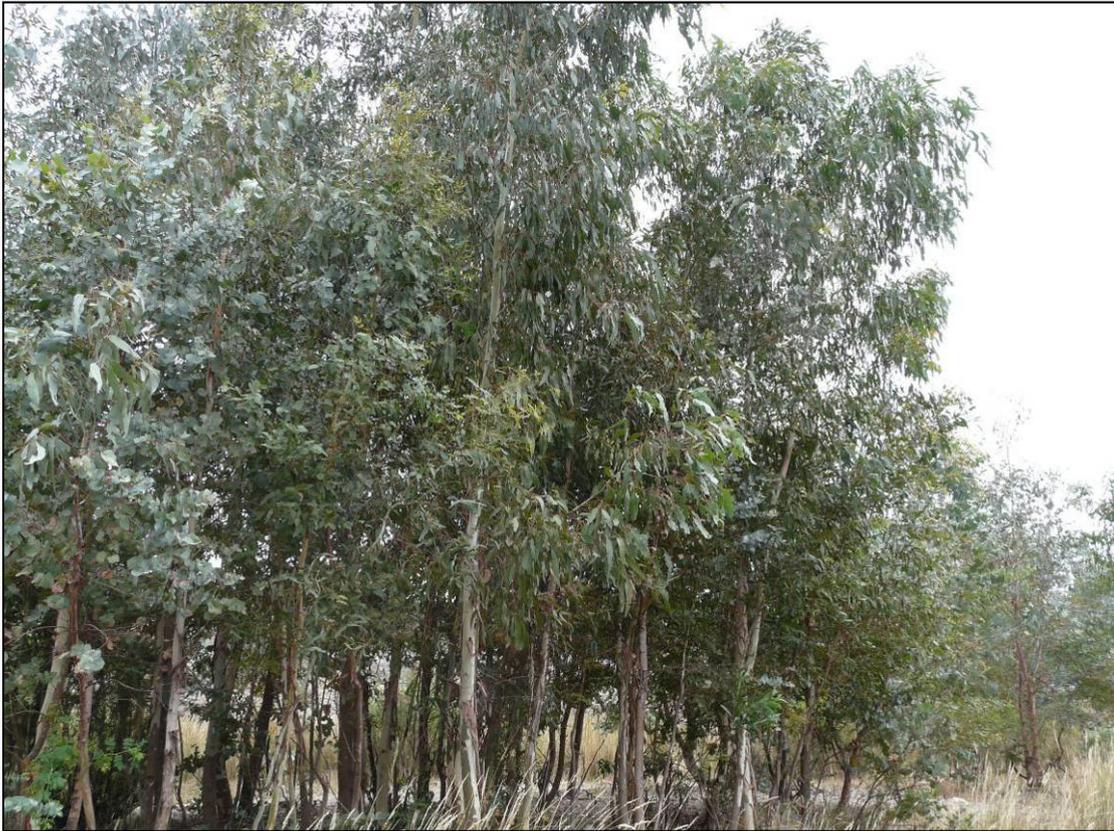
**Plate 5.2: *Eucalyptus viminalis* and *Eucalyptus bridgesiana* saplings above source of Paddys River**

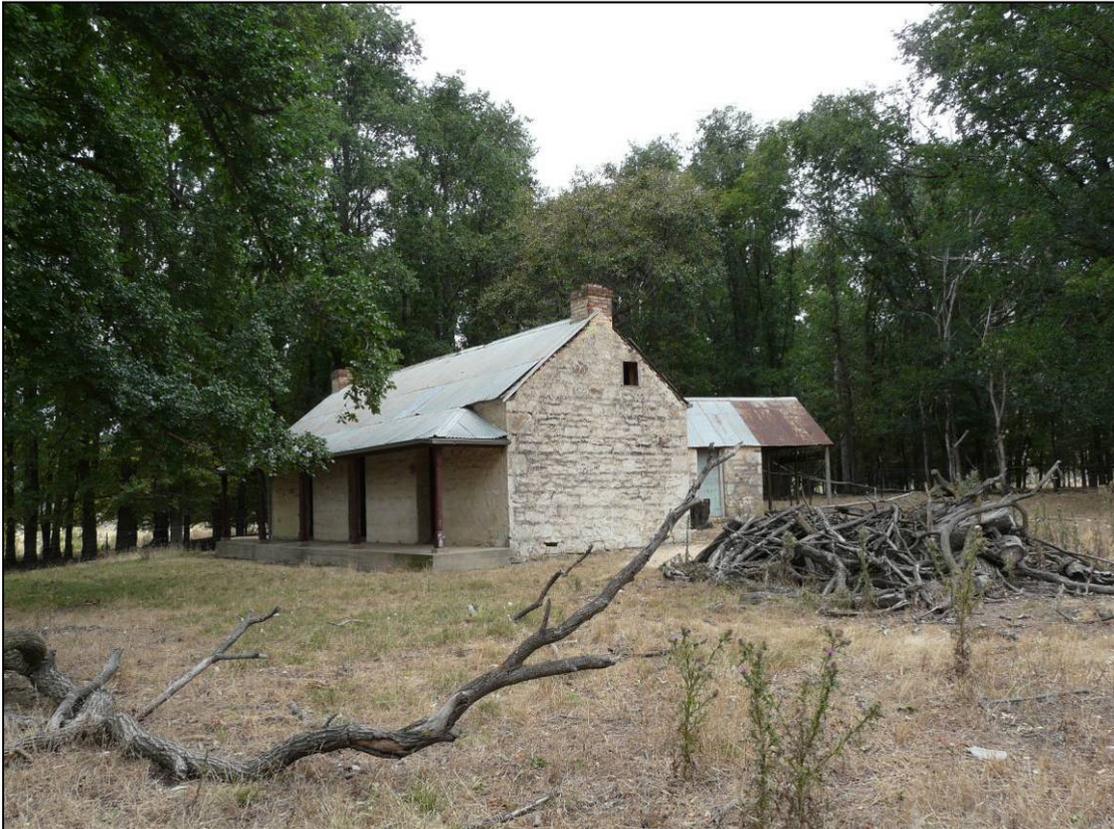
The adjacent valley slope is relatively treeless and contains River Bottlebrush – Burgan Tableland Riparian Shrubland. *E. rubida* and *E. bridgesiana* are scattered on the valley floor with coppices of unique assemblages in drainage lines such as *E. bridgesiana*, *E. viminalis* and the occasional *E. rossii*, *E. stellulata* and *E. pauciflora*. Exotic trees planted near Punchbowl Creek, above the old McKeahnie house ‘Blythburn Cottage’, are well established. These include *Ulmus procera* and *Pinus* spp. (Plate 5.3).

**Plate 5.3: Blythburn Cottage with exotic tree plantings**

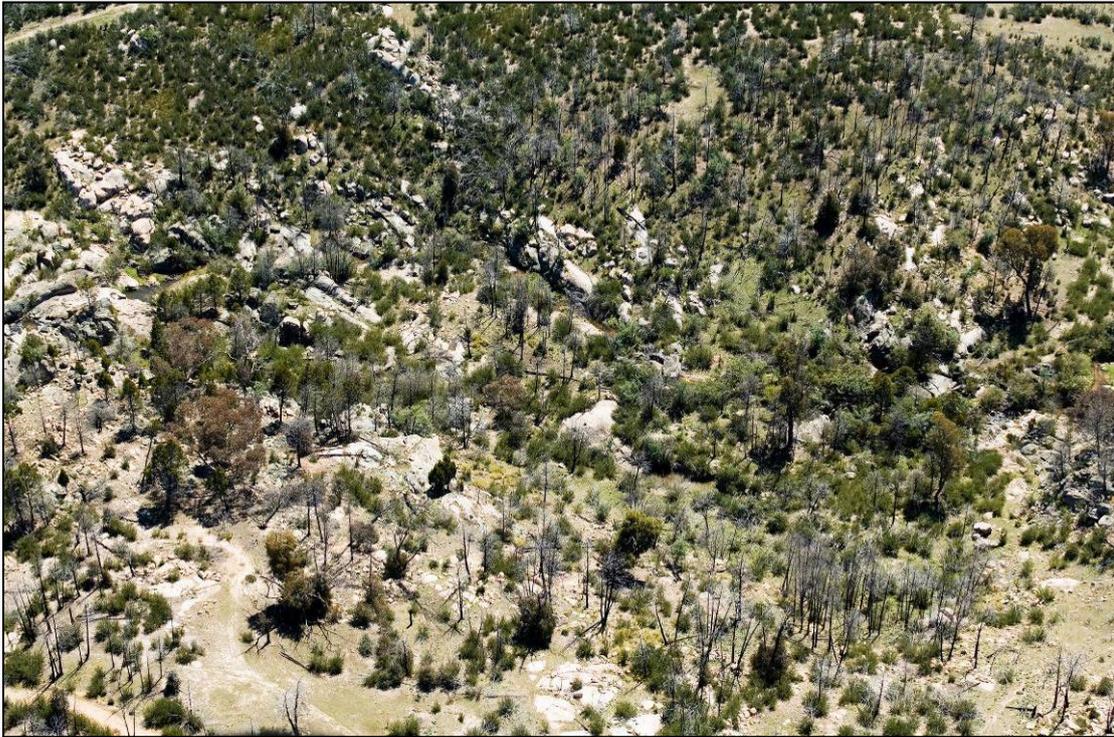
The riparian vegetation is River Bottlebrush – Burgan Tableland Riparian Shrubland dominated by *K. ericoides* and *A. dealbata* in parts, especially in rocky riffle/run areas. At such locations rocky niches in the adjacent hillslope provide a refuge for many native shrubs. Black Cypress Pine Tableland Woodland occurs on the hillslope north of the Booroomba Road and although heavily affected by fire, appears to be recovering well with many small seedlings and the occasional mature tree visible (Plate 5.5).

**Plate 5.5: Black Cypress Pine Tableland Woodland on Paddys River north of Booroomba**

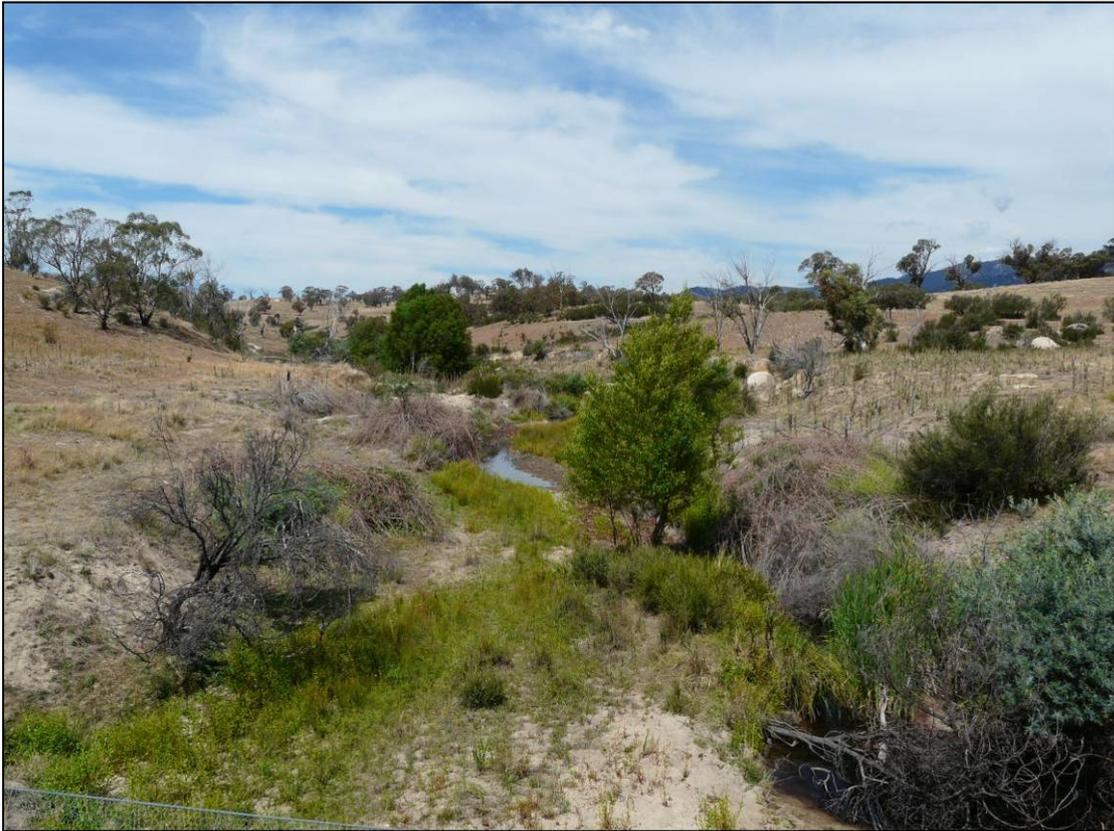
Some sections of river contain River Bottlebrush – Burgan Tableland Riparian Shrubland dominated by *A. dealbata* and *K. ericoides* with a high cover of blackberry, many willows in parts, and a long stretch of planted poplars. The adjacent valley slope is highly modified rural land with pasture grasses the dominant ground cover. Some patches of remnant Snow Gum – Candle Bark Tableland Woodland occur in frost hollow areas with Broad-leaved Peppermint – Apple Box Tableland Woodland comprising the remainder. In some sections, the scattered trees may represent remnants of Yellow Box – Blakely’s Red Gum Tableland Grassy Woodland (Plate 5.6).

**Plate 5.6: Paddys River, upstream from Discovery Road bridge**

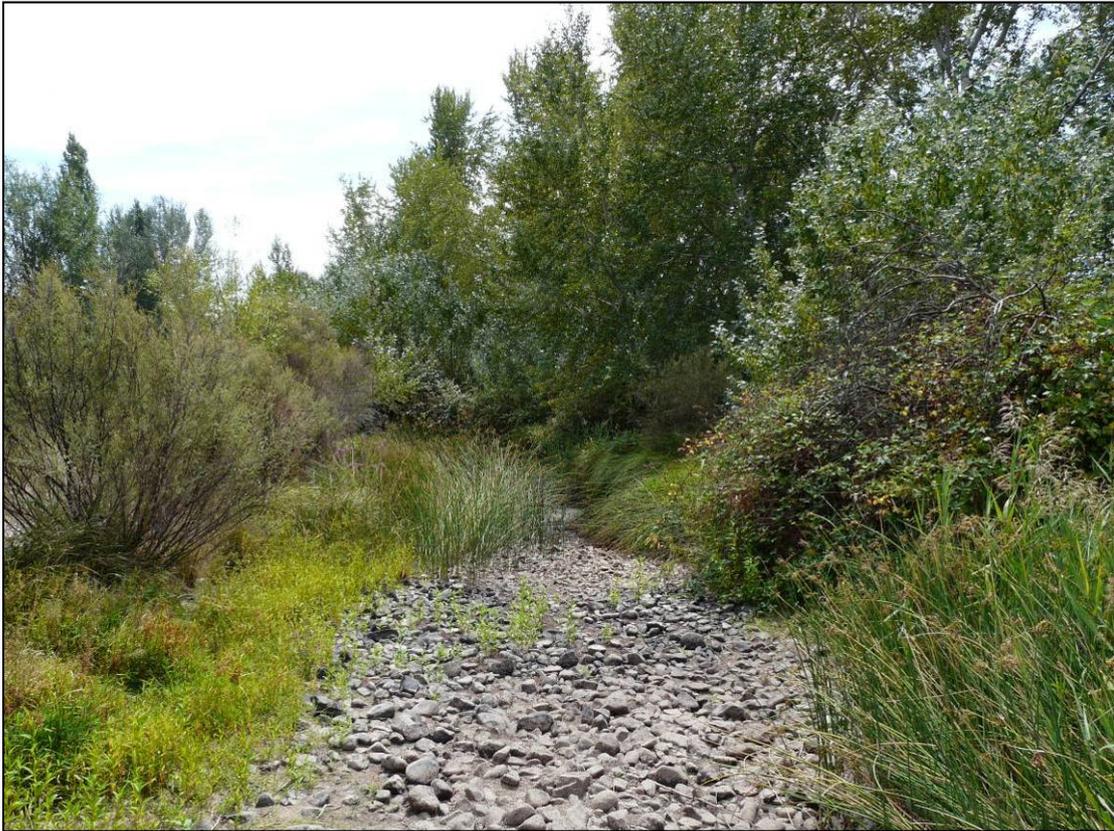
There is a partially cleared stand of *P. radiata* on 'Miowera' property (now being colonised by Burgan Derived Tableland Shrubland) as well as intact stands of mature trees. As the river continues through to Tanners Flat the landscape remains highly modified rural land dominated by exotic trees and understorey in both the riparian zone (a broad floodplain) and adjacent valley slope. In the riparian zone, native species that do occur include *L. obovatum*, *K. ericoides*, *A. dealbata*, *A. siculiformis*, *Phragmites* sp., *Cyperus* sp., *Schoenoplectus* sp., *Carex* sp., *Mentha* sp., *Persicaria* sp., *Rumex* sp., *Bolboschoenus* sp. Introduced species (including some ACT declared pest plants) include *Eragrostus curvula*, *Cardus nutans*, *Phalaris aquatica*, *V. bonariensis*, *Conyza bonariensis* and *Lactuca serrulata* (Plate 5.7).

**Plate 5.7: Paddys River at Tanners Flat**

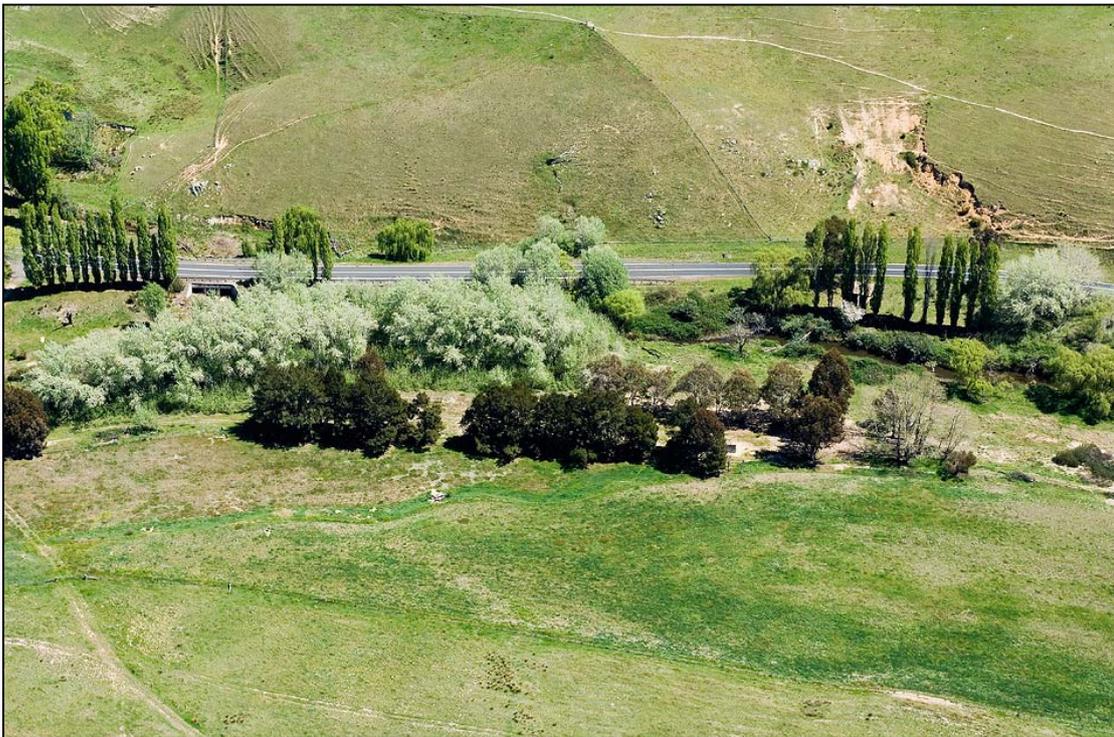
A mixture of exotic trees including poplars, willows (*S. nigra*, *S. babylonica*, *S. fragilis*) and elms (*Ulmus* sp.) occur within the riparian zone along with dense blackberries. Plantings of *C. cunninghamiana* and *Eucalyptus globulus* occur nearby on the adjacent valley slope at the edge of the broad floodplain. A solitary remnant mature *E. viminalis* suggests that the area may have formerly been Ribbon Gum Tableland Riparian Woodland. The river continues through this highly modified and degraded rural landscape (Plate 5.8) to the gorge, where the vegetation is in a more native state.

**Plate 5.8: Paddys River in highly modified rural land at Tanners Flat**

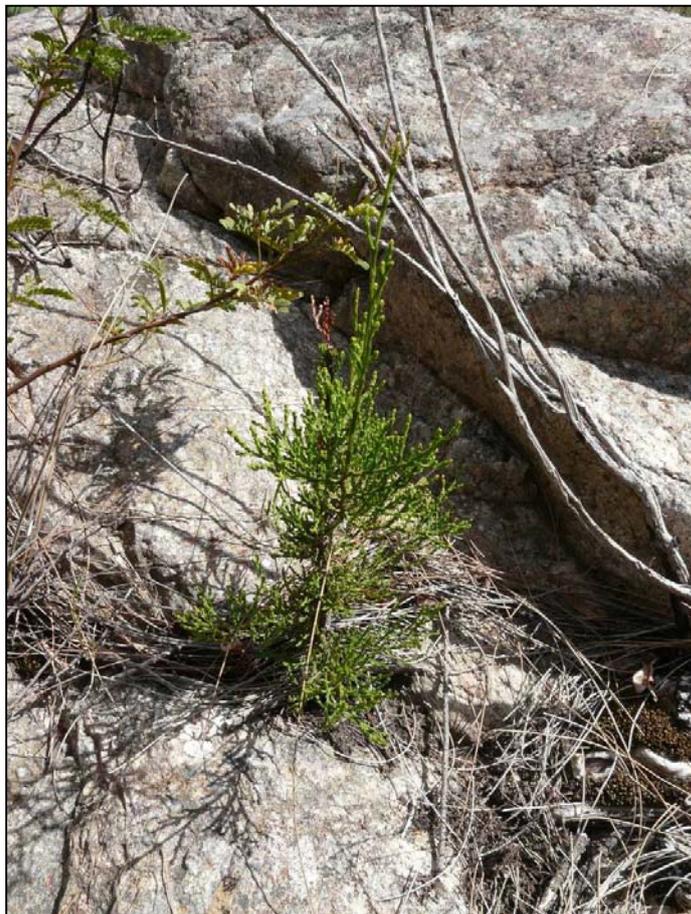
**Plate 5.9: *Callitris endlicheri* seedling regeneration post-2003 bushfire in the gorge on the Paddys River**
