# **SURVEY OF VEGETATION AND HABITAT IN KEY RIPARIAN ZONES OF TRIBUTARIES OF THE MURRUMBIDGEE RIVER IN THE ACT: Naas, Gudgenby, Paddys, Cotter and Molonglo Rivers**

Technical Report 23

November 2011

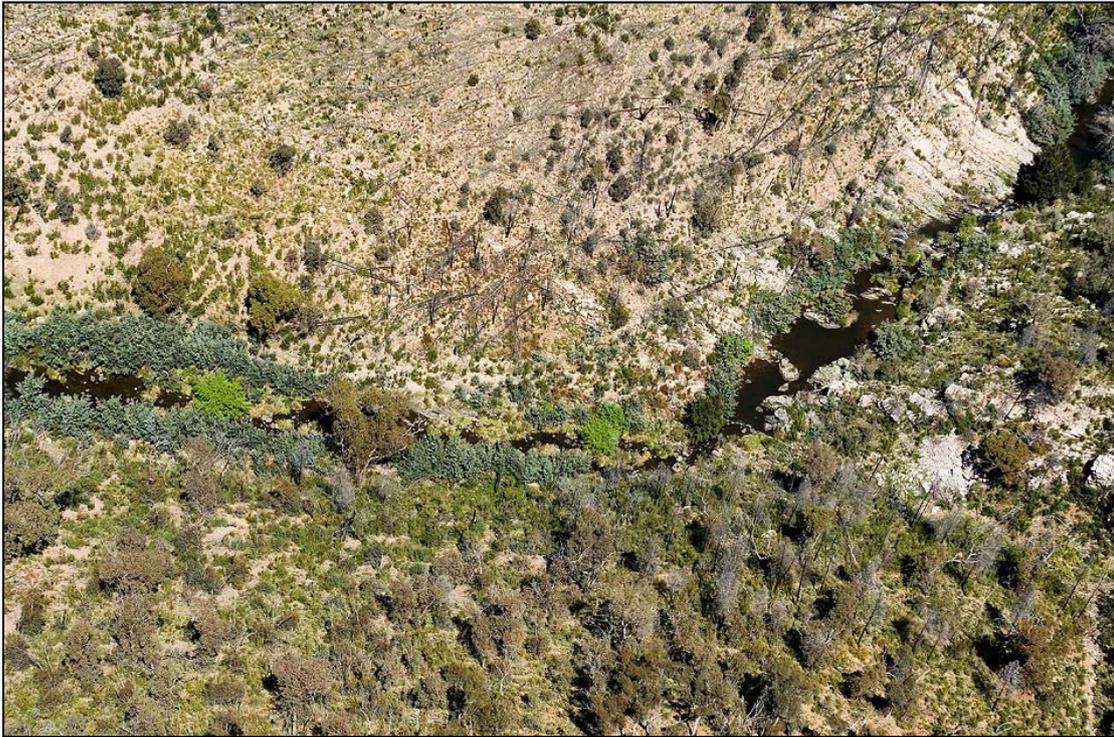
Just downstream of this point the vegetation community changes to She-oak Tableland Riparian Woodland. Many of the *C. cunninghamiana* were killed in the 2003 bushfire and the riparian zone is currently dominated by the primary coloniser *A. dealbata*. A few scattered mature *C. cunninghamiana* remain and some females carried a heavy seed load at the time of the survey. Many seedlings were also visible along the creek line (Plate 5.10).

**Plate 5.10: Gorge on Paddys River showing the upstream extent of She-oak Tableland Riparian Woodland**

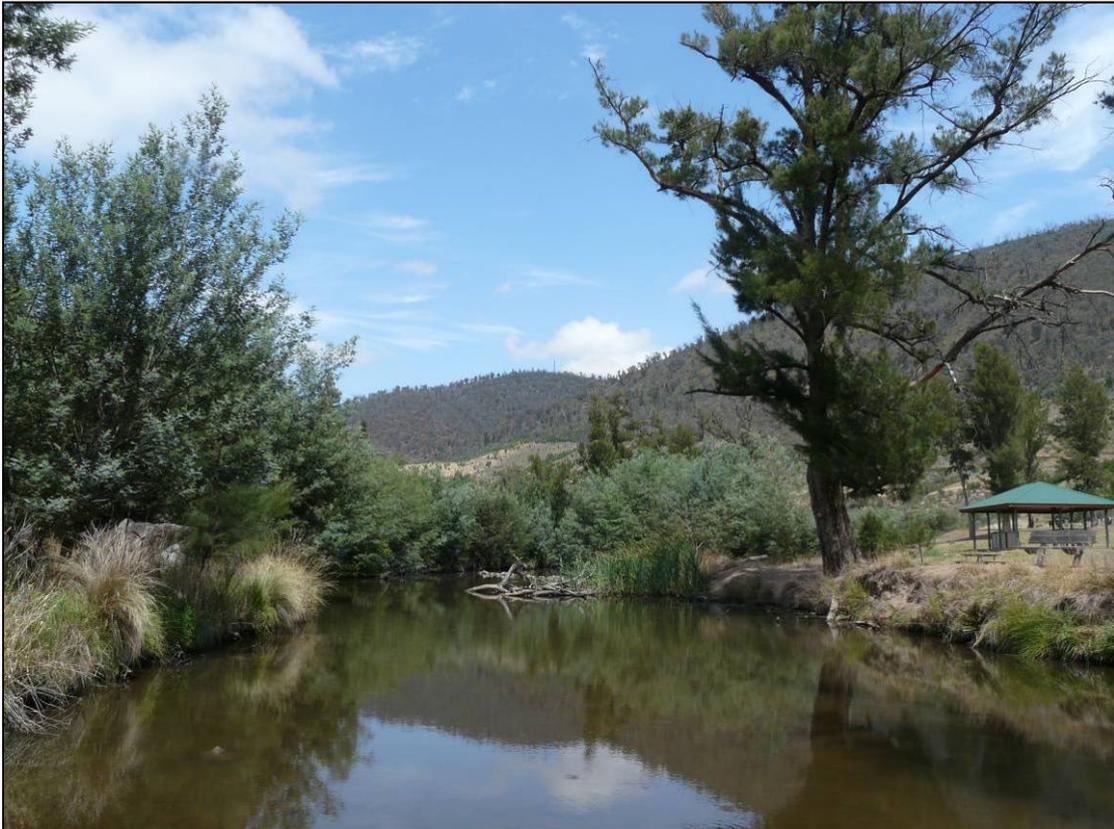
Continuing downstream, the river flows through Murrays Corner recreation area (Plate 5.11). This area was severely burnt in the 2003 bushfire and there are dense stands of *A. dealbata* along the river banks. Some mature *C. cunninghamiana* remain in the recreation area near the river crossing and many trees are regenerating from seed. The river continues as a series of pools with extensive riparian growth of blackberries and willows. A few *E. viminalis* are present in the riparian zone and the occasional *E. polyanthemos*, probably dispersed from the adjacent hillslope. The recreation area is presently being replanted with native and exotic species. In an open area on the eastern side of the river, bulldozed after the fire, poplars and other exotics are regenerating from rootstock (Plate 5.12). There are *E. globulus* plantings at the Blue Gum car park.

**Plate 5.11: Murrays Corner recreation area showing dense *Acacia dealbata* growth post-2003 bushfire**

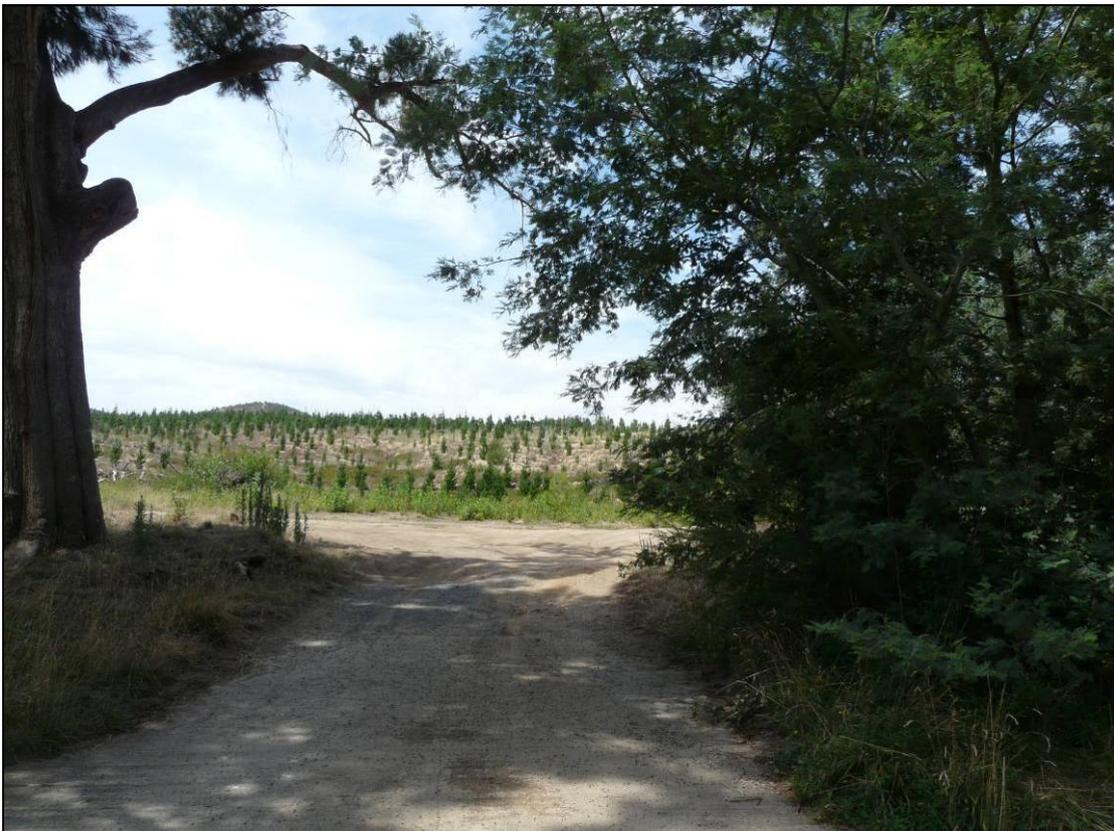
**Plate 5.12: Murrays Corner showing regeneration of radiata pine and poplars**

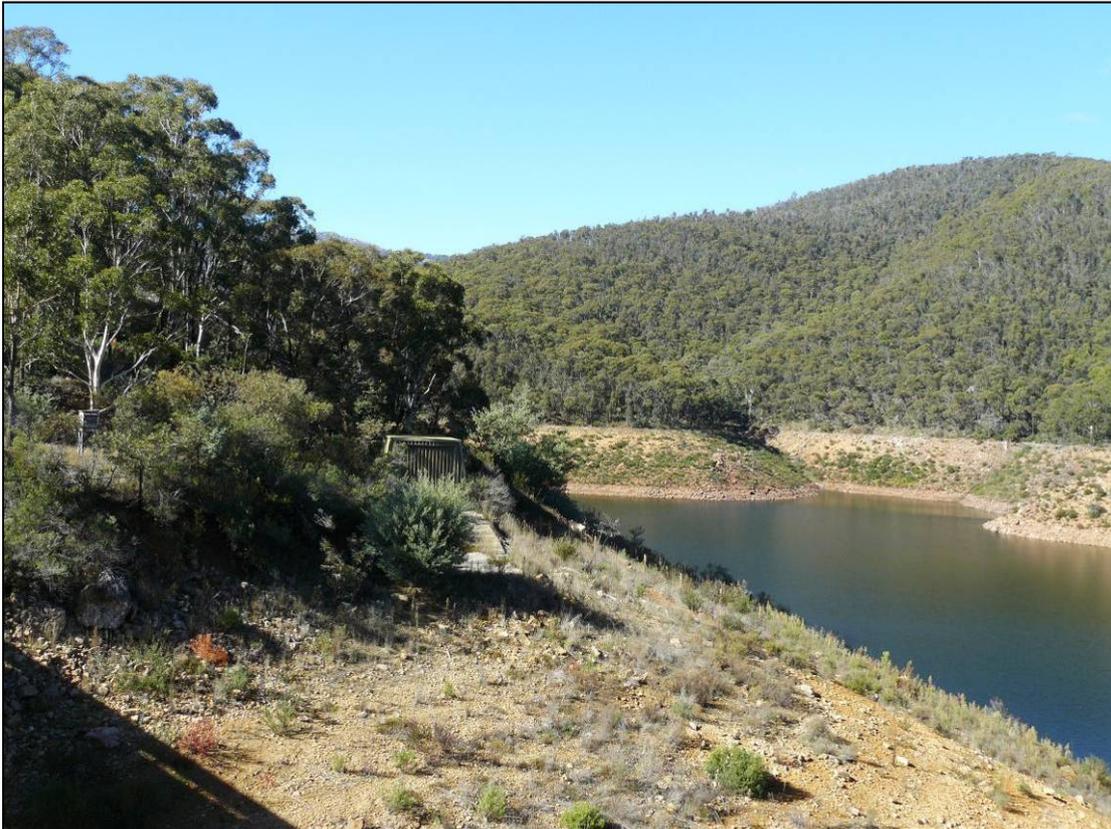
The area below the high water mark in Corin Reservoir is dominated by herbaceous species adapted to periodic inundation. At the time of survey, water levels had been below the high water mark for some years, resulting in patchy growth of species (notably *A. rubida* and *Daviesia mimosoides*) derived from upslope communities mainly Narrow-leaved Peppermint – Ribbon Gum Montane Forest (Plate 6.3).

**Plate 6.3: Corin Dam: area below high water mark showing patchy growth of herbaceous species and shrubs derived from upslope Narrow-leaved Peppermint – Ribbon Gum Montane Forest**

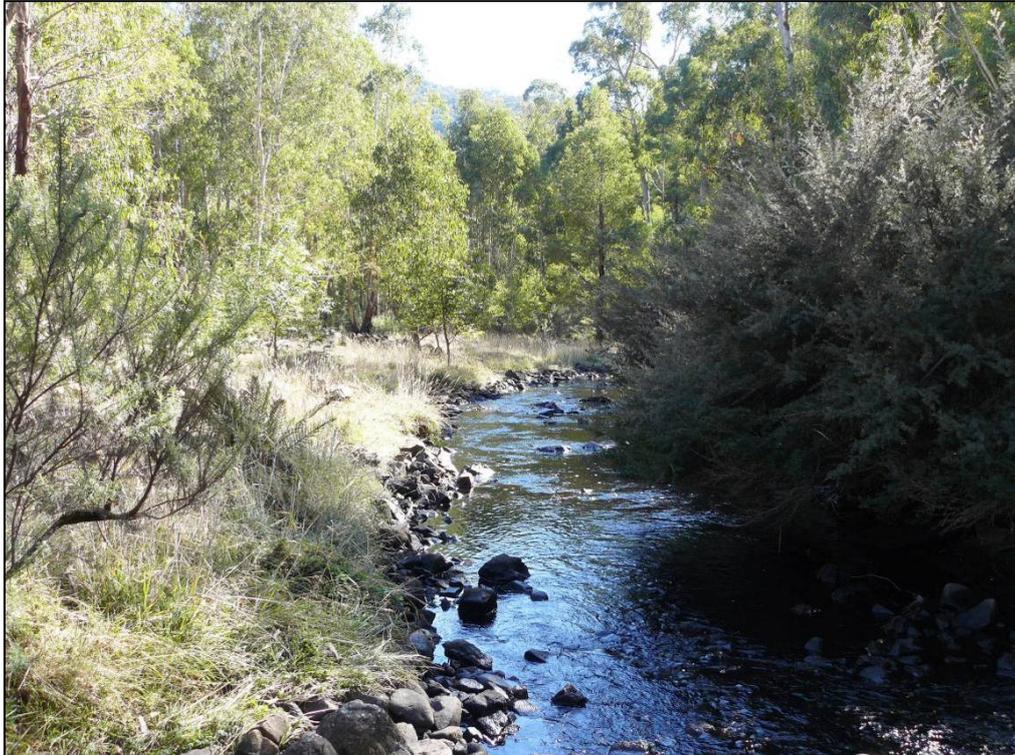
This reach is approximately 20.3 km in length and also occurs entirely within Namadgi National Park (Appendix 6A Maps 6.5a to 6.8a). Very high quality Ribbon Gum Tableland Riparian Woodland occurs along the river from Corin Dam to the Bendora Reservoir (Plate 6.4). The cobbles and riffles just downstream of Corin Dam contain *M. varriifolium*, *Crassula helmsii*, *G. peruviana*, *Elatine* sp., *Nitella* sp. and *Stigeoclonium tenue*, a silkweed, and pink tussocks of *Audouinella hermannii* on nearly all the rocks. The river margins contain *Juncus polyanthera*, *Carex* sp., *Blechnum* sp., *Polystichum proliferum* and *L. lanigerum*. A cobbled area with occasional *E. viminalis* saplings and a ground cover of *Acaena novae-zelandiae* and introduced grasses like couch (*Cynodactylon* sp.) and Yorkshire fog (*Holcus* sp.) with a little *Poa sieberiana* merges with the Ribbon Gum Tableland Riparian Woodland. Notable understory shrubs included *Davesia mimosoides*, *L. myricoides*, *Grevillea oxyantha*, *Exocarpos stricta*, *Hovea* sp. and *A. pravissima*, *A. rubida*, *A. siculiformis* and *A. melanoxyton*.

**Plate 6.4: Cotter River below Corin Dam showing Ribbon Gum Tableland Riparian Woodland**

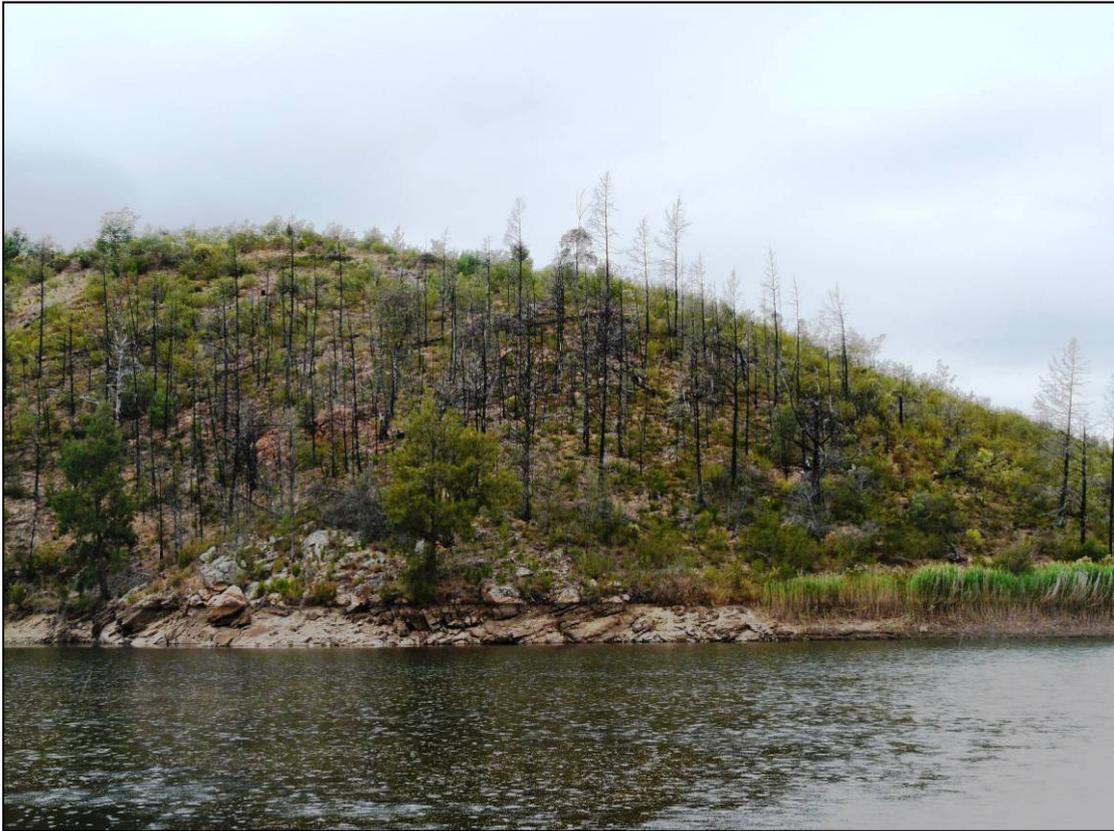
Historically, the hillslope has been managed as softwood plantation which was destroyed in the 2003 bushfire. *A. rubida* is the main colonising species in fire affected areas and there are a few scattered *E. bridgesiana* and *E.dives* higher up the hillslopes. On the northern slope opposite the boat ramp there is a small patch of Black Cypress Pine Tableland Woodland which has been heavily fire affected. Some *C. endlicheri* seedlings are visible beneath the dead standing trees (Plate 6.12).

**Plate 6.12: Cotter Reservoir: fire affected Black Cypress Pine Tableland Woodland**

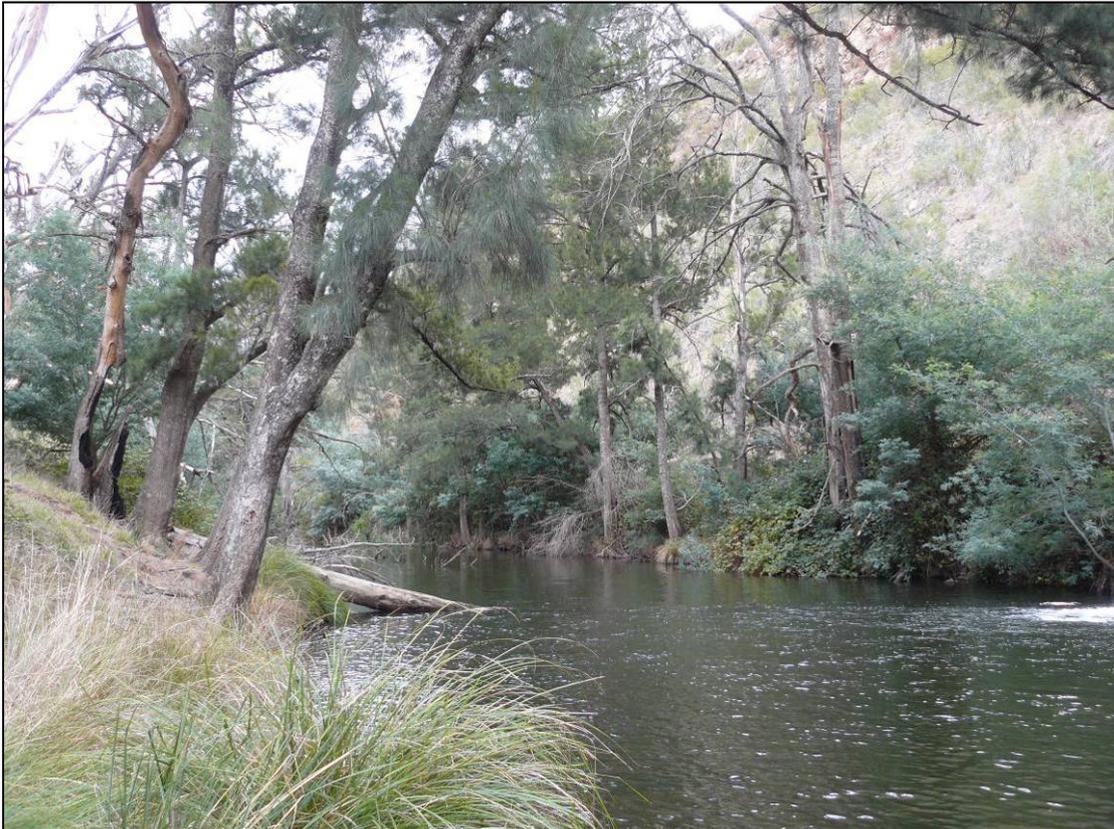
**Plate 6.13: Cotter River below Cotter Dam: She-oak Tableland Riparian Woodland with a shrub layer of *Acacia dealbata***

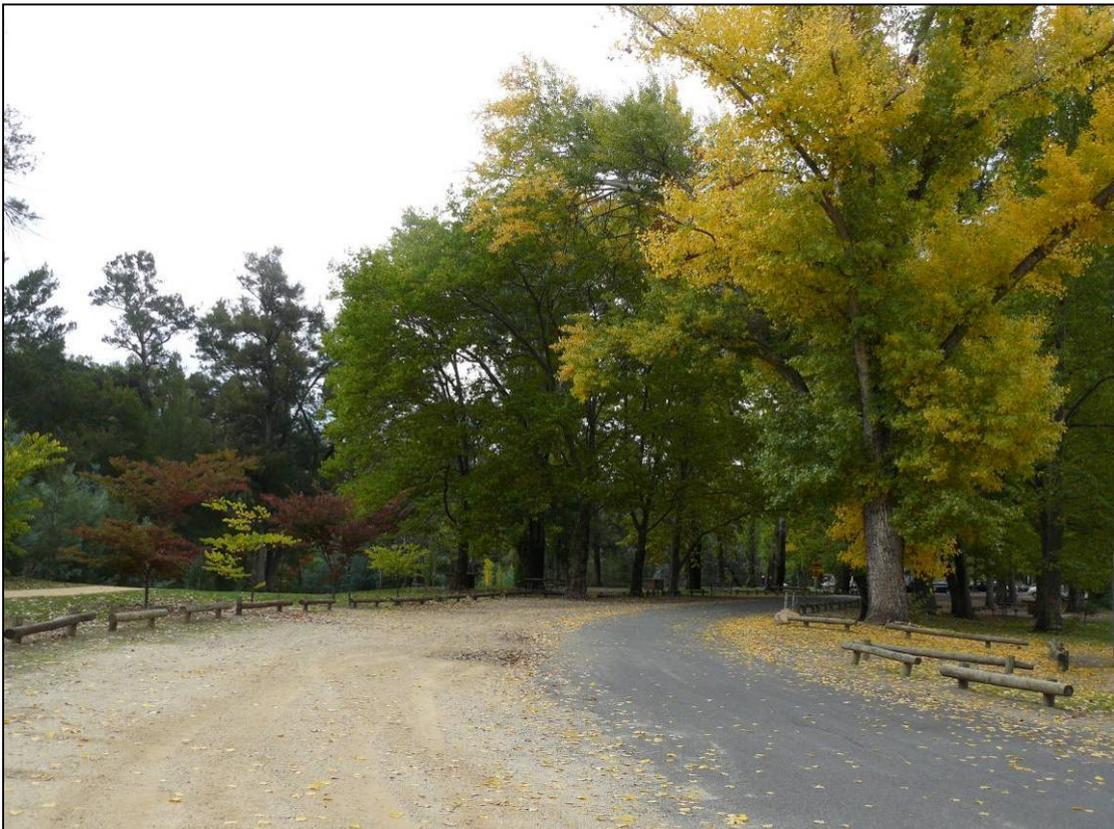
**Plate 6.14: Cotter Recreation Area with exotic tree plantings**

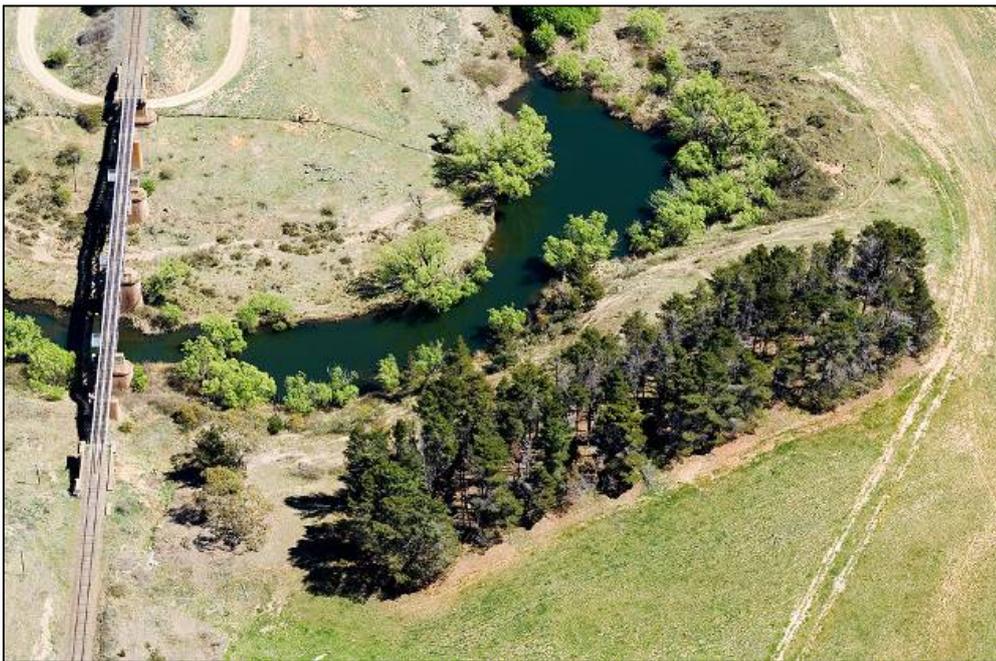
**Plate 7.1: Molonglo River downstream of Burbong Bridge with River Bottlebrush – Burgan Tableland Riparian Shrubland and willows *Salix* spp.**

Where the river flows into the ACT at Burbong, the riparian vegetation community consists of River Bottlebrush – Burgan Tableland Riparian Shrubland with many willows and poplars. The river contains a varying sequence of this shrubland and bedrock areas with pools where there is limited riparian vegetation. *P. australis* beds (Tableland Aquatic and Fringing Vegetation Complex) line muddy banks and there are a few patches of *Myriophyllum crispatum* among a mixture of riparian shrubs (*L. obovatum*, *K. ericoides* and *C. sieberi*). In places, the instream vegetation has created a damming effect, contributing to the formation of pools. As the river continues downstream, dead willows line the banks as a result of control work (Plate 7.2).

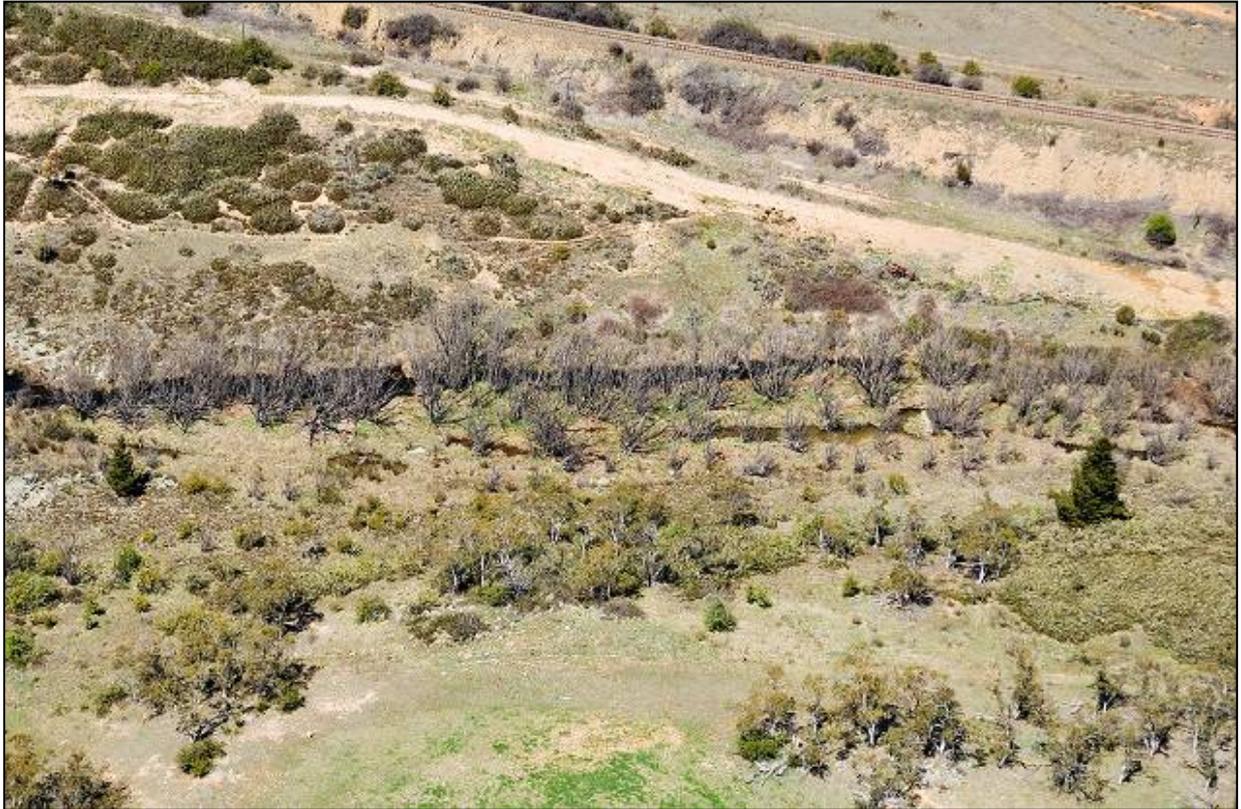
**Plate 7.2: Downstream of Burbong Bridge showing successful control of willows**

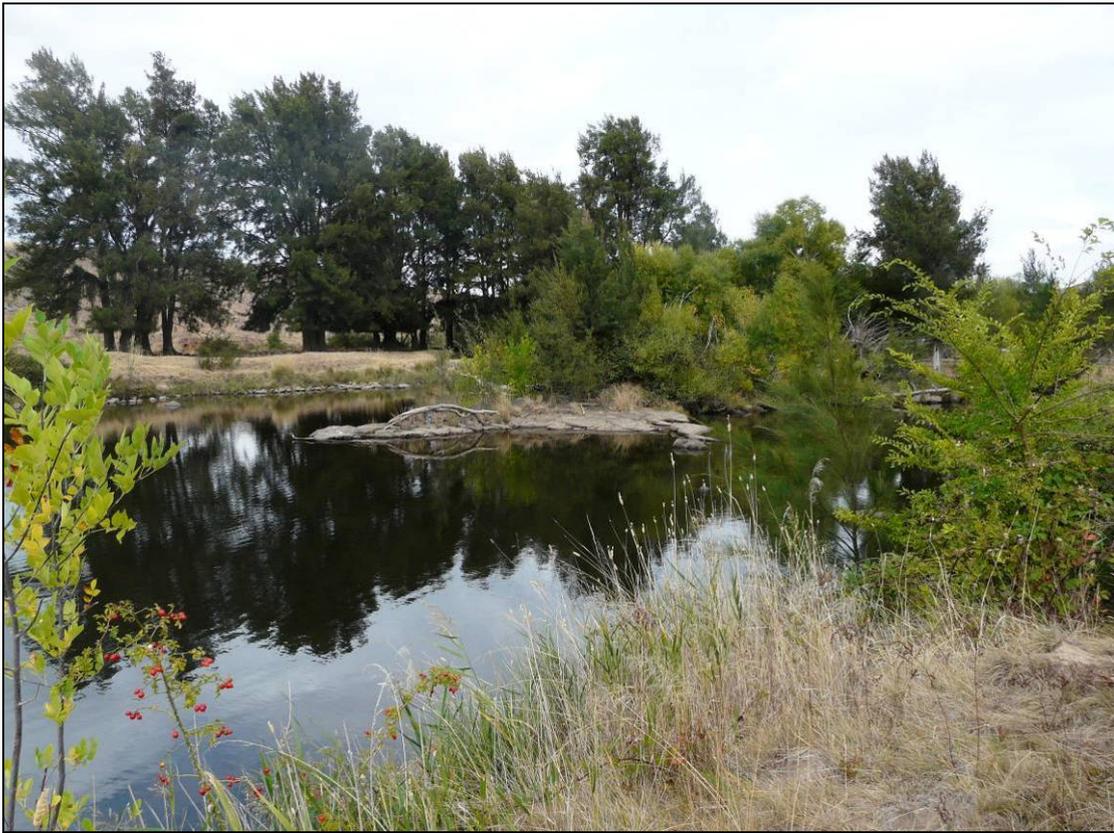
Along the floodplain below Misery Hill the riparian vegetation returns to more native condition with the beginning of She-oak Tableland Riparian Woodland and a marked decrease in the number of willows (Plate 7.11). The *C. cunninghamiana* trees have been affected by fire but are regenerating well, with many seedlings observed along the river bank. The river opens up into a large, clear pool with Tableland Aquatic and Fringing Vegetation Complex (*P. australis*, *Persicaria*

**Plate 7.11: Molonglo River below Misery Hill where the riparian vegetation returns to She-oak Tableland Riparian Woodland**

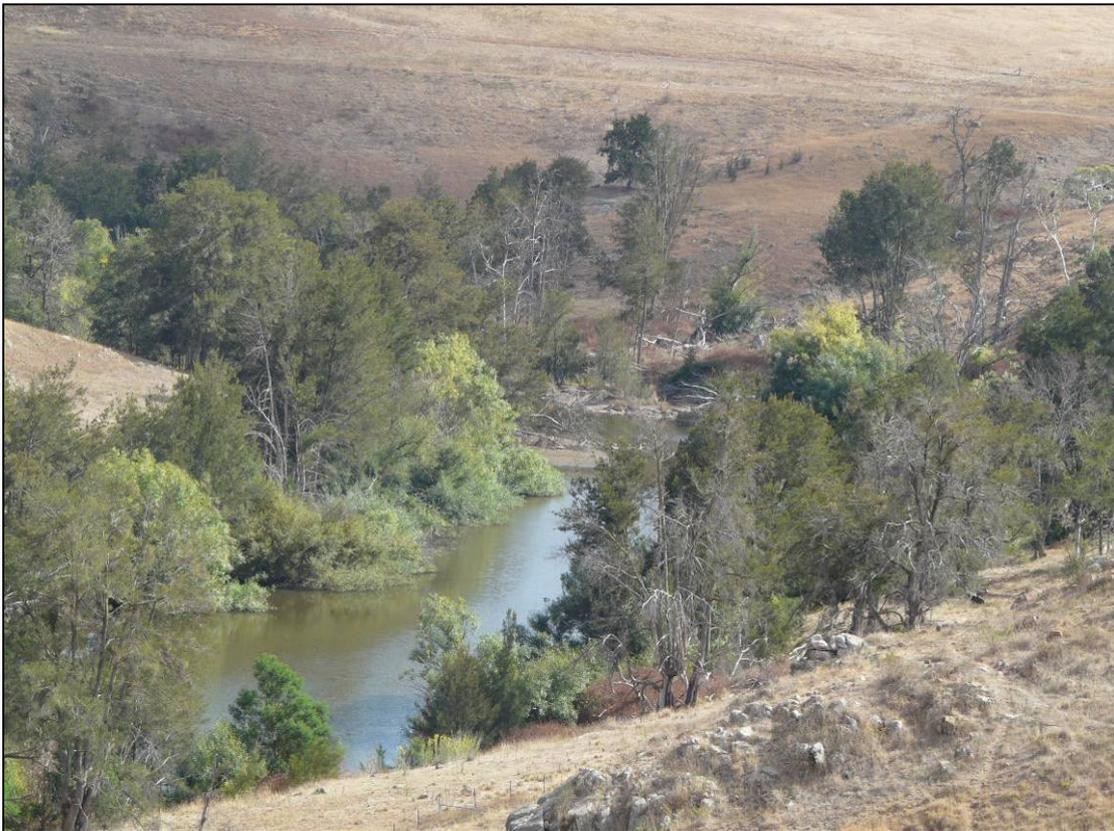
Just upstream of the gorge there is a stand of She-oak Tableland Riparian Woodland in excellent condition with plenty of mature and regenerating plants (Plates 7.13 and 7.14). On a midstream island there are several ages of *C. cunninghamiana* represented, some with mistletoe. Willows are also establishing in the area, mainly *S. fragilis* with some *S. babylonica*. The adjacent hillslope and some of river bed are fire affected, especially to the east. On the right side, there is a stand of *E. pauciflora* with about three mature and dead standing trees and one regenerating mature tree, and a coppice of perhaps 25 young trees.

**Plate 7.13: Molonglo River below Coppins Crossing showing high quality She-oak Tableland Riparian Woodland**
