Asset 18: Medhurst Crescent Swale

General information

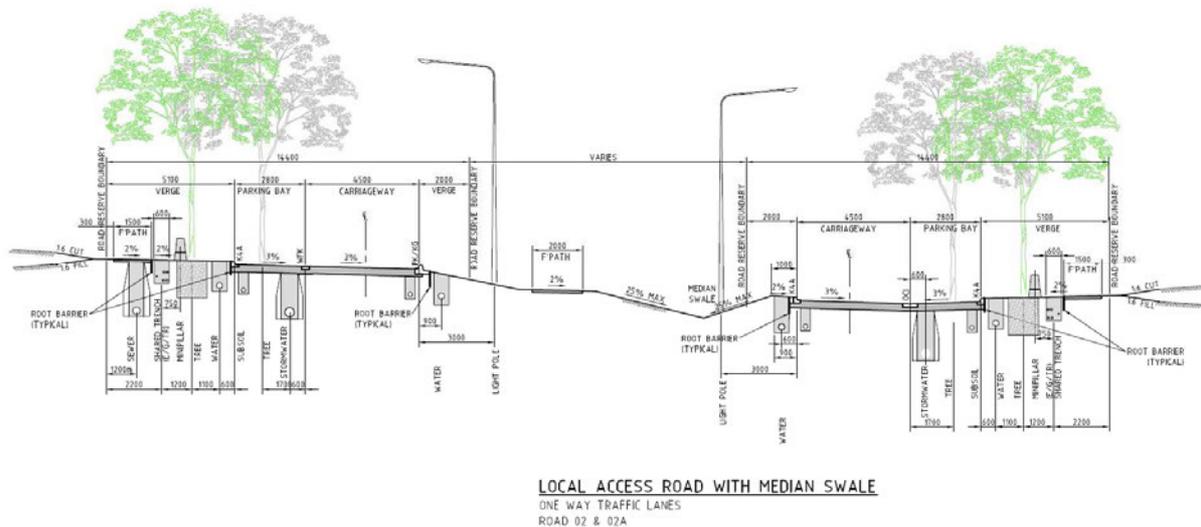
Figure 12: Typical swale section from the civil drawing set (4555-70-021)

Therefore the problems appear to have arisen in part at the construction stage, however the design drawings also indicate that the design was not developed well enough to demonstrate how the swale would work, and there is an inadequate level of detail on the drawings to provide appropriate instruction to the contractor. Civil drawings show some very basic swale sections (typical example shown in Figure 12) with the only detail on swale levels being a maximum slope of 25%. Landscape drawings show surface finishes and planting, but no levels in the swale. With this gap in the documentation, it is not surprising that there have been issues at the construction and establishment stages.

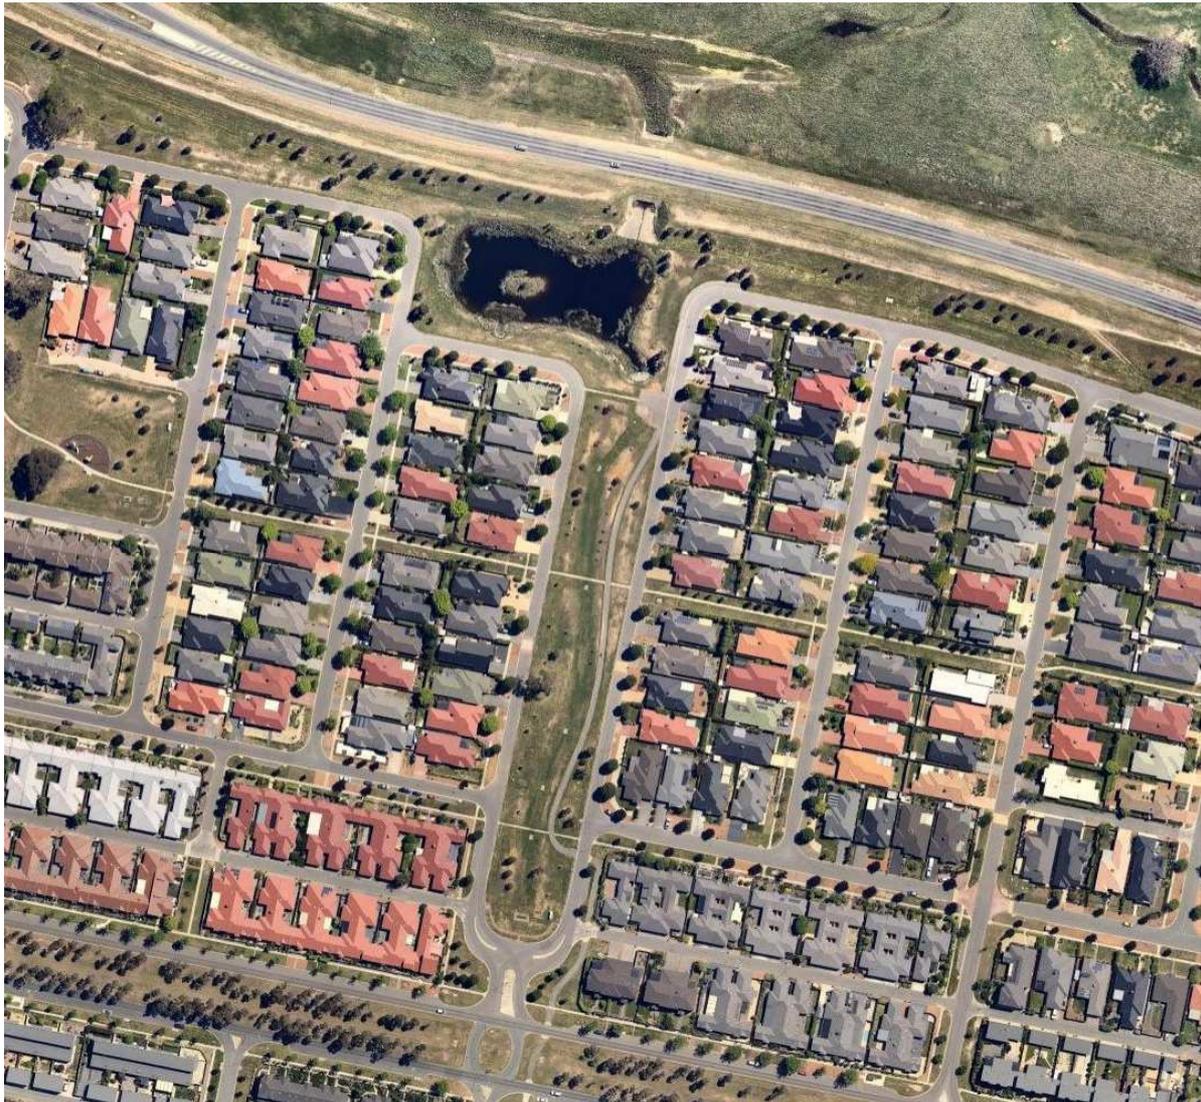
Figure 1: Swale aerial photo 29 October 2014 (NearMap)

The swale is located in the middle part of the catchment and is the first step in the treatment train for the roadway catchments of Tsoulias Street. The swale drains directly into to an estate-scale pond and then via a waterway into Yerrabi Pond.

The Tsoulias Street swale is designed to treat stormwater from the roadway catchment areas to the east and west of the swale and any runoff from the turfed areas adjacent to the swale. It also appears that high flows surcharge into the swale however this is a conveyance role rather than a treatment role.

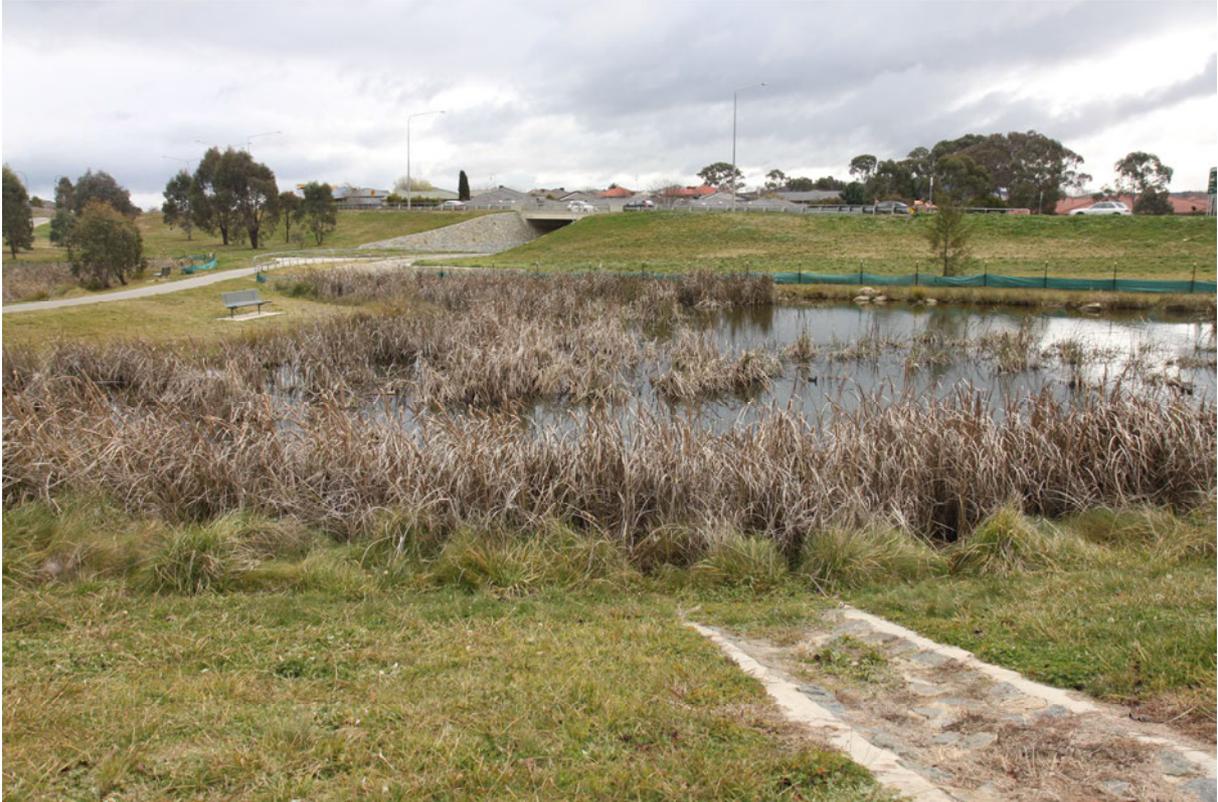
Figure 1: Vegetation condition in winter (July 2014)

- As the pond has no high flow bypass, it receives high flows in larger rain events
- The low-level outlet is relatively large, so we expect that there would be a relatively short detention time in the system
- This pond has a higher coverage of macrophytes than others in ACT, but the macrophytes are dominated by *Typha* which senesces in winter, reducing treatment performance and visual amenity at this time of year (refer to Figure 1). *Typha* is common in urban systems and can grow in deeper water than many other species
- Analysis of aerial photography indicates that the pond is sometimes covered in floating weeds, as shown in Figure 2. This is a common issue in urban ponds and is fuelled by similar conditions as algal blooms

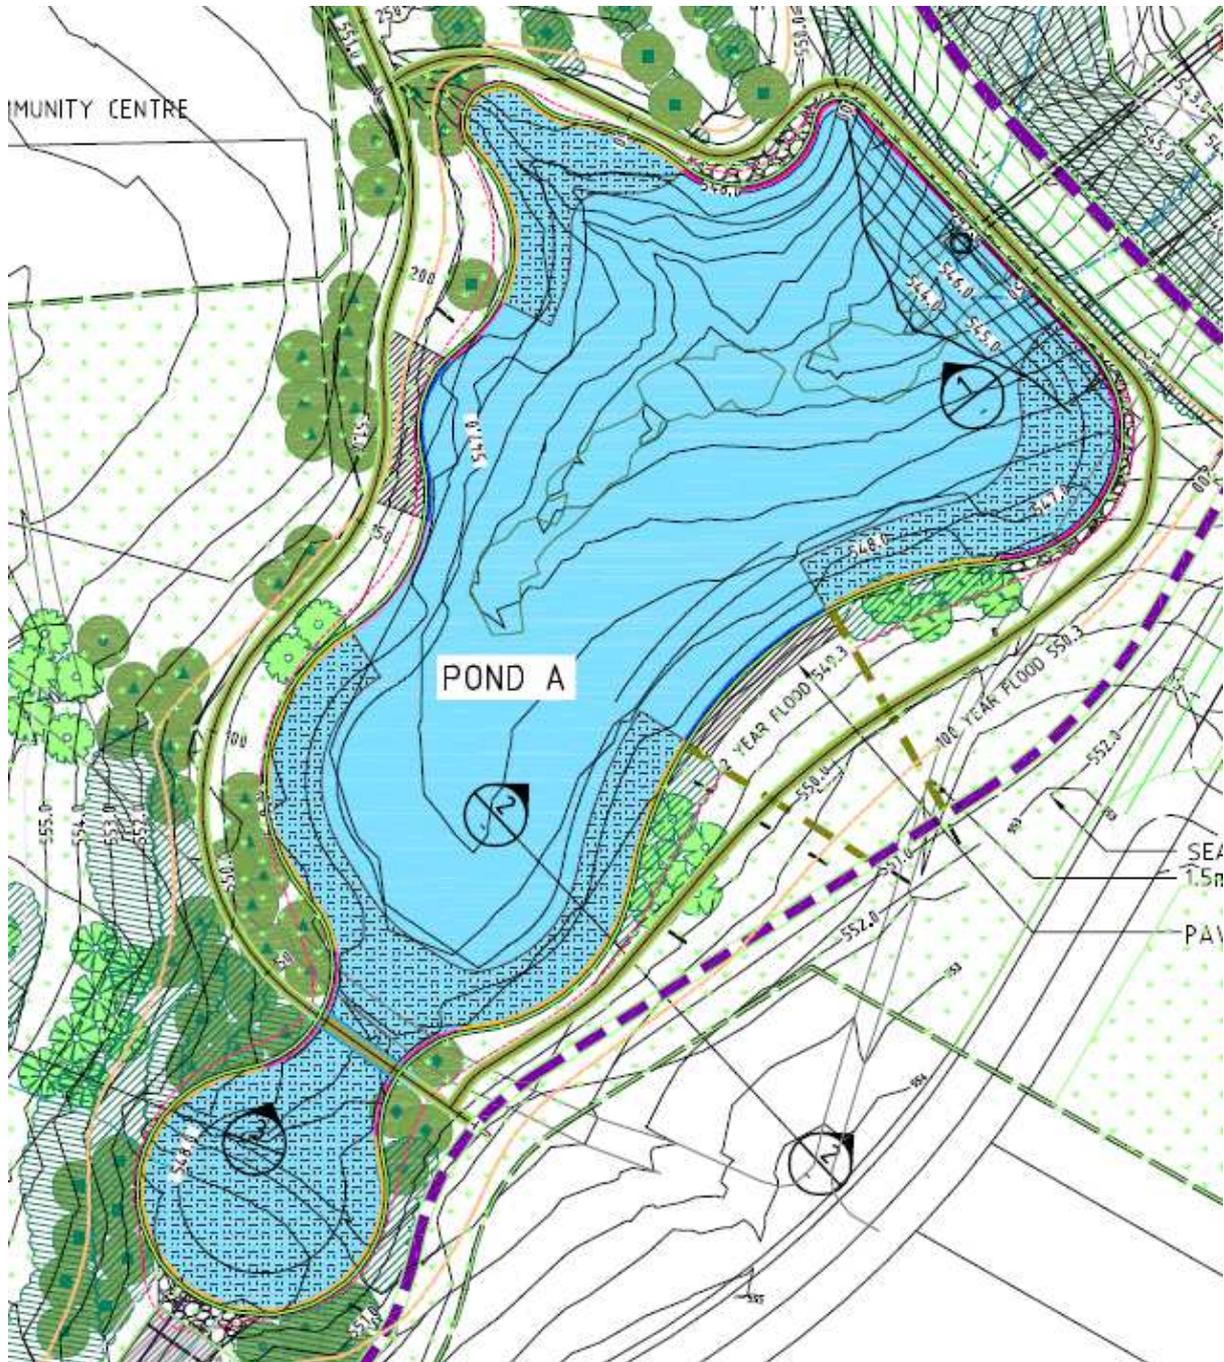
- There is very limited macrophyte coverage (although we note that the design drawings included a more significant extent of macrophyte planting, which has not been established – refer to Figure 2)
- The pond is deep and therefore at risk of thermal stratification, which tends to exacerbate water quality issues associated with anaerobic decomposition and re-release of pollutants from accumulated settled sediments

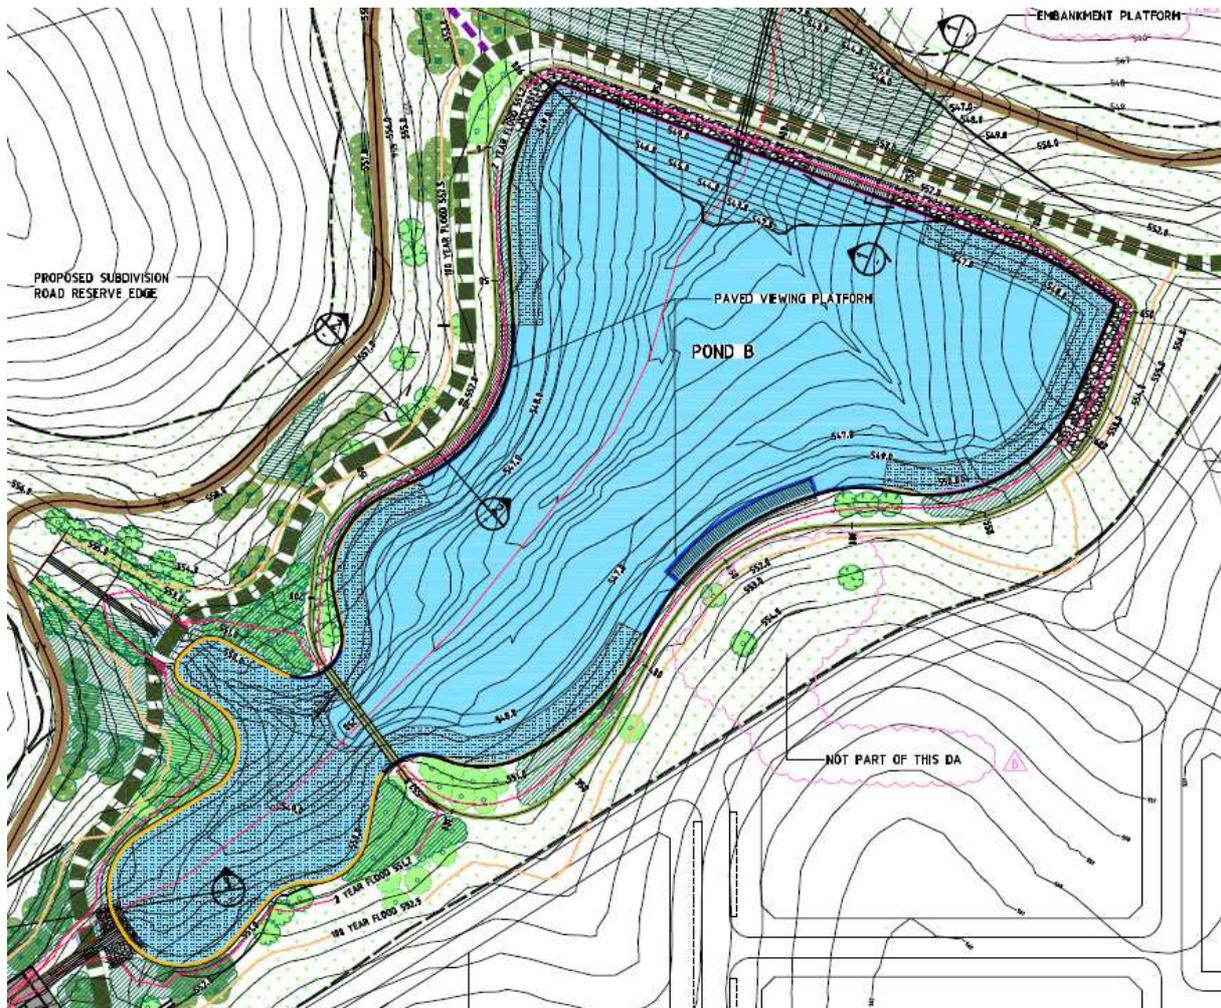
- There is very limited macrophyte coverage (although we note that the design drawings included a more significant extent of macrophyte planting, which has not been established – refer to Figure 2. Analysis of Nearmap aerial photography shows that macrophytes were planted in the pond but failed to establish – it appears that water levels were raised too quickly over small establishing seedlings – refer to Figure 3, Figure 4 and Figure 5)
- The pond is deep and therefore at risk of thermal stratification, which tends to exacerbate water quality issues associated with anaerobic decomposition and re-release of pollutants from accumulated settled sediments

Figure 2: Snapshot from the landscape master plan for Pond B, showing proposed macrophyte area (hatched)

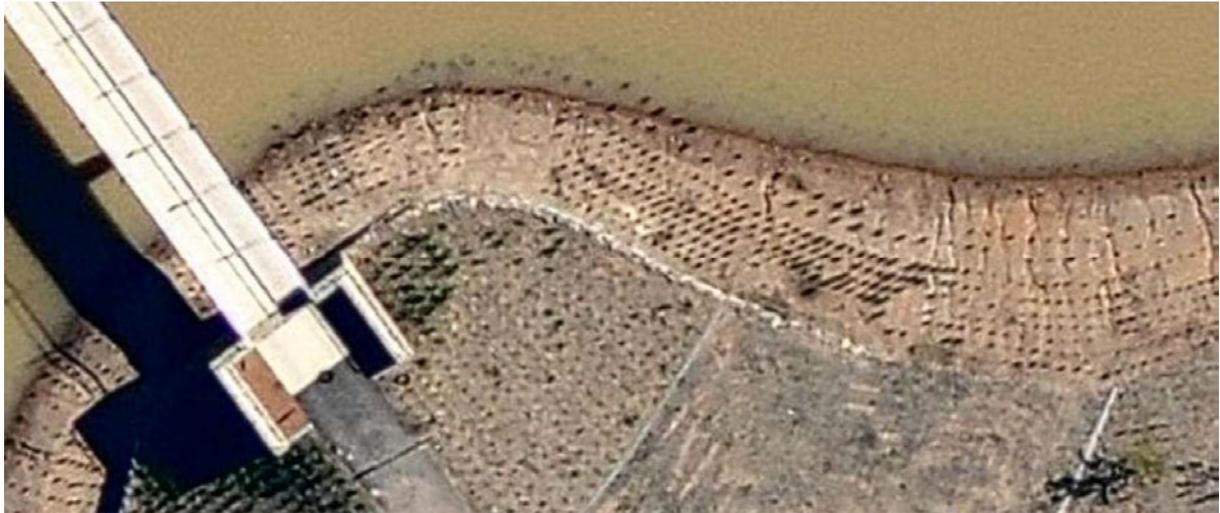
Figure 3: Snapshot of macrophyte planting at one location at Coombs Pond B (Nearmap 13 March 2013)
