Asset 3: Ultimo St rain gardens (Crace)

Asset 4: Digby Circuit rain gardens (Crace)

Asset 5: Langtree Crescent rain gardens (Crace)

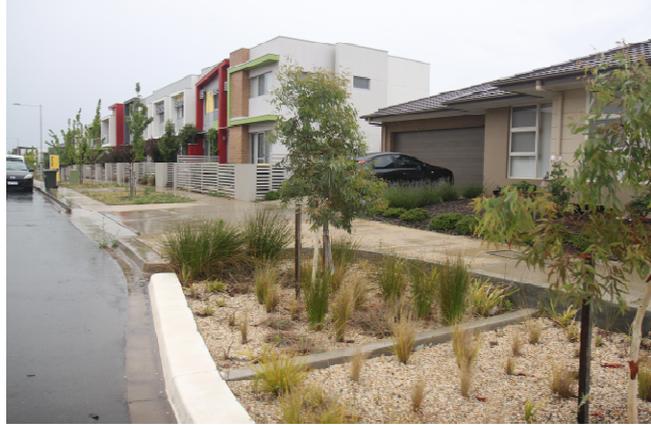
There are 6 rain gardens on Ultimo St in Crace. They are all built to the same design, and are located in the verge in three groups.

Each rain garden has two or three cells and two kerb inlets at each end of the rain garden. There are multiple connections at the back of the rain garden allowing footpath runoff to drain into the garden. Some rain gardens also have a connection from the property into the rain garden. The rain gardens include street trees and understorey planting.

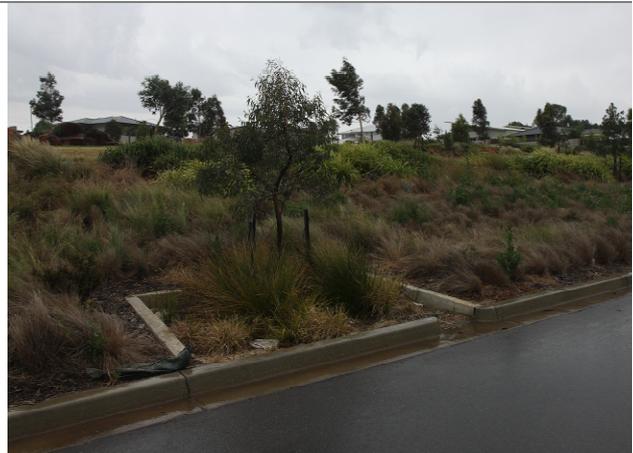
Each rain garden has one cell and one kerb inlet into the rain garden. The rain gardens are surrounded by a low concrete wall to take up the grade. There are no visible connections from the properties into the rain garden. The rain gardens include street trees and understorey planting.

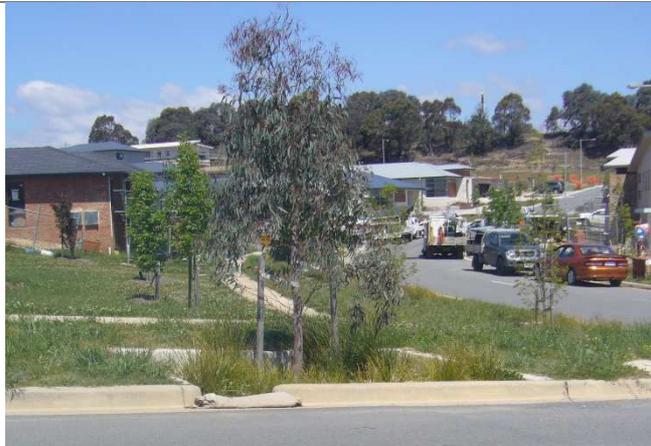
There are 31 rain gardens on Langtree Crescent in Crace. They are all built to the same design, and are located in the verge in three groups:

Rain gardens include street trees and understorey planting.

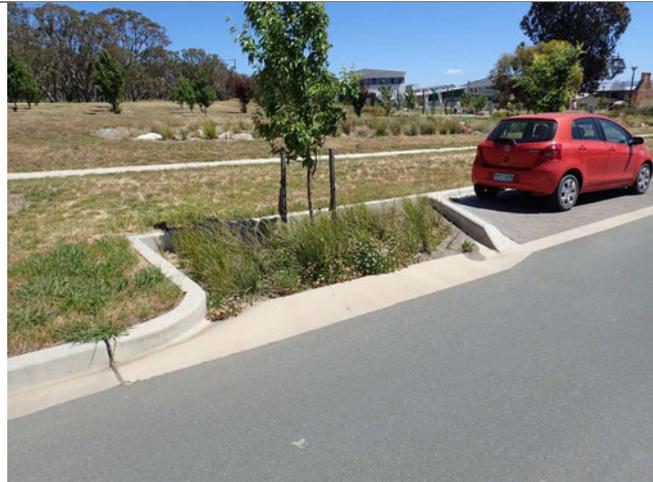
Three rain gardens on Turbayne Crescent in Forde. Rain gardens mark the ends of car parking bays at the southern end of Turbayne Crescent, adjacent to a small park.

Rain gardens include street trees and understorey planting.

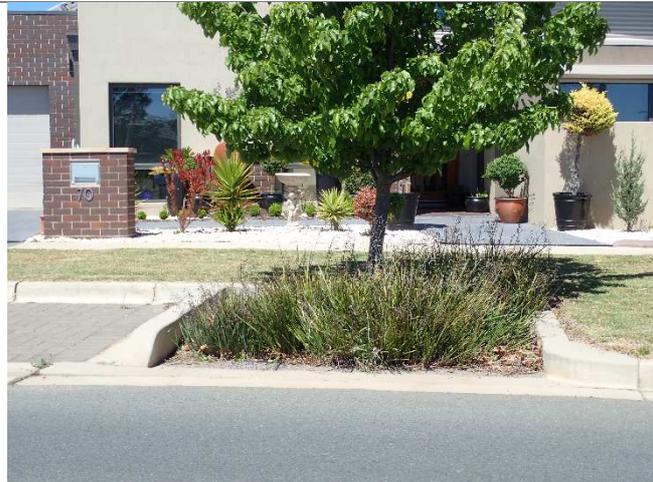
There are 61 rain gardens on Zakharov Avenue in Forde. They are all built to the same design, and are located between car parking bays in the roadway.

Rain gardens include street trees and understorey planting.
