Asset 27: Yerrabi Pond

Asset 39: Isabella Pond

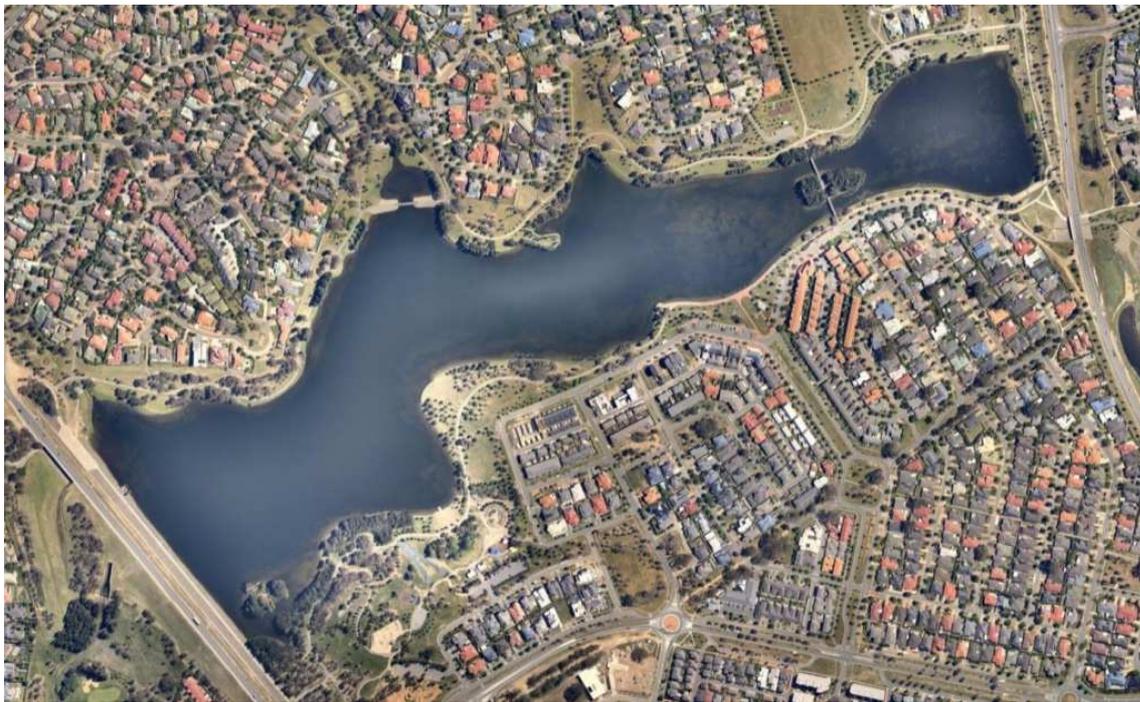
Figure 2: Aerial photo showing recent conditions (NearMap 29 October 2014)

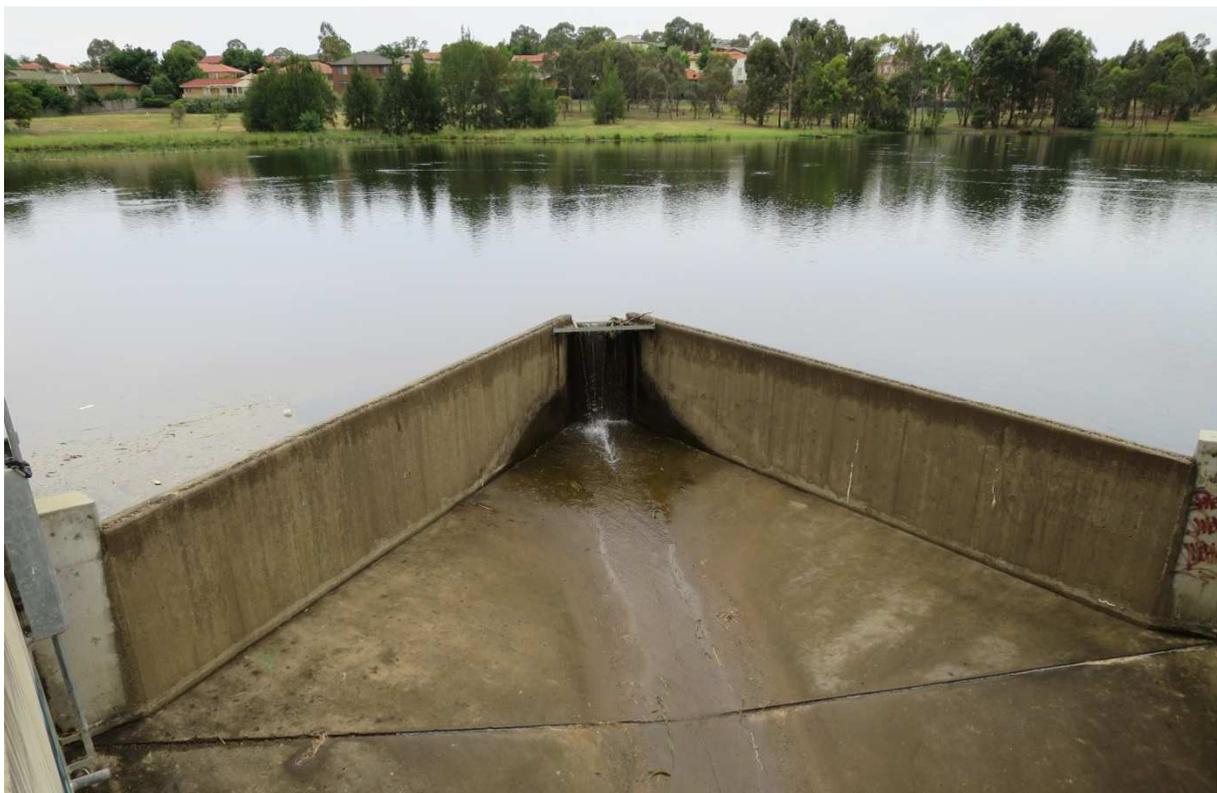
Figure 9: Existing primary (low flow) pond outlet

- Assess the feasibility of re-designing the inlet areas for the two main open channels to include stand-alone sediment basins upstream of the pond
- A riser outlet and extended detention may be able to be retrofitted to the outlet (Figure 9) which would allow more stormwater runoff to be retained for longer in the system

- A modified outlet could also allow better water level control in the upper zone, which would assist with macrophyte establishment along the pond edge. Note that there is limited opportunity to alter the pond's normal water level due to the wall treatment to much of the southern edge of the pond.

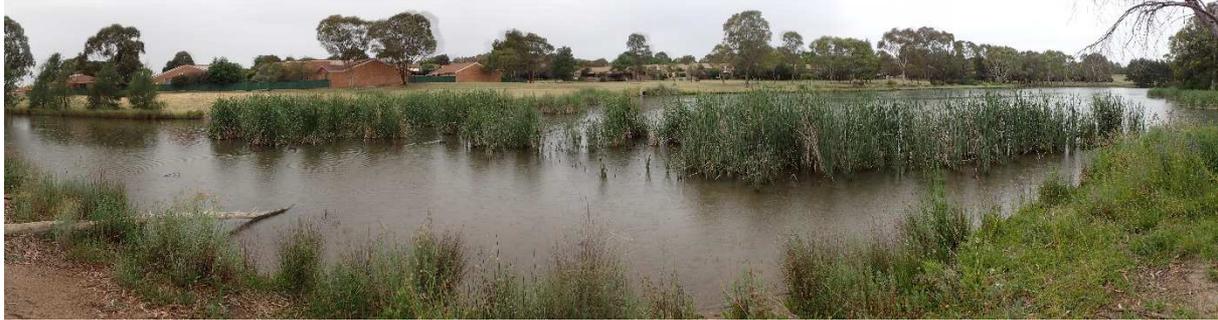
- A smaller upstream catchment area
- Smaller GPTs with less propensity for anaerobic conditions
- Lower Stranger has a shallow inlet area (constructed some time between 2004 and 2009) which appears to be partially effective as a pre-treatment zone. Figure 3 shows an example where the water quality is distinctly different in the inlet zone and main pond, with higher turbidity in the inlet zone. A small band of macrophytes forms a partial barrier between the inlet zone and main pond. This macrophyte band is shown in Figure 4.
- Higher landscape value in the pond surrounds

Figure 4: Band of macrophytes in Lower Stranger Pond

Note that we would not recommend significant effort to establish more macrophytes in the inlet zone unless other measures are also undertaken to reduce high flows and velocities through this area.

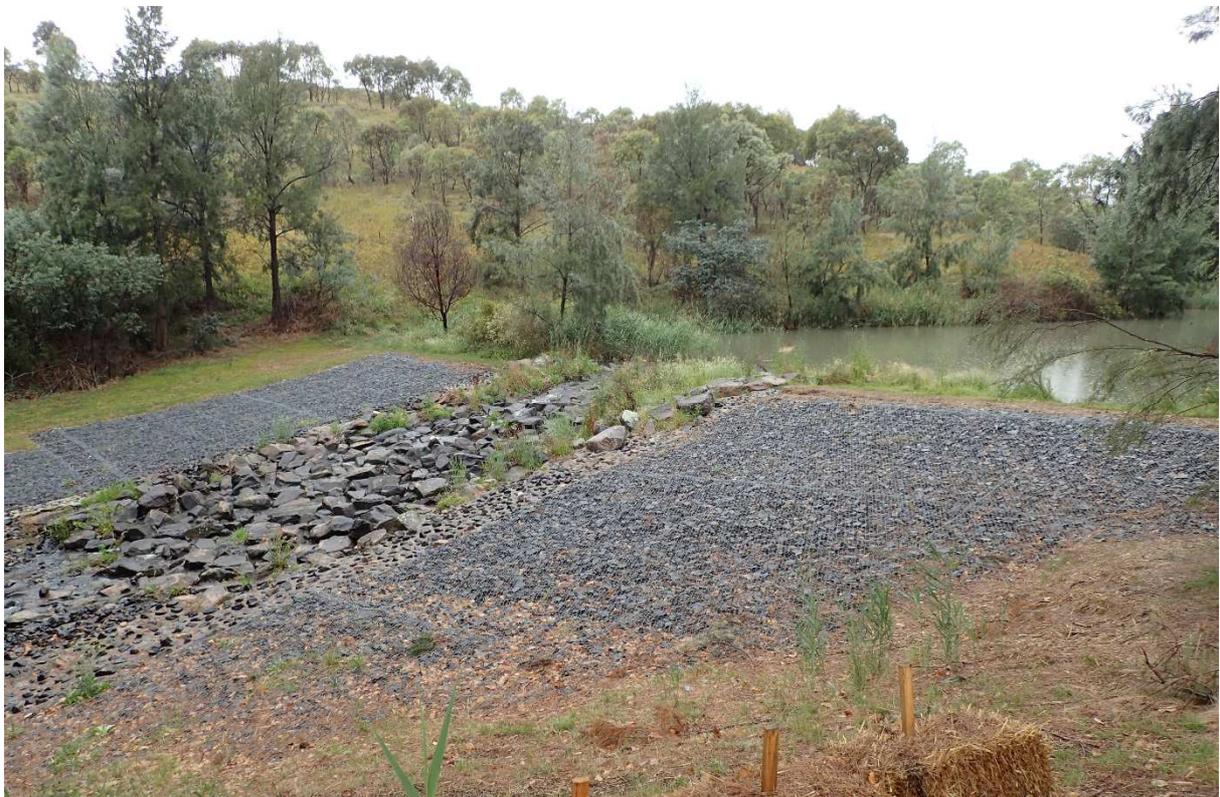
The scour hole was repaired in 2014 and Reno mattresses were installed either side of the rock chute. The finished works are shown in Figure 2. These works are now relatively stable. We observed minor erosion at the top of the embankment, on the edge of the Reno mattress (refer to Figure 3), however this is not yet threatening the stability of the structure. We observed the site after a moderate rain event on 3 December 2014 and flows were confined to the central (older) part of the chute.

Figure 2: Completed works in 2014

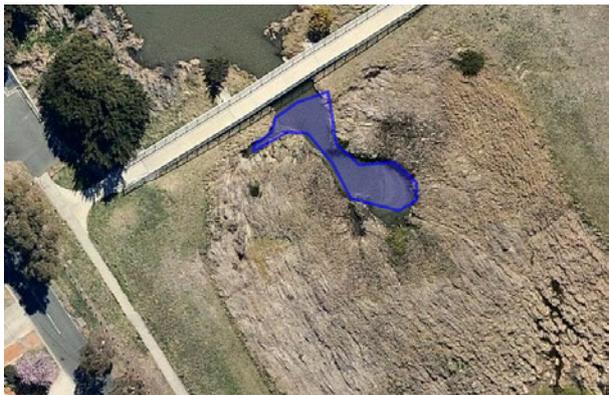
Figure 2: Headcut area shown in blue in September 2011

The headcut at the downstream end of this section is undermining these values. This is being caused by the steep gradient change between the vegetated portion of the channel and Point Hut Pond, the nature of the soils and the quantity of the water flowing in the channel. As the water is flowing over this steep gradient change in an un-controlled manner the bed is eroding and has formed its own informal drop structure to reduce the erosive forces in the channel.

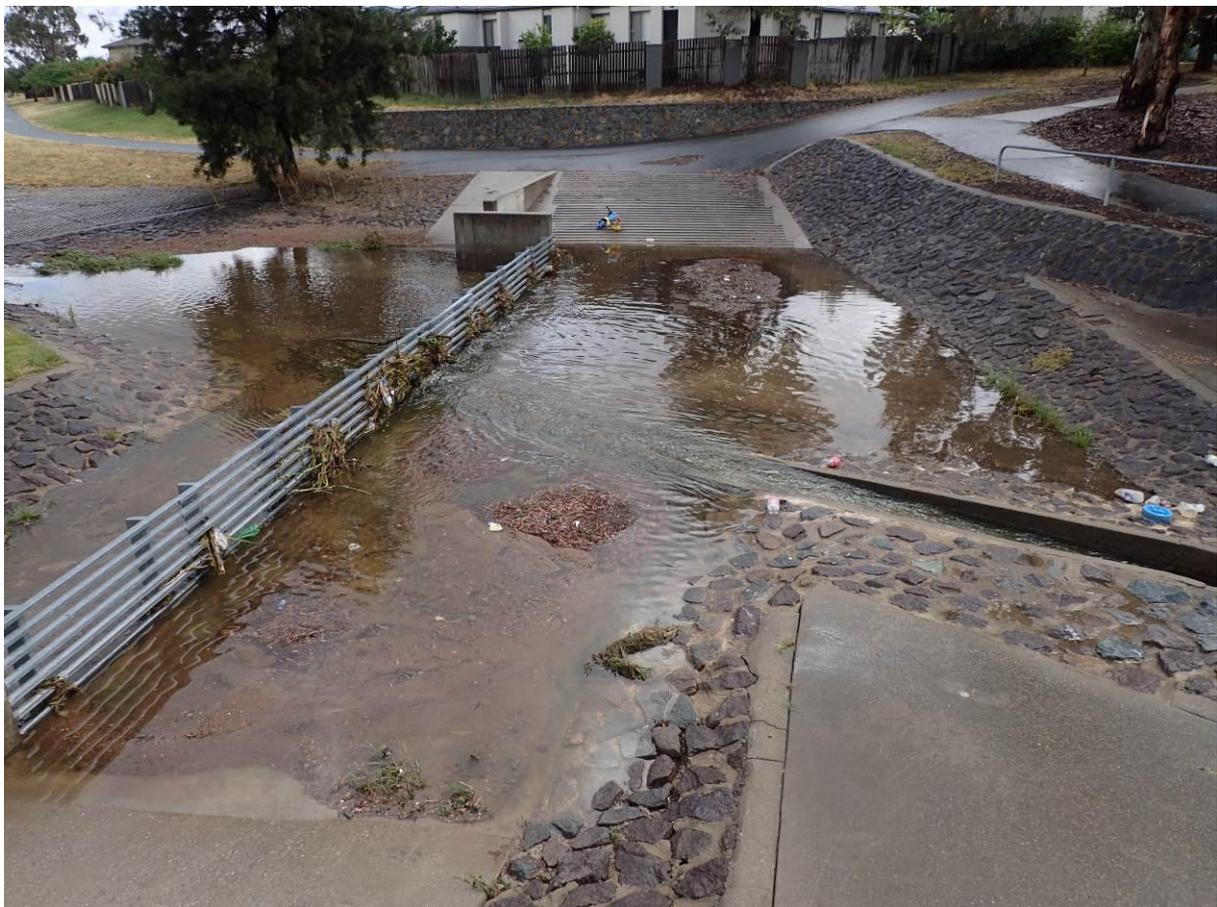
- There was very little litter in the waterway
- The gross pollutant trap had accumulated almost no litter and very small amounts of sediment (refer Figure 7)
- The drop structures were generally stable and did not have obvious signs of instability or scouring (refer Figure 8).
- Safety is a potential concern at the drop structures as they are generally easily accessible to the public and it is relatively easy to gain access to the top and bottom of the drop structure. Water is flowing with relatively high velocities at the drop structure and in even small events it would be difficult to cross the channel without being knocked over. It is unlikely that the safety criteria would be met at these locations.
- In some locations the drop structures were better screened with vegetation which reduce the accessibility of the drop structures to the public.

Figure 7: Gross Pollutant Trap in wet weather event

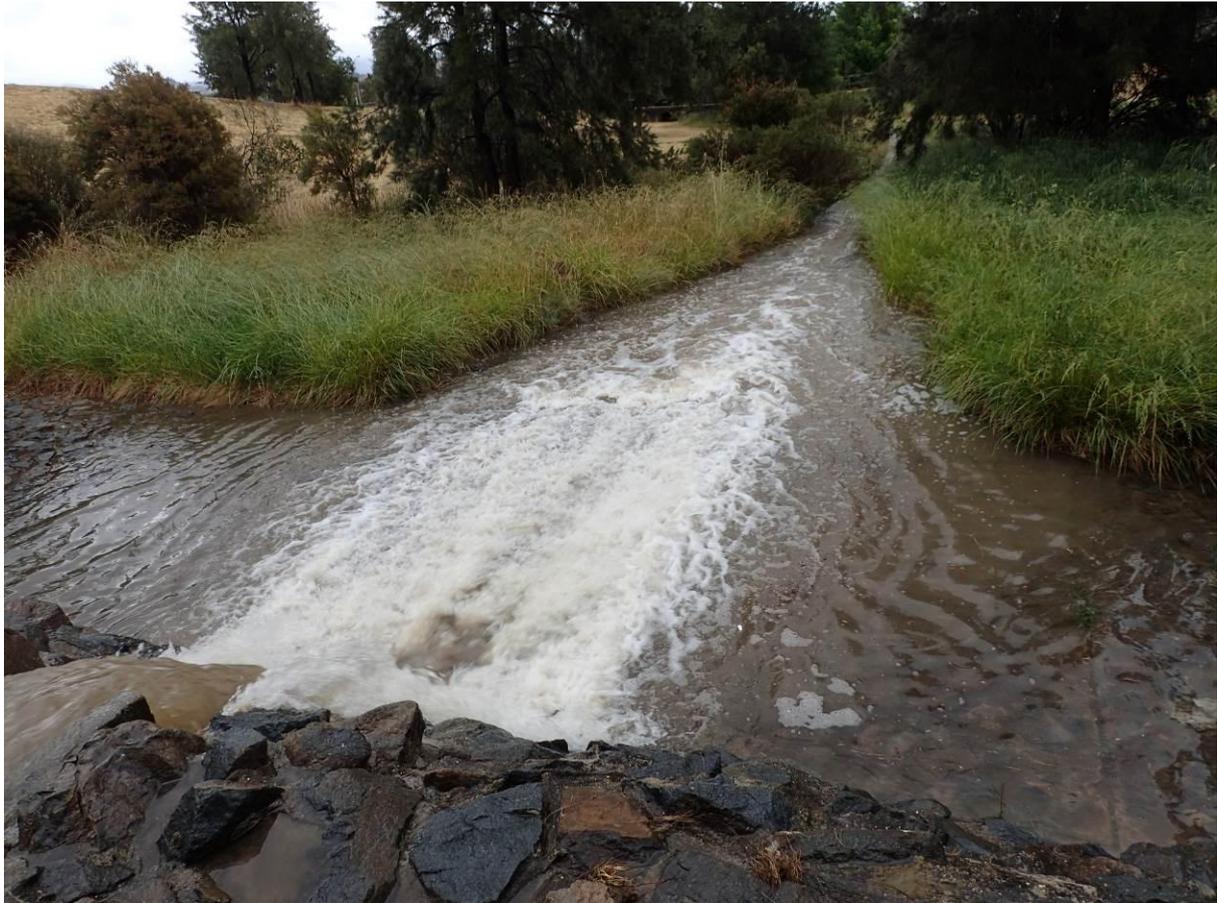
Figure 8 Example of drop structures in wet weather event

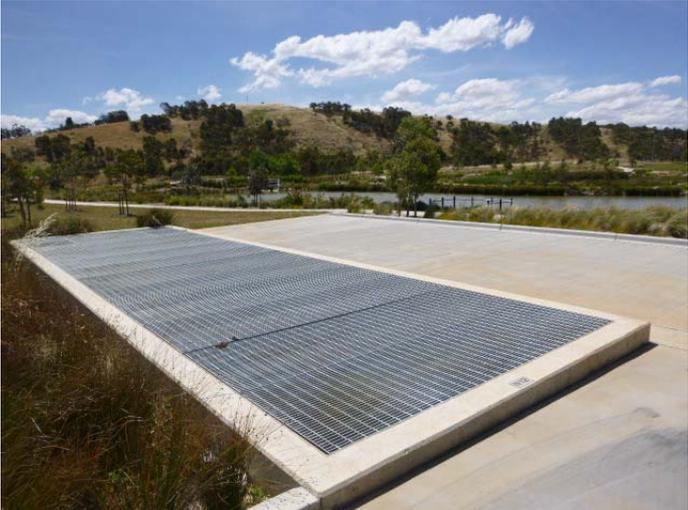
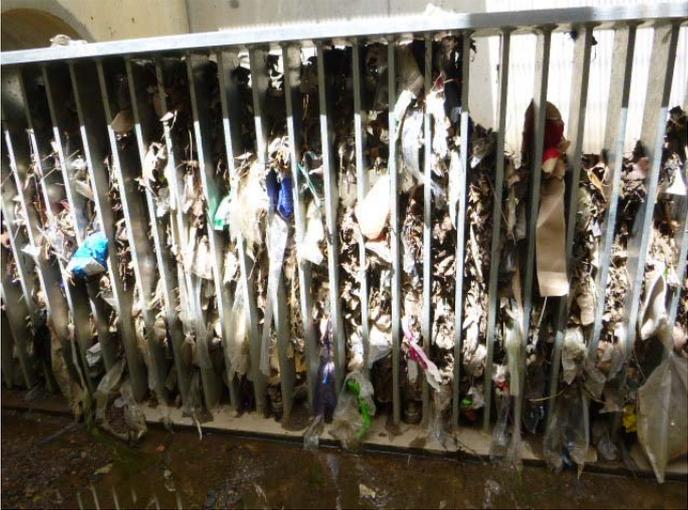
The trash rack has been cleaned recently but there is a large build up of sediment on the downstream side of the trash rack, that was not removed. This shows there is a need for a different type of GPT that will better capture and remove silts/sediment. If this volume was captured purely by deposition in elevated levels of standing water during a storm, imagine how much has come down the line.

The outlet pipe into the downstream pond is submerged, which is good, but the GPT offtake is not, which is also good. There are some positive elements to this GPT, but it could be massively improved.

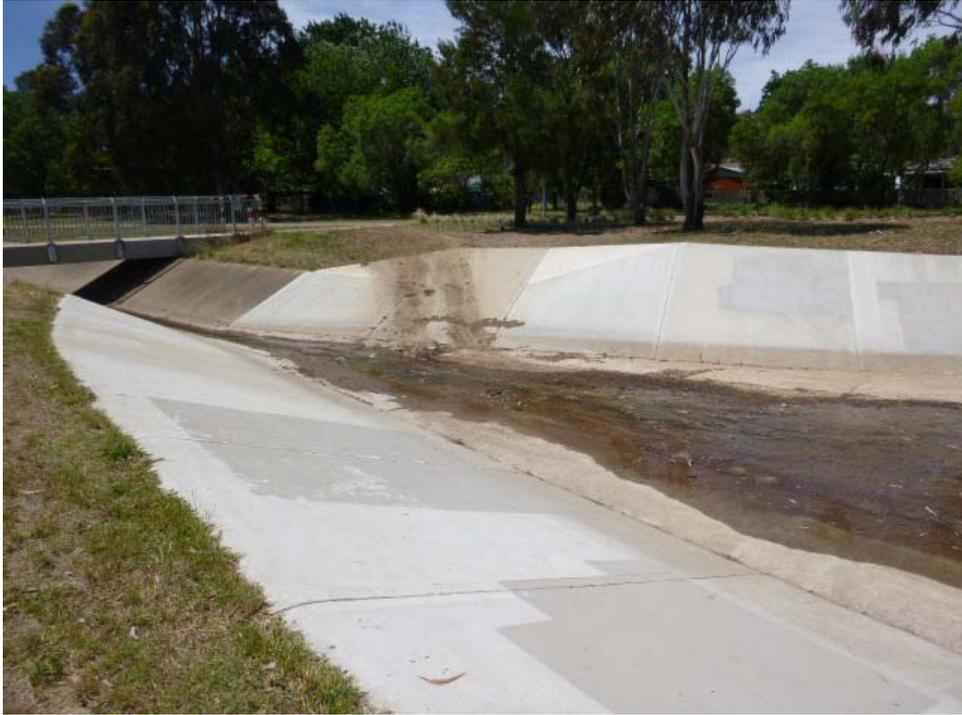
ACTGPT-12

Address	Dickson Wetland, Dickson
Device	Trash Rack
Site Details	Access way off Majura Ave, Opp 112
Estimated catchment area	-
Device Status at Nov 2014	Operational, device 35% full
Device comments and recommendations	The device is not large enough for the size of the upstream channel and catchment area; there is clear evidence of bypass downstream. The rack space is too small and would block too easily causing stormwater and pollution to top the weir and bypass the trash rack & pond. There is a lot of room for new racks and other options. The angle of the vertical bars makes it more likely that pollution will settle on the racks and will help to ramp floatables up over the device. The existing racks could stay, but if you were going to build a massive new rack, it would pay dividends in ease of cleaning to replace the existing rack as well.
Rectification works required	Install new racks across the length of the sediment basin in front of weir. Rack length could be increased up to 30m long in addition to existing rack.

Open channel upstream of Trashrack showing current vehicle access point.

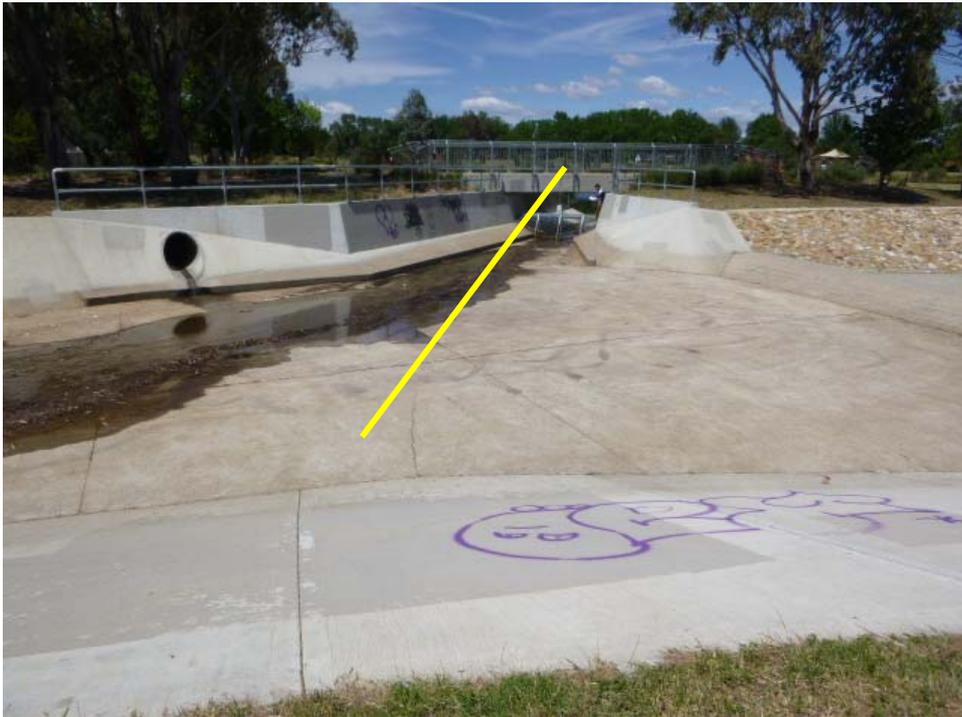
Upstream showing weir and trashrack, and location of new trashrack extension

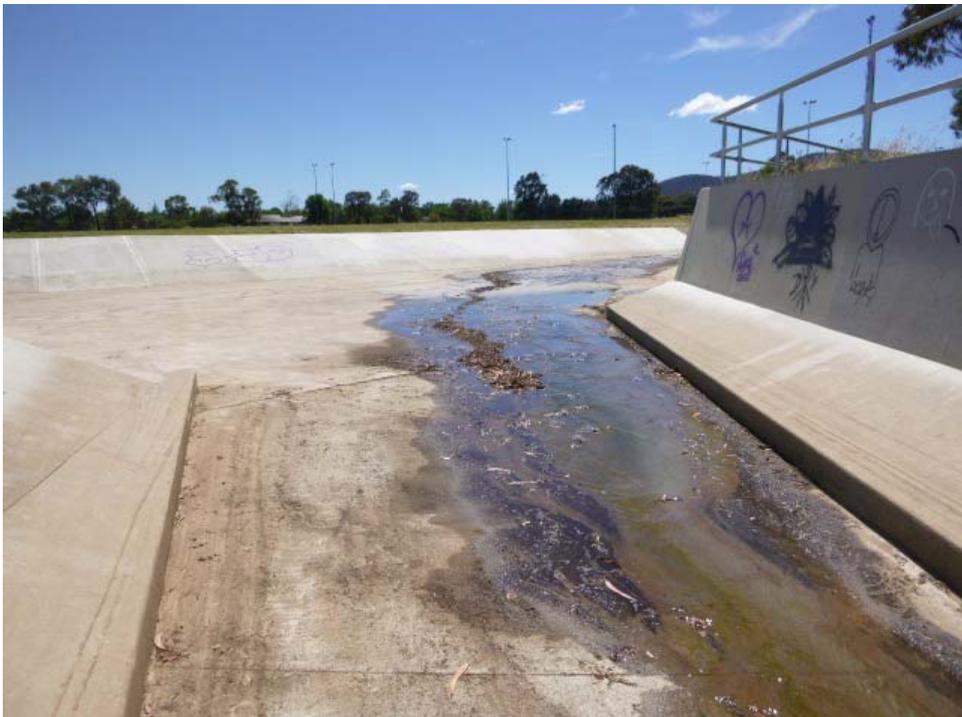
Upstream there is plenty of area for pollution storage, with good access.

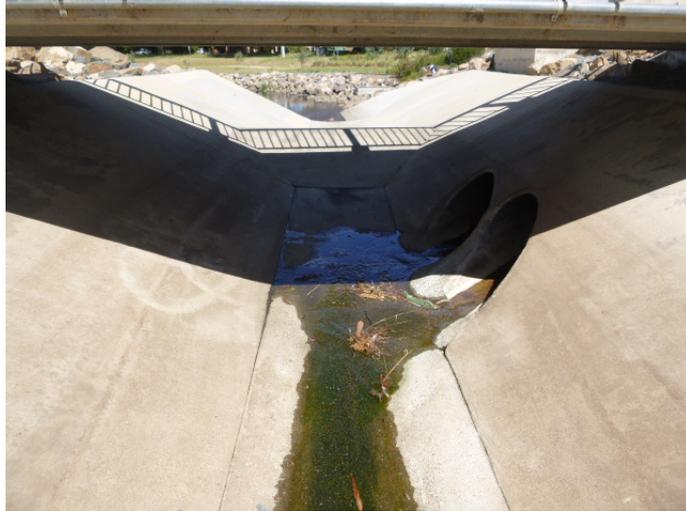
Small diversion weir and inlets into Nettech Chamber.

The “flume weir” is in the shade of the bridge, and is roughly the same height at the pipes.

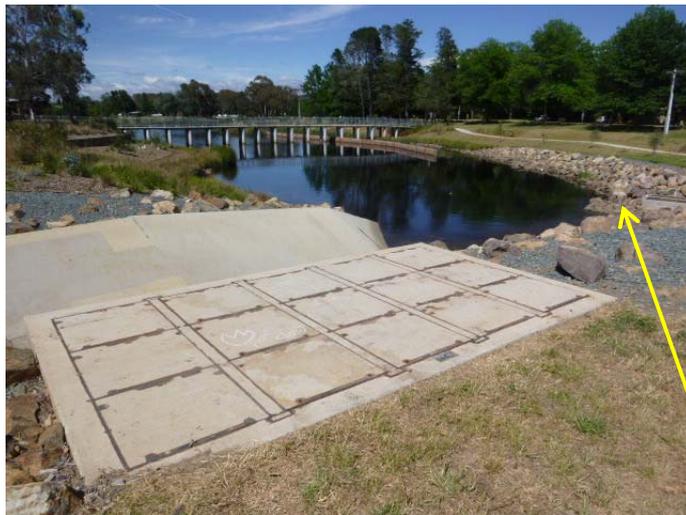
Site and access to Nettech Chamber. Outlet approx. here

There is good access to the site, but with 15 lid sections to come off, this does not make for easy maintenance. These all need to be greased, and so do the removable beams.

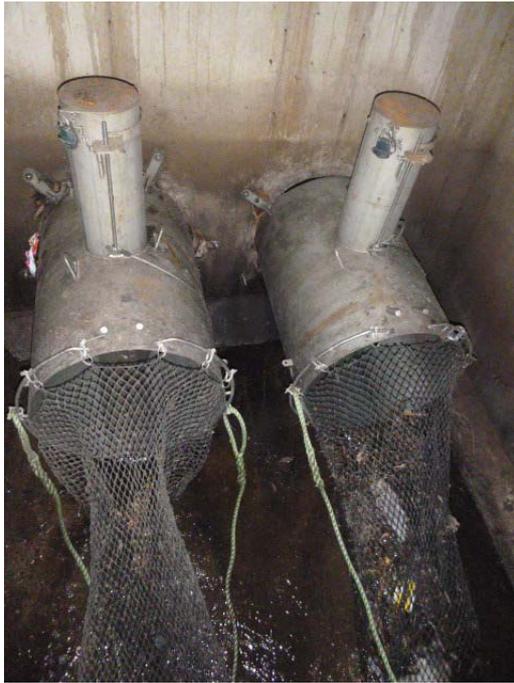
Nettech device over the inlet pipes

This was never the intention of the Nettek inventors from Port Macquarie. It was designed to go onto a pipe outlet, where all other options were unfeasible. This site has lots of options, a nice hydraulic drop at the back of the chamber, and Nettek is a strange solution for this site.

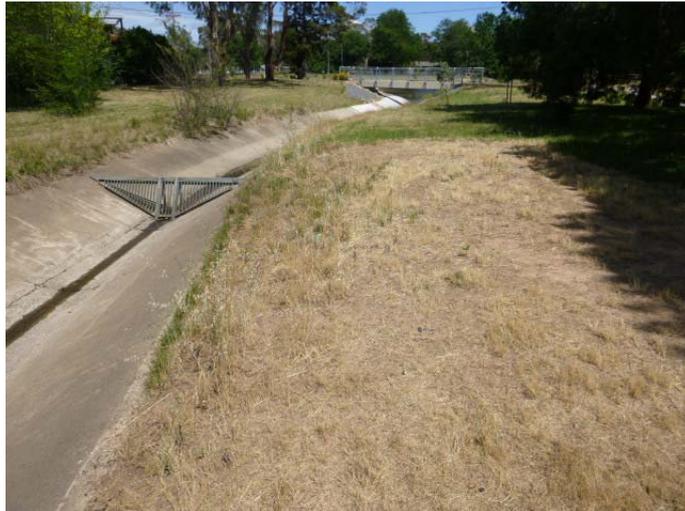
The site has plenty of room for an offline GPT.

As can be seen, the current trashrack eliminated over 80% of the channel capacity!

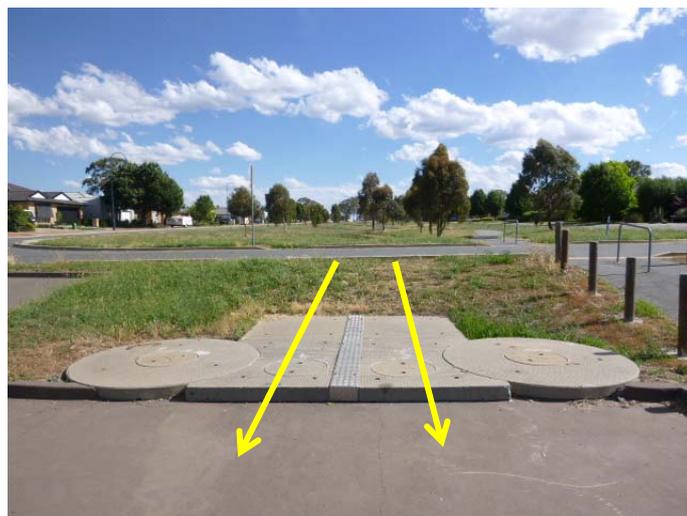
ACT GPT-22

Address	Ian Potter Crescent, Gungahlin
Device	Twin Cleansall 750s
Site Details	Corner of Ian Potter Cres and Tesselaar St
Estimated catchment area	-
Device Status at Nov 2014	Only just operational, device 5% full
Device comments and recommendations	These devices could work well but the downstream vegetation is creating a permanent backwater. Downstream of the devices surrounding outlet vegetation has become overgrown and is now dramatically affecting the performance of this device.
Rectification works required	5m of vegetation downstream of outlet should be cleared
Maintenance expectations with rectifications	Device will be working with twice the efficiency, so twice the pollution could be expected. So cleaning would increase.
GPS Coordinates	-
Notes	There is excellent access for cleaning the current devices, and good areas for dewatering.

CleansAll site from downstream

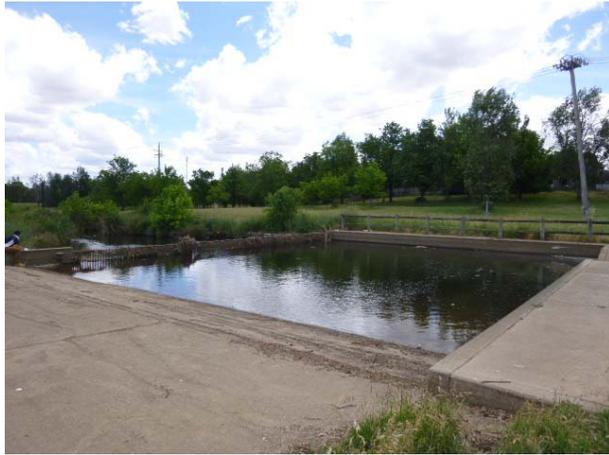
Sediment basin upstream of existing trash rack

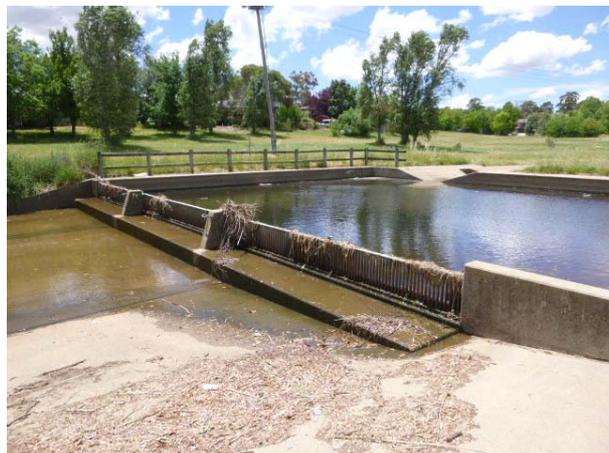
Length of trashrack, there is plenty of room with easy access in front of existing racks

There are lots of opportunities to dramatically improve performance at this device
