Tablelands Explosives Pty Ltd

Blasting Report

**RE: Contract No: 2015.26841.103
Throsby Stage 3 – Defect rectification Blasting Damage**

Contract No: 2015.26841.103 – Throsby Residential Estate Stage 3 – Civil and Landscape Construction
Defect rectification – Blasting Damage

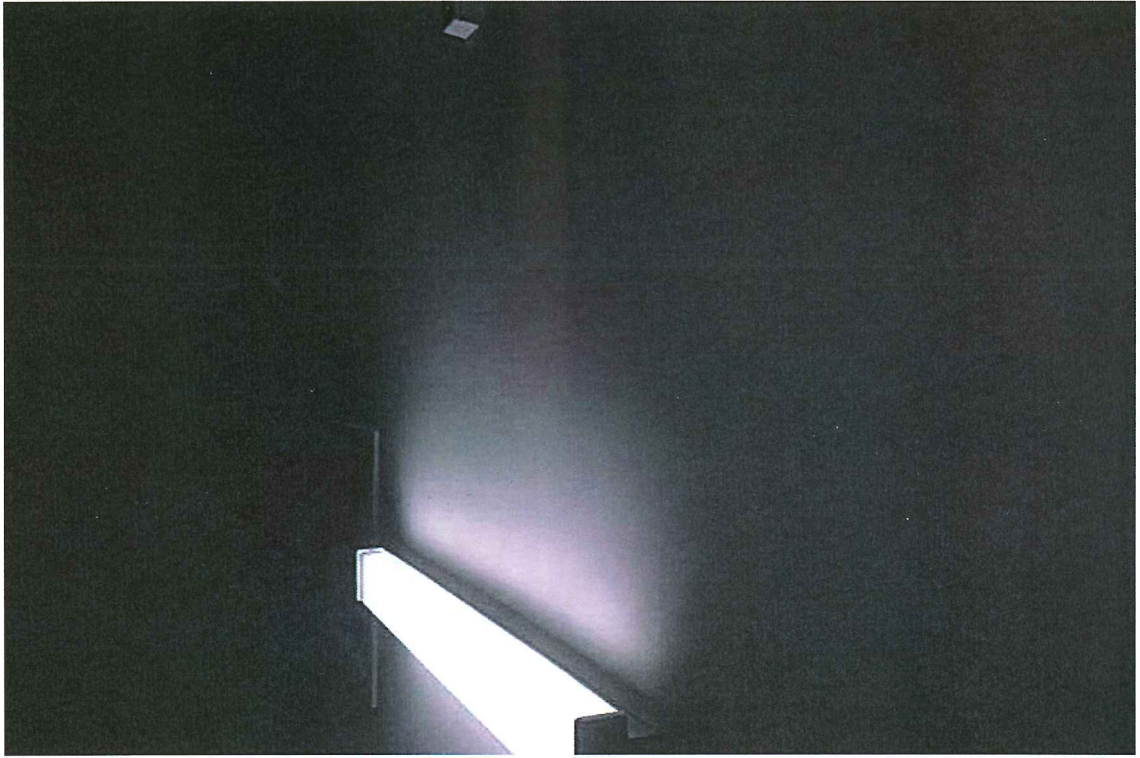
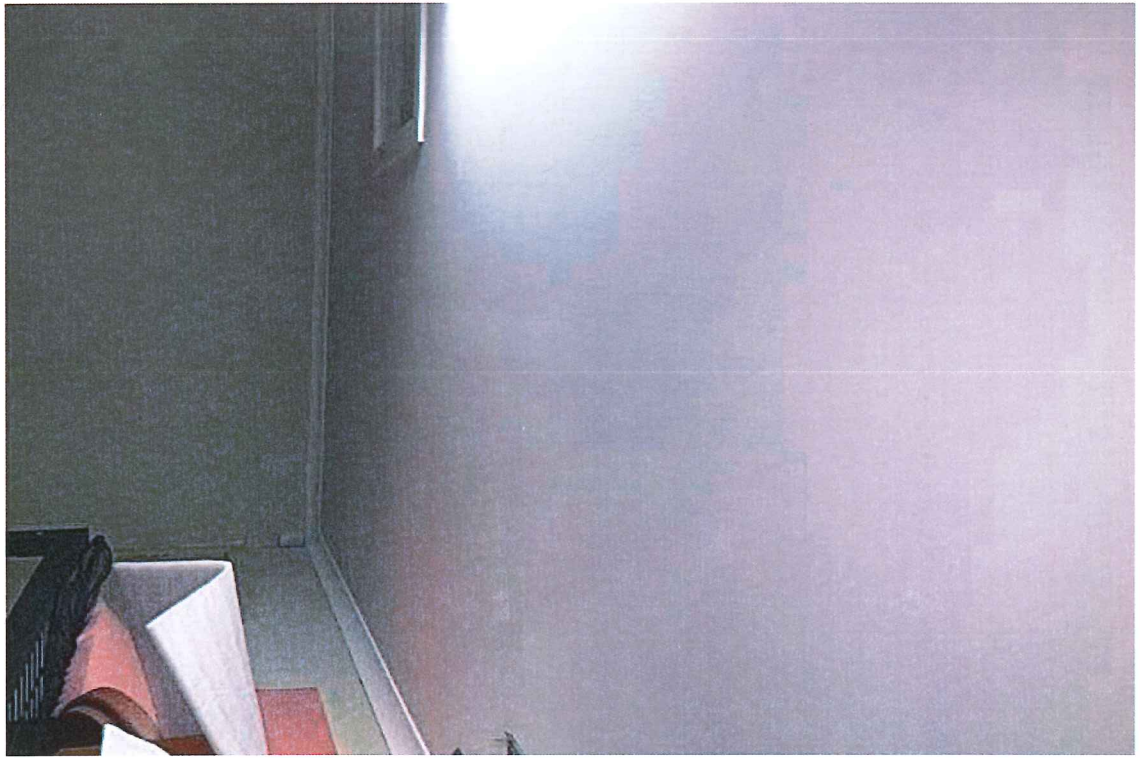
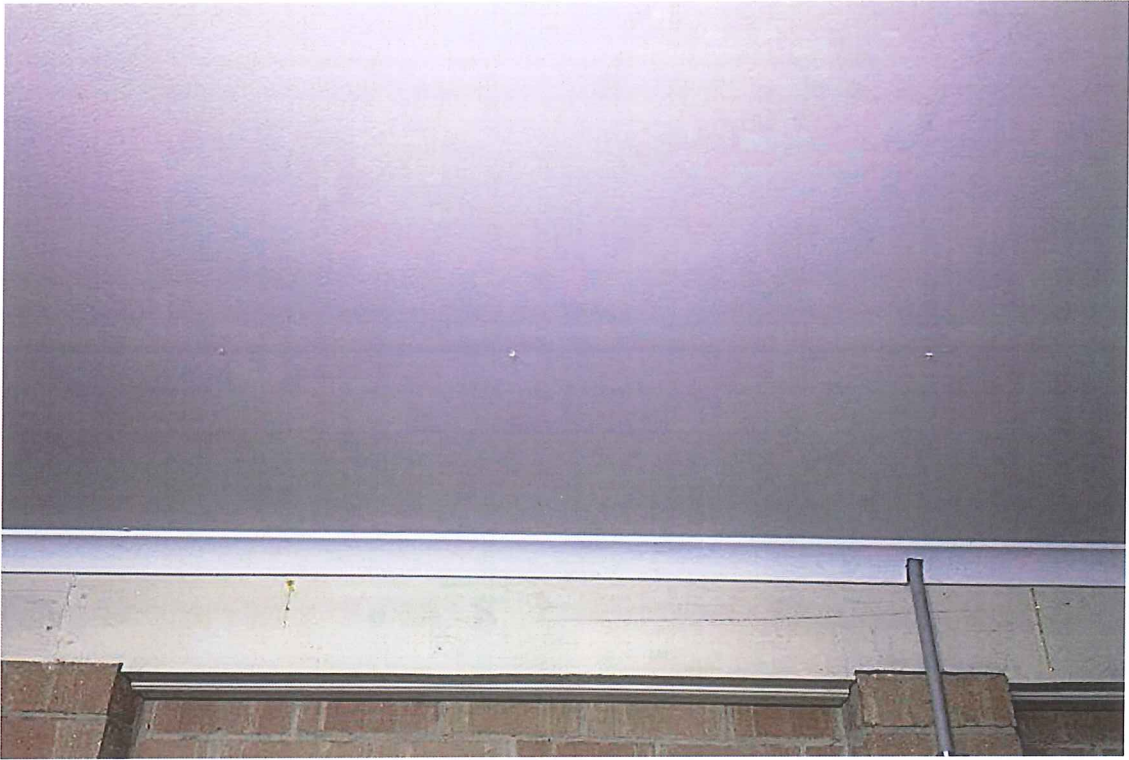
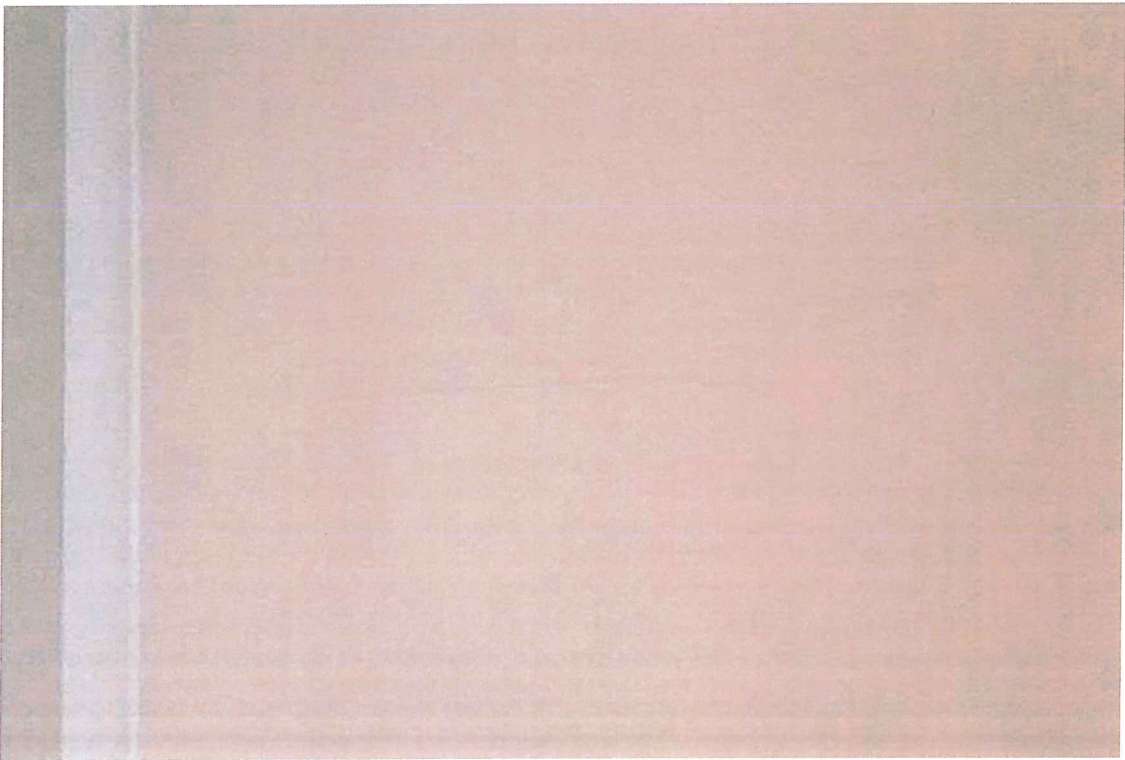
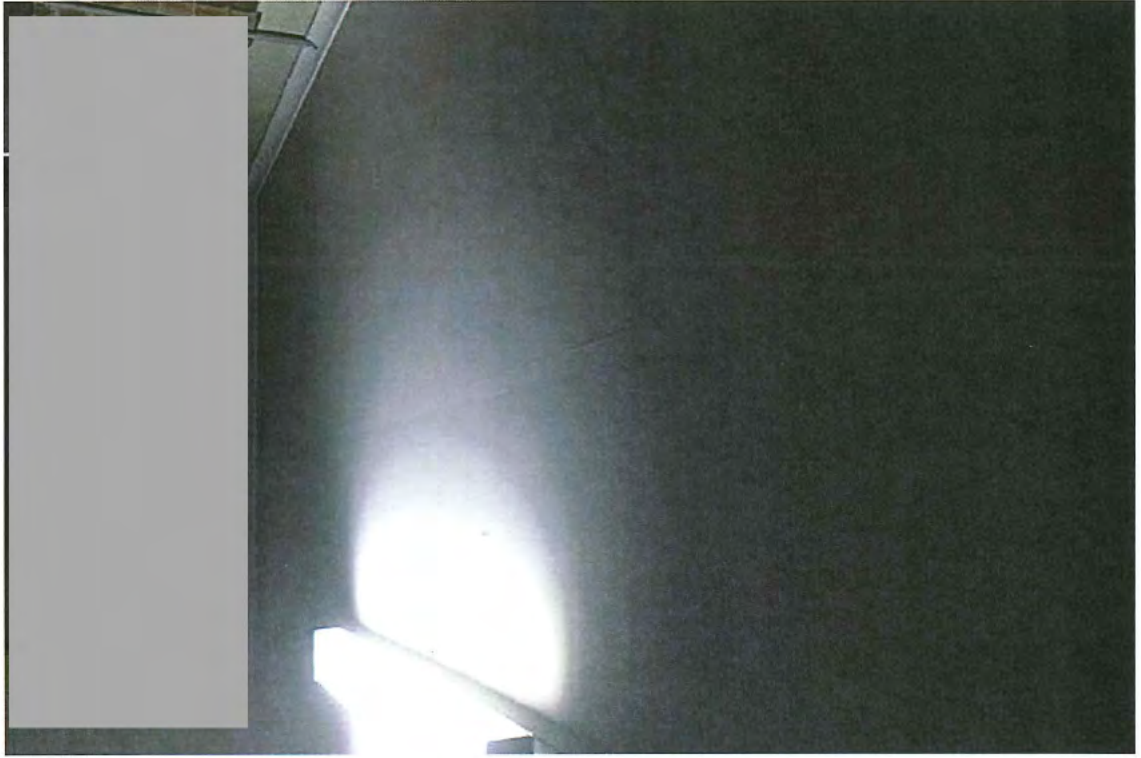
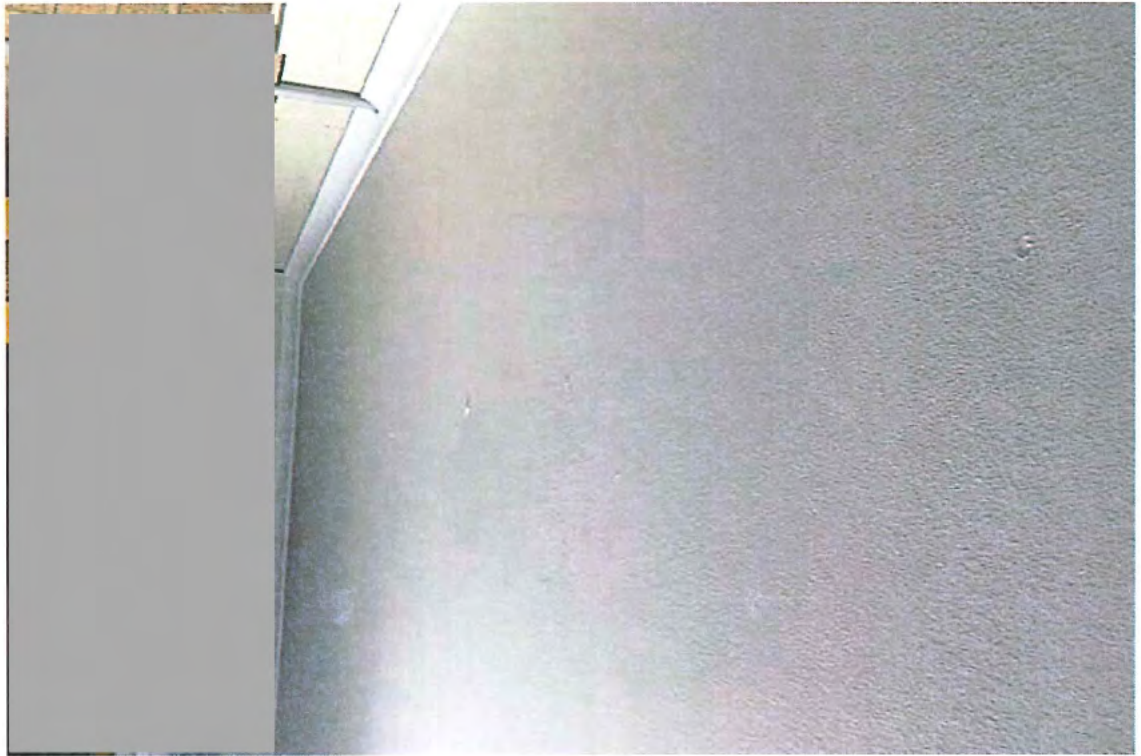
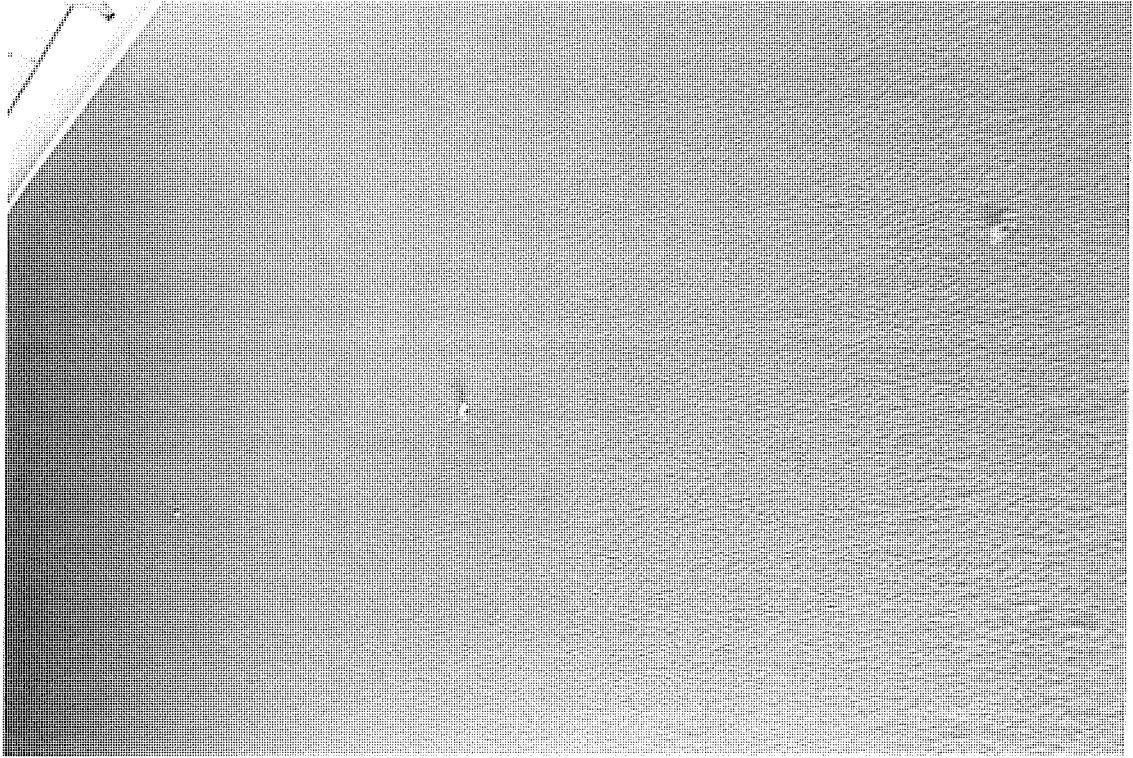
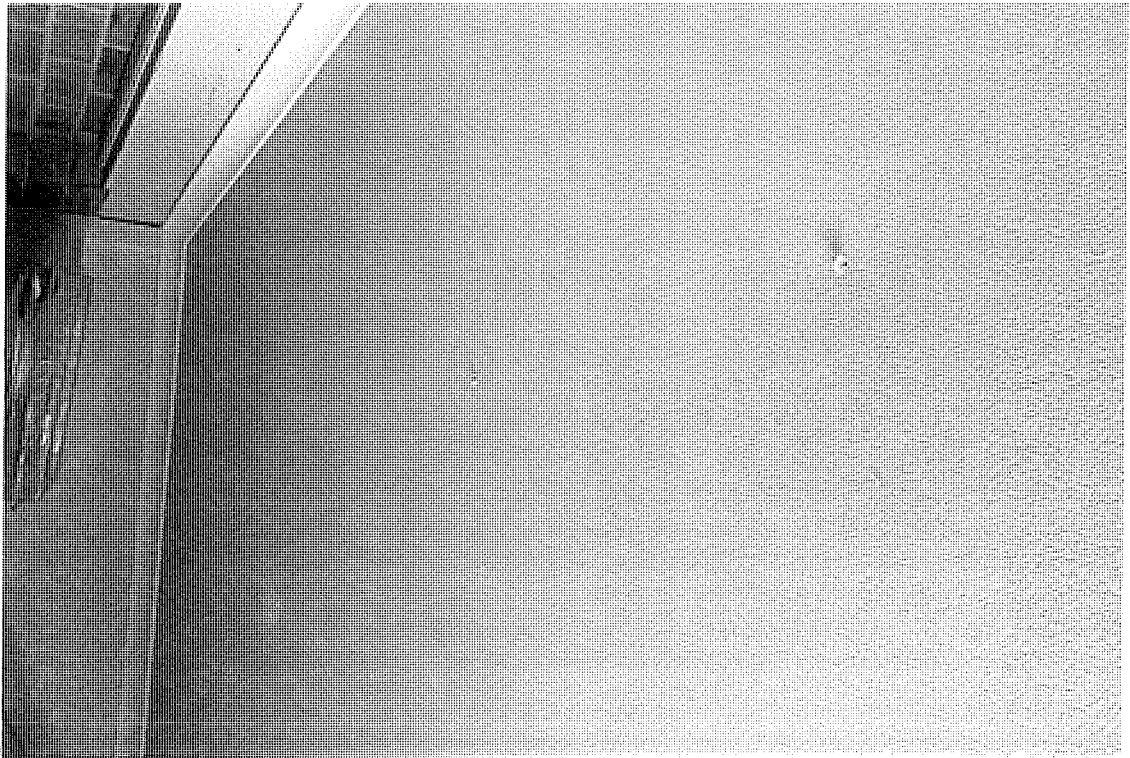
Please find attached the photos of the damage to the ceiling of my house. Unfortunately some of the photos are a little hard to see.

I have discovered a little damage in the dining area as well as the garage.
