Kaleen Group Centre

Stage 1 Site Investigation Report

14 August 2024

JPS Engineering Consultants

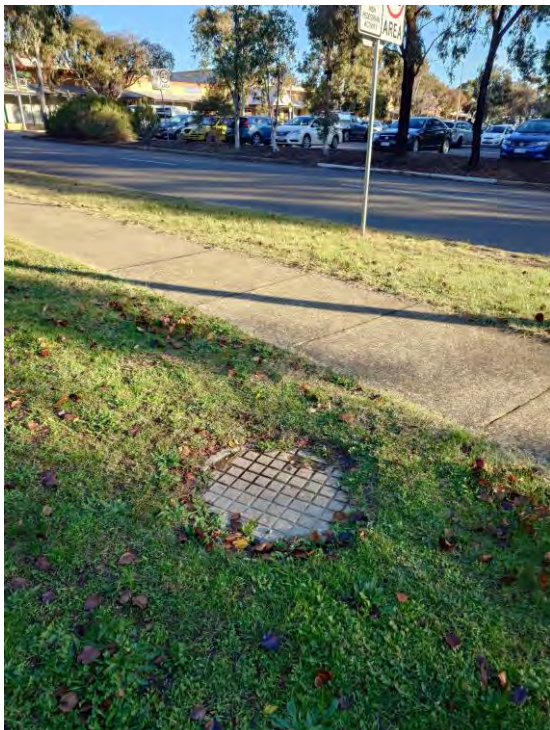
Figure 12 – Receiving Sewer Manhole on DN225 Main in Maribyrnong Avenue

The DN150 mains on either side of the site within Georgina Crescent connect to a DN225 sewer main in the northern verge of Maribyrnong Avenue. Figure 12 shows a photo of the receiving manhole for the site flows in Maribyrnong Avenue. The west crossing of Maribyrnong Avenue also upsizes from the DN150 main in Georgina Crescent to a DN225 main. See Figure 11 for a photo of manhole at the junction of the DN150 and DN225 main crossing Maribyrnong Street within the north west corner of the site.

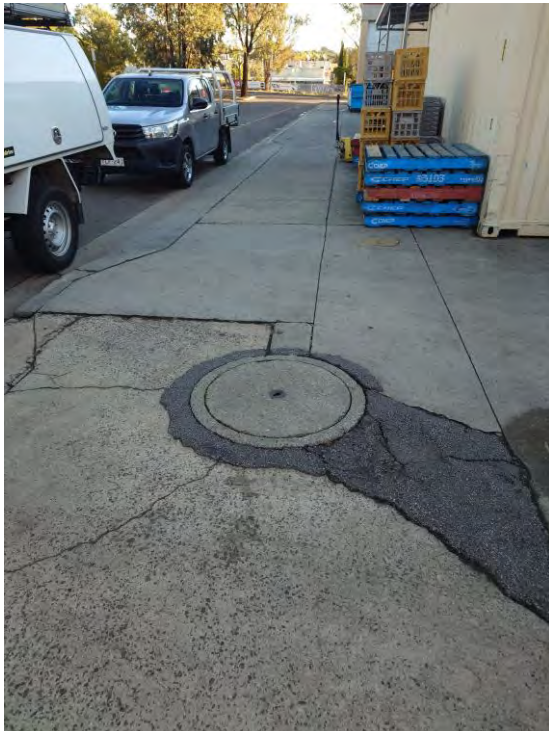
Figure 15 – Sewer Manhole in Southern Internal Road

The Icon Water BYDA information indicates that a sewer network runs within Georgina Crescent (east and west), servicing individual blocks in the group centre and developments to the east. All sewer mains on the site are DN150 and are predominantly located within the Georgina Crescent road reserve. However, a sewer main extends along the southern internal road to provide service to the development on Block 13 Section 88. Additionally, a small DN150 main extends along the northern internal road to provide service to Block 10 Section 88 (Kaleen Plaza). Easements over these DN150 main extensions through Block 9 Section 88 and Block 14 Section 88 are not shown on ACTmapi. Refer to Figure 14 and Figure 16 for photos of manholes over the sewer extension into the northern access road and Figure 15 for a photo of a manhole over the sewer through the southern access road opposite Block 13 Section 88.

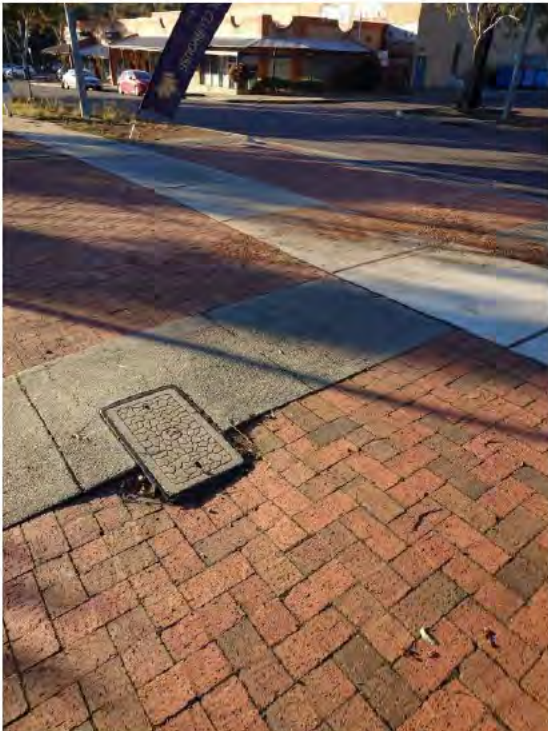
Figure 35 – Telstra Pit in West Verge of Georgina Crescent (west)

A Telstra P80 conduit extends north from Rubicon Street along the west verge of Georgina Crescent (west). This line branches into Block 4 and Block 26 Section 89 with P50 and P20 conduits, respectively. See Figure 35 for a photo of a Telstra pit in Georgina Crescent (west). The P80 conduit crosses Georgina Crescent (west) and continues east along the northern verge of the southern internal road to the west verge of Georgina Crescent (east), although it does not have a telecommunications easement as shown on ACTmapi. Refer to Figure 34 and Figure 36 for photos of Telstra pits identified in the northern verge of the southern access road and Figure 38 for the pit near Georgina Crescent (east).

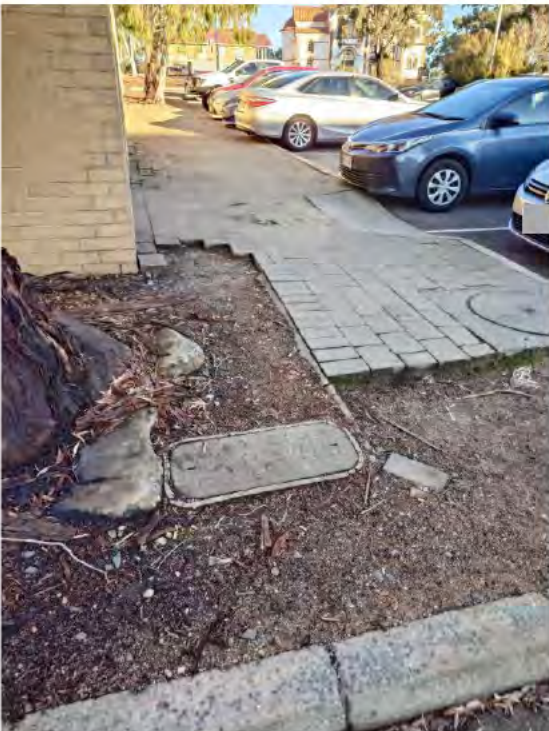
Figure 37 – Telstra Pit Near Block 13 Section 88

The P80 conduit run in the southern internal access road services Block 10 Section 88 via a P100 conduit and Block 13 and Block 9 via a P35 conduit. Figure 37 shows a photo of a Telstra pit adjacent Block 13 Section 88. In the west verge of Georgina Crescent (east), the conduit is shown as a P35 conduit and branches off to provide service lines to Block 11 and Block 12 Section 88. See Figure 39 for a pit identified in the west verge of Georgina Crescent (east).

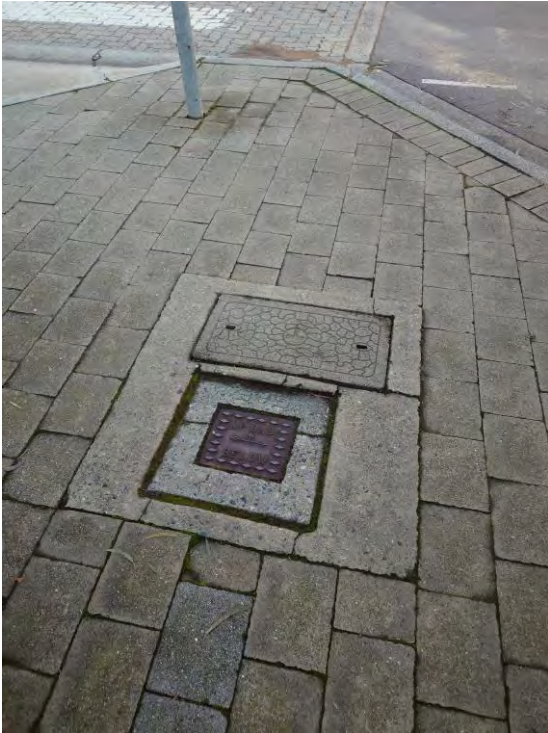
Figure 43 – Gas Marker in the Southern Internal Access Road

- Another DN32 210kPa nylon gas main branches off the main in Georgina Crescent (east) into the southern internal access road and terminates near Block 13 Section 88. No easement is currently registered over this gas main. See below Figure 43 for a photo of a gas marker over the main in the southern internal access road.

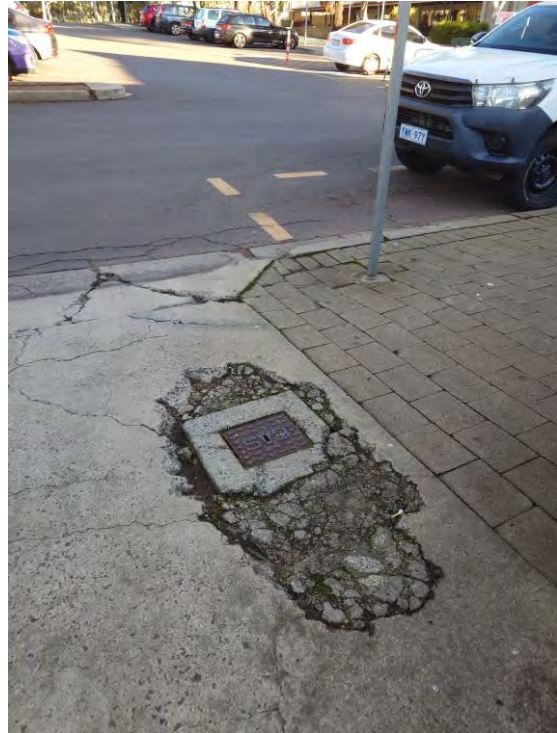
Figure 44 – Gas Isolation Valve in the Southern Internal Access Road

- Three service ties branch off the DN32 gas main in the southern internal access road to Block 10 and Block 13 Section 88 Kaleen. Refer to Figure 44 for a photo of an isolation valve to the eastern service tie to Block 10.

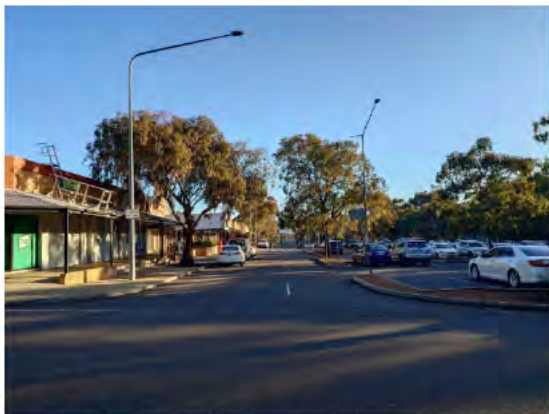
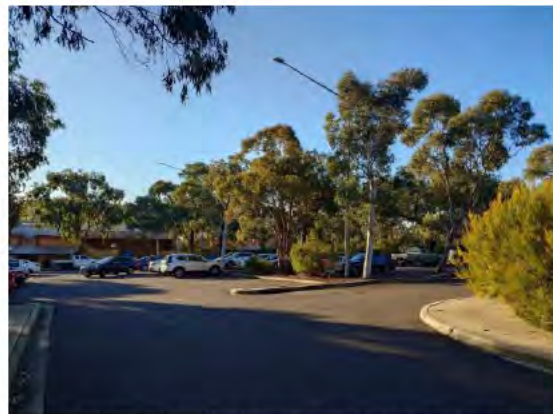
- Streetlights and interconnecting low voltage (LV) lines are present across several roads and car parks within and surrounding the subject site, including:
 - The northern verge of Maribyrnong Avenue, with one streetlight in the southern verge
 - The east verge of Georgina Crescent (east)
 - The south verge of Georgina Crescent (south)
 - The west verge of Georgina Crescent (west)
 - The west verge of Rubicon Street
 - Within the northern and southern car parking lots in the group centre. See Figure 46 and Figure 47 for photos of streetlights in the northern and southern car parks, respectively.

Figure 46 – Streetlights in Northern Car Park

Figure 47 – Streetlights in Southern Car Park

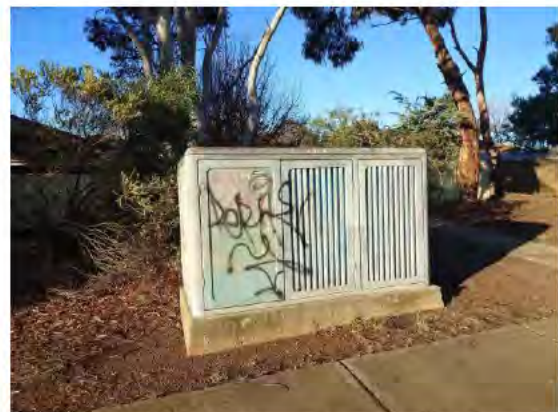
- The HV lines in the east verge of Georgina Crescent (east) continue to a substation (S 4057) located southeast of the southern internal access road. See Figure 50 below for a photo of this substation.

Figure 50 – Electrical Substation S 4057 in East Verge of Georgina Crescent (east)

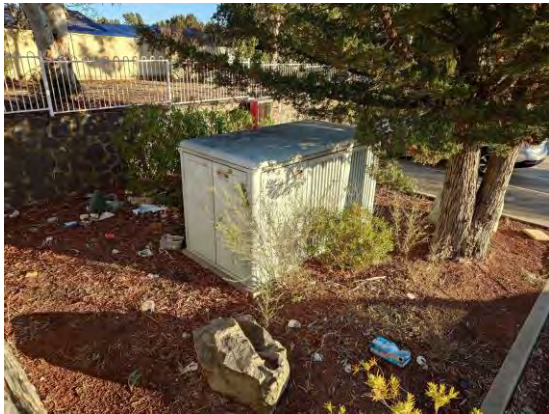
- The HV lines in Georgina Crescent (east) proceed to the southern verge of Georgina Crescent (south) and terminate near the intersection of Rubicon Street and Georgina Crescent (west), at a substation (S 4895) in Block 4 Section 89. This substation can be seen in Figure 51 below.

Figure 51 – Electrical Substation S 4895 in Block 4 Section 89 Kaleen

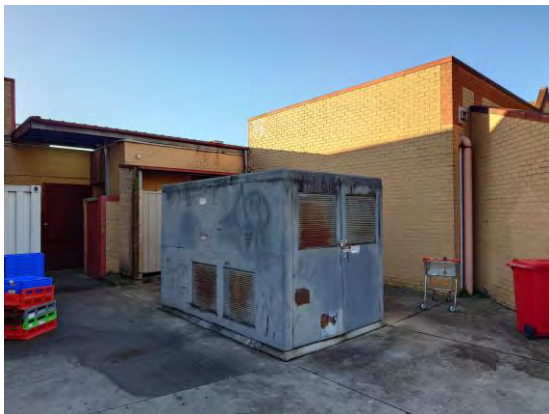
- The LV and HV lines in Georgina Crescent (east) branch off, crossing the road through a DN140 and three DN125 conduits to continue west in the northern verge of the southern internal access road. These services terminate approximately halfway along the southern internal road at a substation near Block 10 (S 4565). An easement is not shown in ACTmapi over the electrical service lines that run through the southern access road, nor over the substation. Refer to Figure 52 below for a photo of the substation in relation to the plaza.

Figure 52 – Electrical Substation S 4565 Near Block 10 Section 88

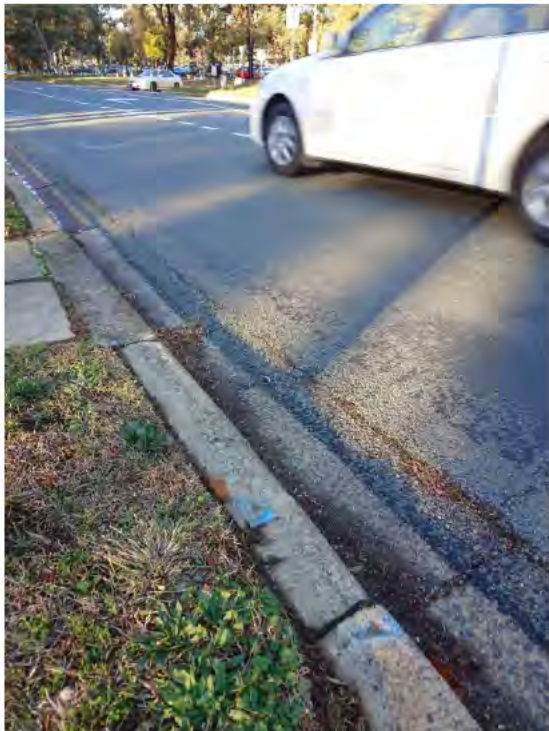
Figure 55 and Figure 56 shows a photo of kerb markers (KBM 3455 and KBM 4685) located during the site inspection on Maribyrnong Avenue and Georgina Crescent (west), respectively.

Figure 55 – Kerb Survey Marker on Maribyrnong Avenue

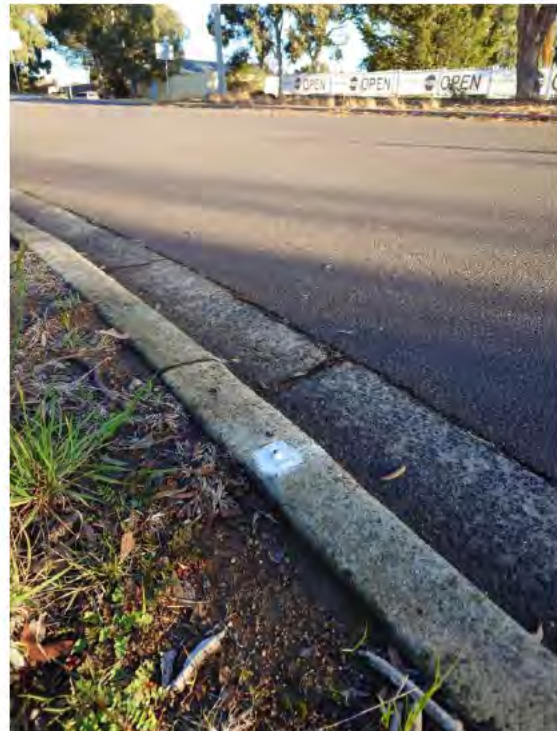
Figure 56 – Kerb Survey Marker on Georgina Crescent (east)

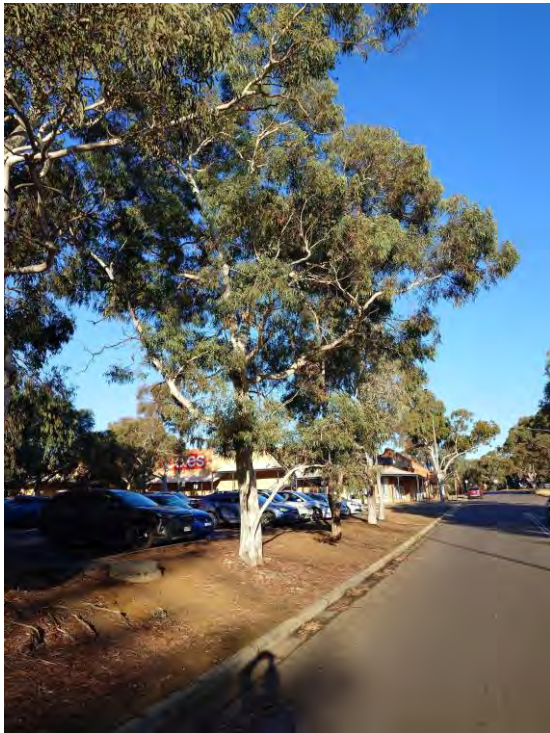
Figure 103 – Large Mature Trees in Georgina Crescent (west)

- Some very large isolated mature trees are present within the car parks on site and in road verges. Refer to Figure 103, Figure 106, Figure 107, and Figure 108 for examples of large mature trees within road reserves and car parks in the subject site.

A tree assessment has not been undertaken on the site, however, it is recommended that one is carried out by an accredited arborist in conjunction with a tree survey, to provide detailed information on the location and status of trees within the site. This information would aid in the development or redevelopment of any portion of the site by identifying and assessing trees that are Protected and Regulated, as covered by the Urban Forest Act 2023. Following a tree assessment, the findings should be provided to the ACT Tree Protection Unit for comment/validation.

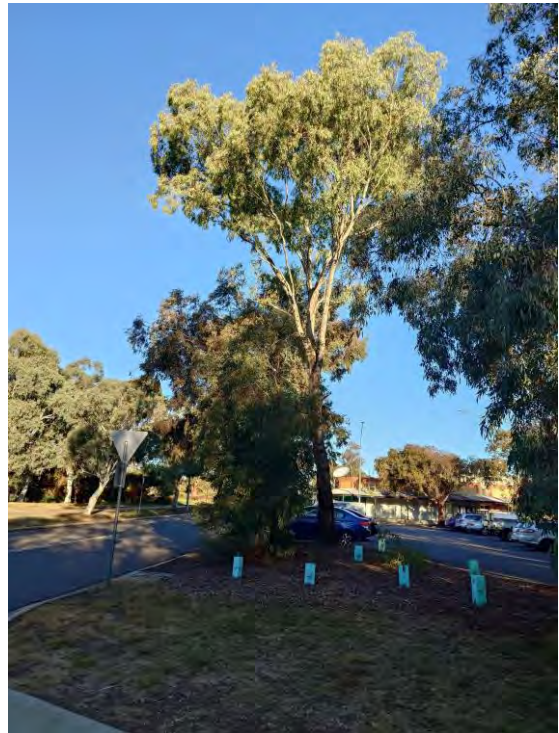
Figure 105 – Large Mature Trees and Newly Planted Trees at Intersection of Georgina Crescent (east) and Maribyrnong Avenue

- Some small relatively newly planted trees were observed during the site inspection within the Maribyrnong Avenue south verge and within the northern portion of the subject site. See Figure 104 and Figure 105 for an example of these newly planted trees observed within the subject site.

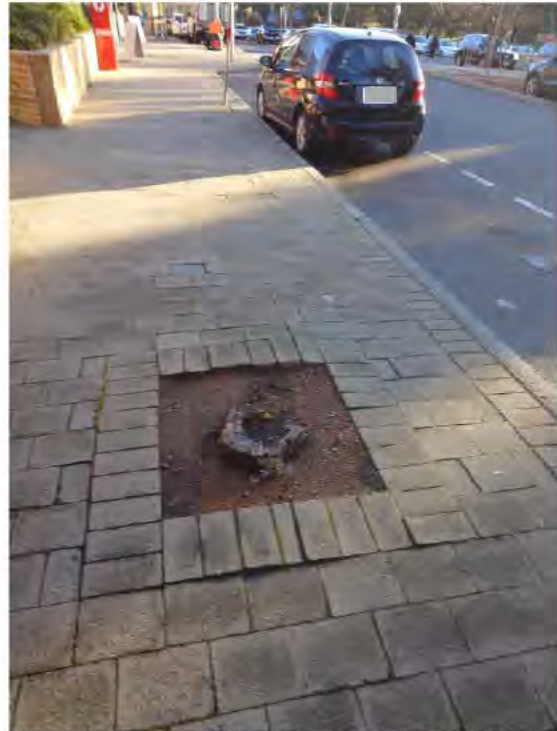
Figure 109 – Tree Stump in Northern Access Road

- Some dead and felled trees were also observed within the site, an example of which is shown in Figure 111 below, north of Block 13 Section 88. Figure 109 is a photo of a felled tree with remnant stump remaining in the paved verge adjacent Block 10 Section 88.

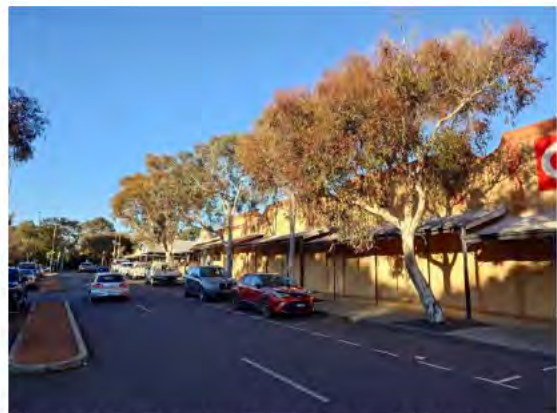
Figure 110 – Large Mature Trees Adjacent Block 10 Section 88

- There are also some large mature trees that are located along both northern and southern internal access roads, adjacent Block 10 Section 88. An example of these trees can be seen in Figure 110 below.

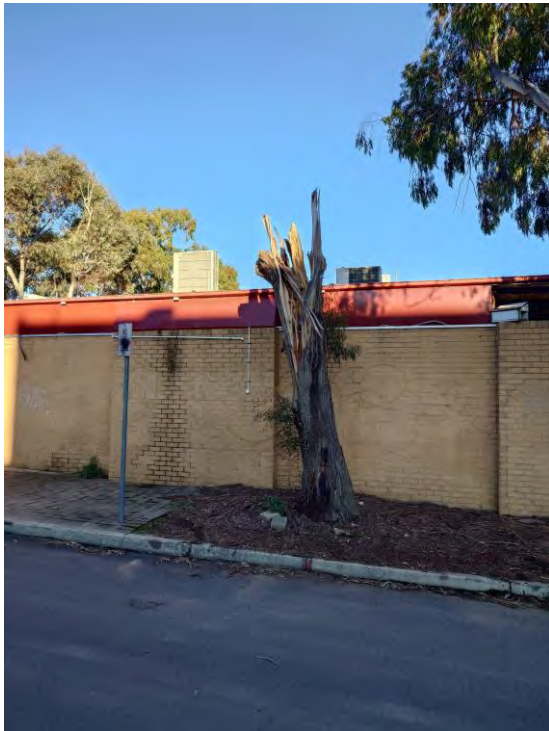
**Figure 111 – Dead Tree North of Block 13
Section 88**
