BACKGROUND INFORMATION – OAKS ESTATE SUBDIVISION & ENVIRONS – APRIL 2017

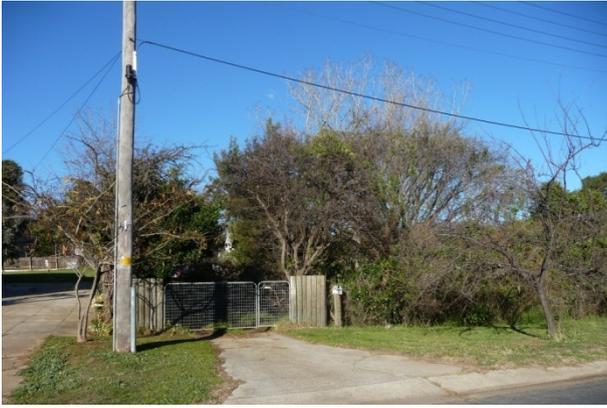
Figure 52 18 River Street - Block 5 Section 8 (ACT Heritage, 2014).

- Block 5 (18 River Street) – In 1926 it was originally a two room weatherboard cottage named "Rose Cottage" with a separate kitchen building. It was gradually expanded over the years and has had extensive gardens. By 1965 it had expanded to a seven room complex with an enclosed verandah.

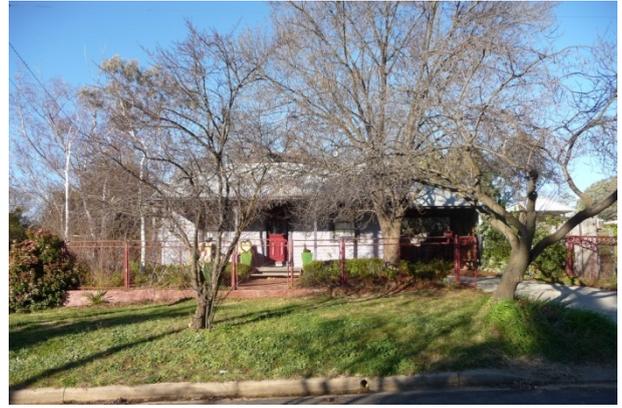
Figure 55 24 River Street - Block 8 Section 8 (ACT Heritage, 2014).

- Block 8 (24 River Street) – A timber cottage with recent galvanised iron cladding, and weatherboard cladding and timber windows. There is a modern two storey addition at rear. The first house built on this block was in the 1940s by Ted Robertson.

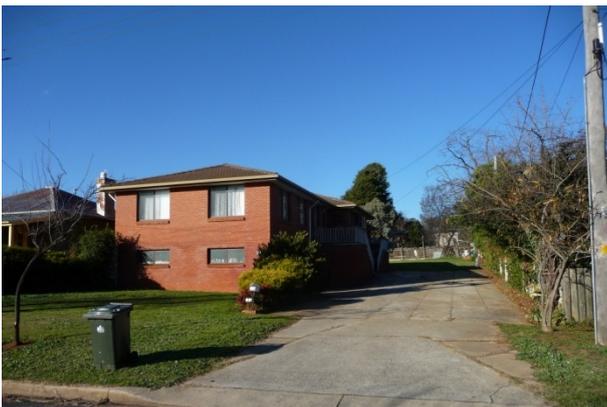
Figure 53 20 River Street - Block 6 Section 8 (ACT Heritage, 2014).

- Block 6 – 20 River Street 1970s brick veneer duplex, concrete roof tiles, aluminium windows. Williams notes that it was not built on until after 1959.

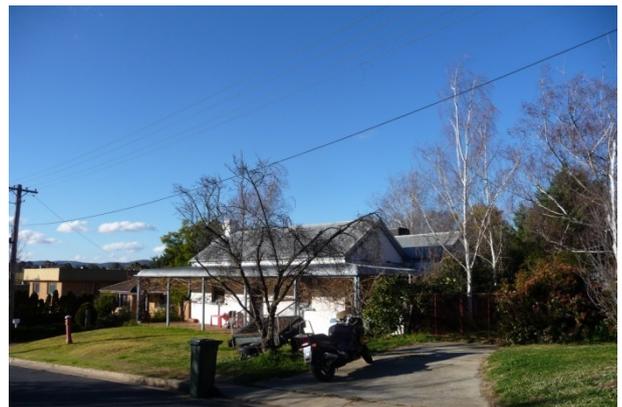
Figure 56 26 River Street - Weowna - Block 9 Section 8 (ACT Heritage, 2014).

- Block 9 (26 River Street) – Named "Weowna". A rendered brick cottage with additions, scored rendered walls (faux-stone coursing), new bullnose front verandah, and 'M' roof addition. In 1902 the property title transferred to Ned Robertson noting that there was a house already on it (possibly from 1890s). The house was extended in stages over time using salvaged materials in vernacular style, including 2 brick rooms added to front c.1906. It has been heavily modified following renovations and much of the original material has been replaced.

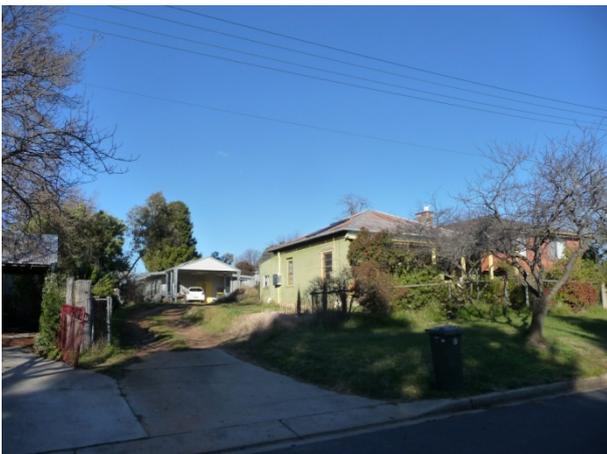
Figure 54 22 River Street - Block 7 Section 8 (ACT Heritage, 2014).

- Block 7 (22 River Street) – A 1920s rendered brick cottage with original galvanised iron roof, rendered brick chimney and wall, double hung windows, reconstructed verandah, modern studio at rear, and 1970s chain fence. Originally built for Ned Robertson by Tom Rickman using concrete blocks made by Dick Robertson.

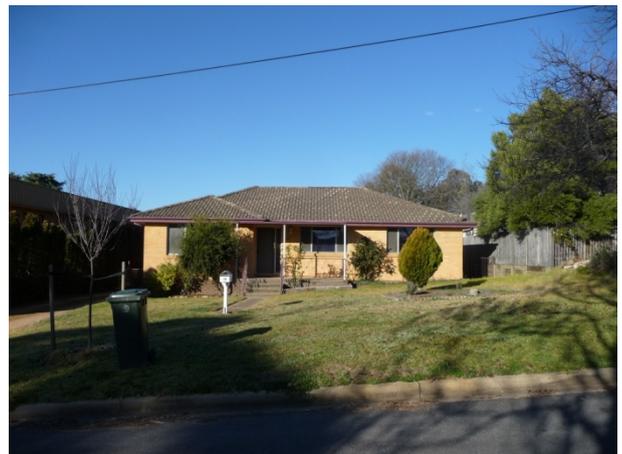
Figure 57 28 River Street - Block 10 Section 8 (ACT Heritage, 2014).

- Block 10 (28 River Street) – A 1970s brick veneer house with concrete tile roof and aluminium windows. In 1926 Ned Robertson bought Blocks 10-13 and operated a sawmill on them. In 1957 Blocks 11-13 were sold off with the sawmill and operated under a different owner.

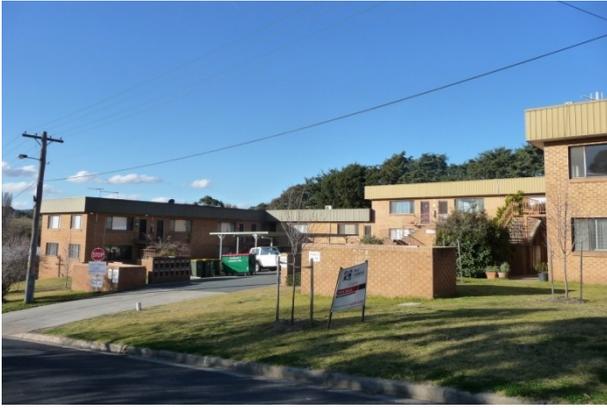
Figure 58 30-34 River Street - Blocks 11-13 Section 8 (ACT Heritage, 2014).

- Blocks 11-13 (30-34 River Street) – 1970s walk up flats in face brick. 1926 Ned Robertson bought Blocks 10-13 and operated a sawmill on these blocks.

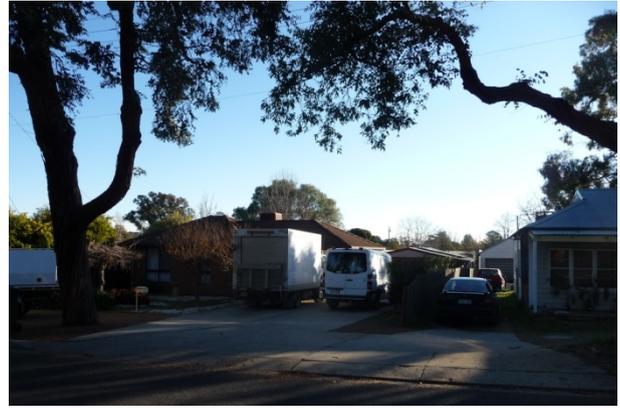
Figure 61 5 George Street - Block 23 Section 8 (ACT Heritage, 2014).

- Block 23 (5 George Street) – A 1970s brick veneer house with concrete tile roof, timber windows, and detached metal garage. The original house on this block was demolished in the 1980s, when the current house was built.

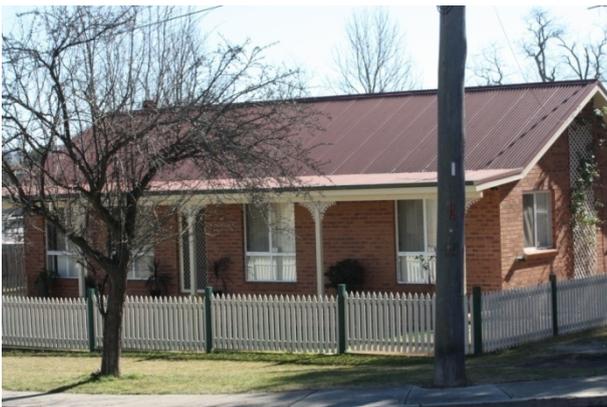
Figure 59 8 Hazel Street - Block 21 Section 8 (ACT Heritage, 2014).

- Block 21 (8 Hazel Street) – A 1990s brick veneer house with Colorbond roof and new picket fence after the late 1980s original house burnt down and was replaced by the current building.

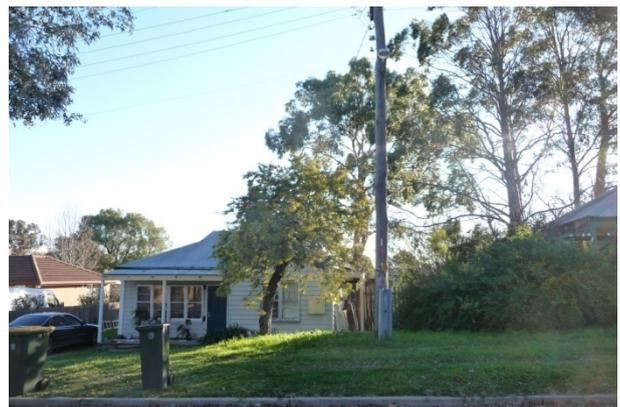
Figure 62 7 George Street - Block 24 Section 8 (ACT Heritage, 2014).

- Block 24 (7 George Street) – A 1920s timber cottage with double-hung windows, new galvanised iron roof, 1950s concrete verandah with single red brick wall on the west side, detached weatherboard garage in rear. The first house on this block dating from c.1893 was demolished between 1908 and 1913. A new house was built between 1913 and 1933 and then extended during the 1940s. The shed at the rear existed before 1913 and it appears to have been used as a residence at some stage in its life or the fireplace etc may just be from it being used as a workshop. Peter Freeman & Associates note that a butcher and his family were living in the hut in the early 1950s and have suggested that the hut pre-dates the subdivision; however, this early date is unlikely as, despite their argument to the contrary, it fits in the orientation and layout of the blocks, slab buildings were being created and reused into at least the 1940s and it was not mentioned in any of the early transfers between Bull and Tomsitt.

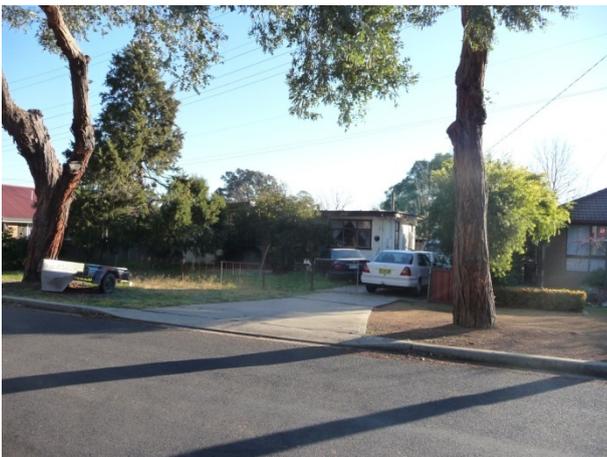
Figure 60 3 George Street - Block 22 Section 8 (ACT Heritage, 2014).

- Block 22 (3 George Street) – A 1950s fibro clad house with timber frame, skillion galvanised iron roof, timber windows, informal salvaged material fence and front.

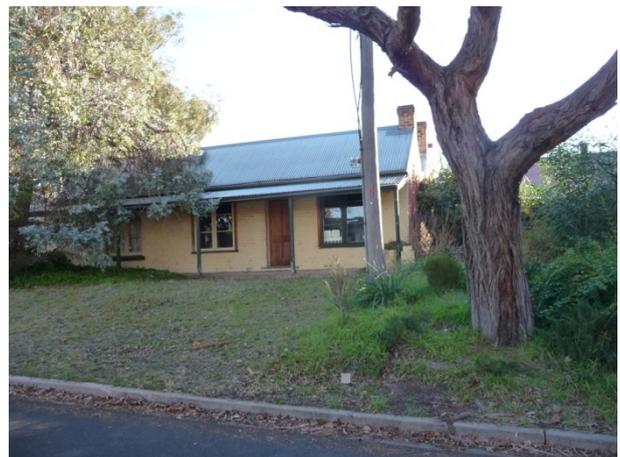
Figure 63 9 George Street - Block 25 Section 8 (ACT Heritage, 2014).

- Block 25 (9 George Street) – Generally noted as an 1890s cottage, but it does not appear in the 1915 survey maps. Like its neighbour on Block 26, it is likely to date from the 1920s and has 1990s renovations and additions (such as a new roof, red brick walls altered and patched or painted), brick garage and timber carport.

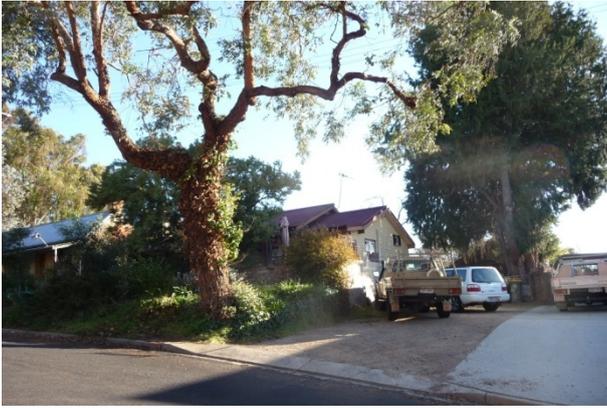
Figure 64 11 George Street - Block 26 Section 8 (ACT Heritage, 2014).

- Block 26 (11 George Street) – Named "Hill Crest". A 1920s rendered cottage with original galvanised iron roof and verandah, and leadlight doors which are period but probably not original. A later addition has been added to the east side of the house. In 1925 the land sold to Elizabeth Jane Robertson with a house built in 1926-27 using Dick Robertson's concrete bricks.

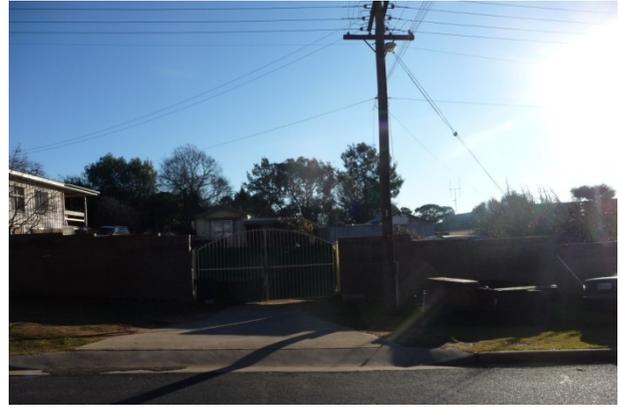
Figure 67 17 George Street - Block 29 Section 8 (ACT Heritage, 2014).

- Block 28 (15 George Street) – A 1950s style timber framed house with corrugated iron roof, ribbed asbestos cladding, brick base which has been significantly remodelled.
- Block 29 (17 George Street) – A collection of attached buildings of various materials and origins containing a demountable building with annexe, 1920s fibro building with gal roof, and a shipping container.
- Block 30 (19 George Street) – A 1980s brick veneer house with pressed metal roof and aluminium windows.
- Block 31 – vacant
- Block 32 (23 George Street) – A 1980s or 90s weatherboard clad demountable building in two halves on a brick base.
- Block 33 (25 George Street) – A 1980s or 90s timber framed weatherboard house with metal garage at rear.

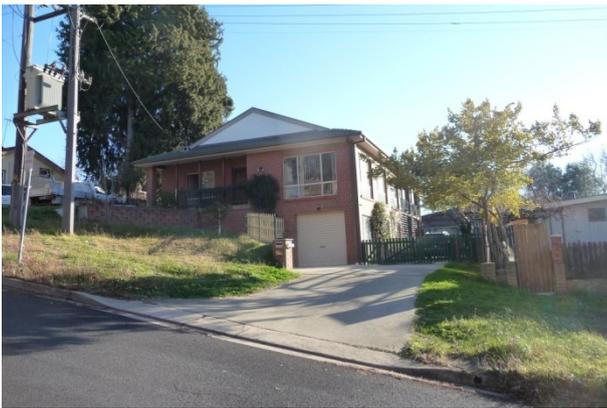
Figure 65 13 George Street - Block 27 Section 8 (ACT Heritage, 2014).

- Block 27 (13 George Street) – The first house was built after 1959 when the parcel of land

made up from Blocks 7 and 27 was split, but had been demolished by the mid-1970s. The current house is a 1980s split level brick house with a separate smaller residence in the rear of the block.

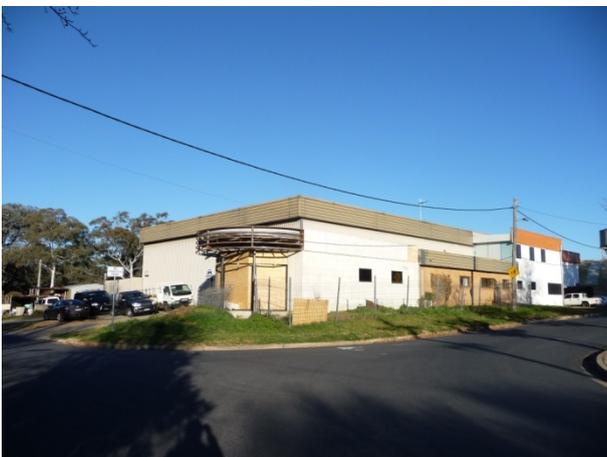
Figure 72 3 Hazel Street / 8-10 McEwan Avenue - Block 1 Section 10 (ACT Heritage, 2014).

- Block 1 (3 Hazel Street / 8-10 McEwan Avenue) – A large 1980s industrial shed with an addition to the front corner. It is a transport warehouse that has been built across historical blocks 3-5 in the 1980s.

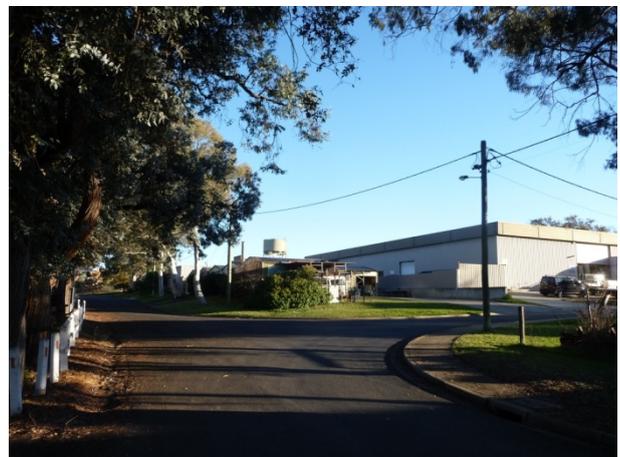
Figure 73 7 William Street/1 Hazel Street - Block 2 Section 10 (ACT Heritage, 2014).

- Block 2 (7 William Street / 1 Hazel Street) – A series of five late 1980s metal-clad workshops/sheds.
 - Block 3 (6 McEwan Avenue) – A 2 storey light industrial workshop from the late 1980s.

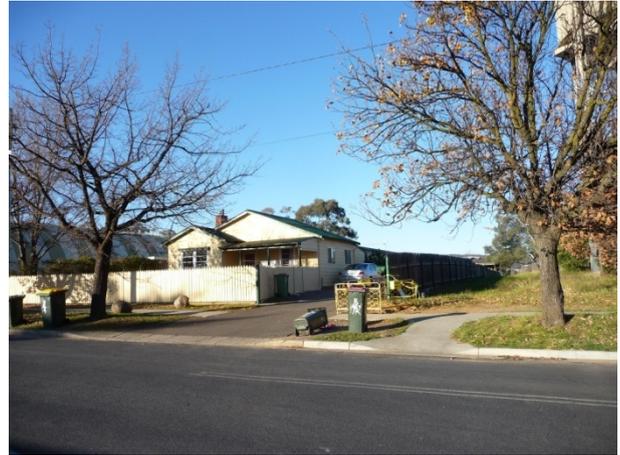
Figure 75 2 McEwan Avenue - Block 5 Section 10 (ACT Heritage, 2014).

- Block 4 (4 McEwan Avenue) – Romney hut (see previous individual section)
 - Block 5 (2 McEwan Avenue) – A 1920s weatherboard cottage with brick chimney, 1960s concrete block motel addition at rear, modern picket fence. Mid-1940s current Block 5 was separated from the previous block layout and a house built for Jack Hustler by Joe O'Rourke with the flats being added later

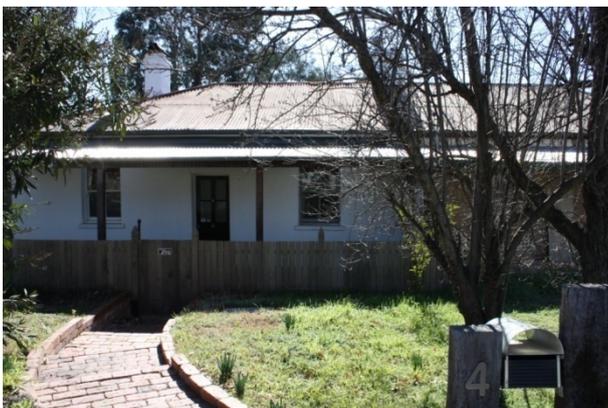
Figure 76 2 Hazel Street - Block 1 Section 11 (ACT Heritage, 2014).

- Blocks 1 and 20 (2 & 4 Hazel Street) – A semi-detached rendered brick residence built by 1889. The semi-detached brick cottage joins across the two blocks. The two blocks were initially owned as a parcel with different people living in each side of the building. In 1947 it was bought by the Corsini family who converted it into a single house; however there is no note of when it was divided again, although it was presumably after 1978 when Mrs Corsini died. The half of the house located on Block 1 has been renovated and restored and is in a good condition while the half located on Block 20 has not been maintained to the same standard.

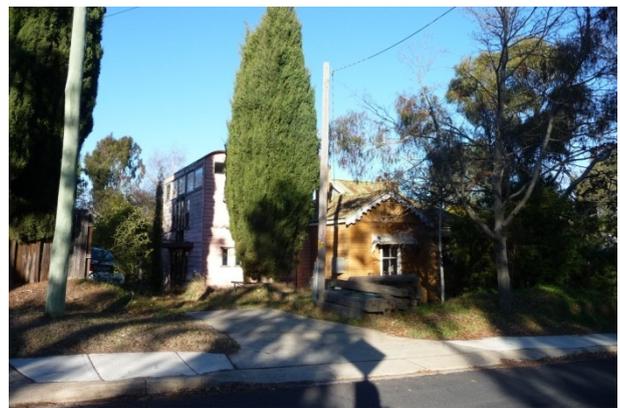
Figure 77 8 George Street - Block 4 Section 11 (ACT Heritage, 2014).

- Block 4 (8 George Street) – A weatherboard cottage with red brick chimneys, painted galvanised iron roof, pressed metal gable cladding, timber windows, fibro enclosed verandah and a weatherboard addition. The house was erected between 1903 and 1913.

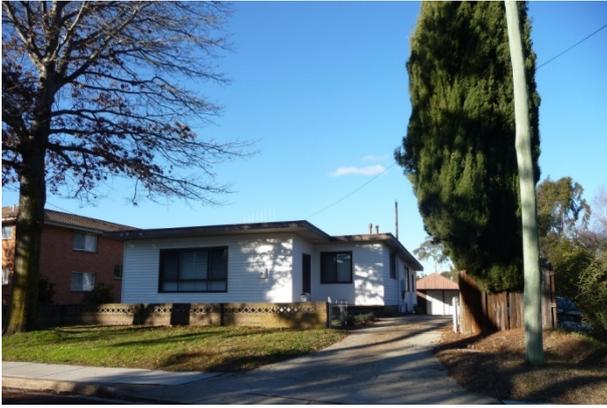
Figure 78 10 George Street - Block 5 Section 11 (ACT Heritage, 2014).

- Block 5 (10 George Street) – A timber frame weatherboard cottage with aluminium windows, skillion roof. It is potentially an older cottage (c.1938, possibly from Molonglo) that has been substantially altered so that the original form is hard to determine. During the 1950s a strong storm blew off the roof and it was extensively remodelled.

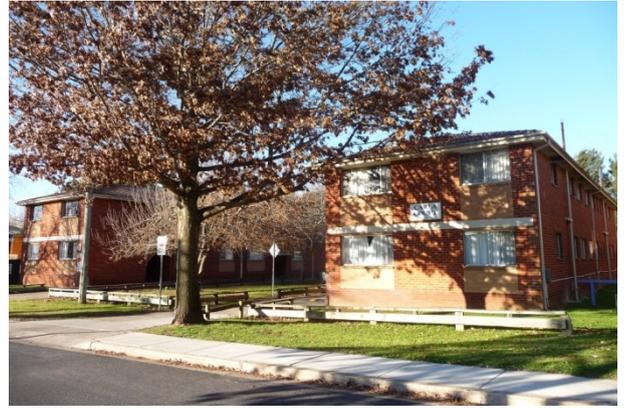
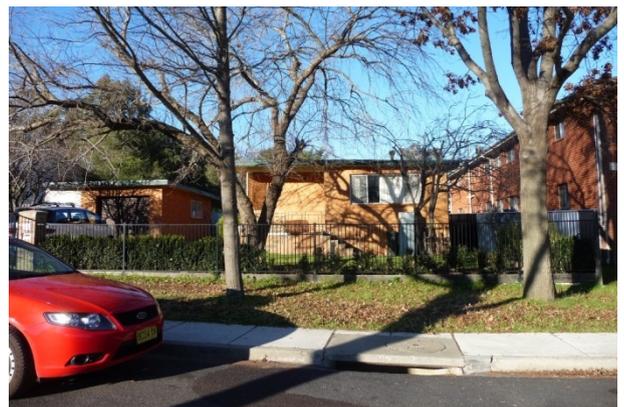
- Blocks 10-11 (20 & 22 George Street) – "Carla Court" 1970s walk up flats.
 - Block 12 (24 George Street) – A 1970s brick veneer house with aluminium windows and a detached garage with Kliplok skillion roof. In 1973 Blocks 12 and 13 had "in principle" support (i.e. they could not object at that point in time) from the NCDC to be developed into flats, but it was noted that the land would be acquired by the Commonwealth in the near future after which it would be uncertain if an approval would be given. The flats were not built.

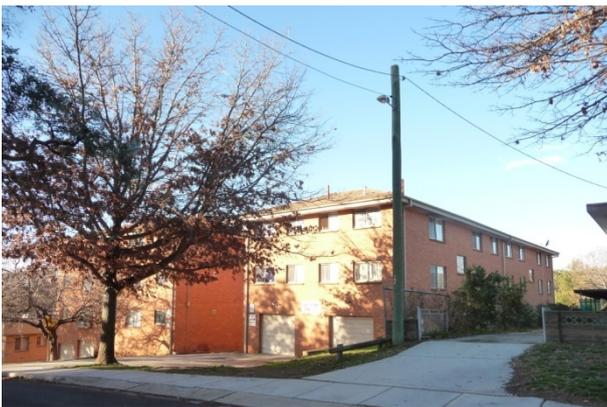
Figure 79 12-14 George Street - Dover Court - Blocks 6-7 Section 11 (ACT Heritage, 2014).

- Blocks 6-7 (12 & 14 George Street) – "Dover Court" walk up flats. In 1972 Blocks 6 and 7 had "in principle" support (i.e. they could not object at that point in time) from the NCDC to be developed into flats. An NCDC file note on the development commented that the building was sited closer to the boundary than they would usually allow, but while it was still under freehold title they had to rely on "persuasion" and that they should be "...thankful for small mercies" that it was not as close as it could have been. The developers were Pals Investment Pty Ltd designed by P. Green. A letter from R. J. Corrigan to the NCDC in March 1974 indicated that they owners were inquiring about the conditions of the possible lease after acquisition, but by November they were no longer interested.

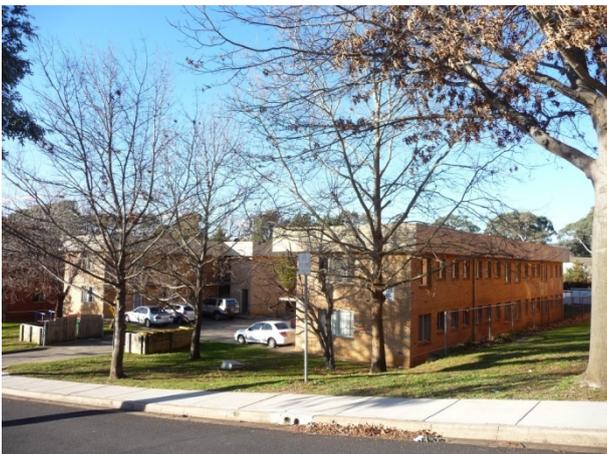
Figure 80 16-18 George Street - Elmsall Court - Blocks 8-9 Section 11 (ACT Heritage, 2014).

- Blocks 8-9 (16 & 18 George Street) – "Elmsall Court" walk up flats. In 1972 Blocks 8 and 9 had "in principle" support (i.e. they could not object at that point in time) from the NCDC to be developed into flats. The developers were Pals Investment Pty Ltd designed by P. Green.

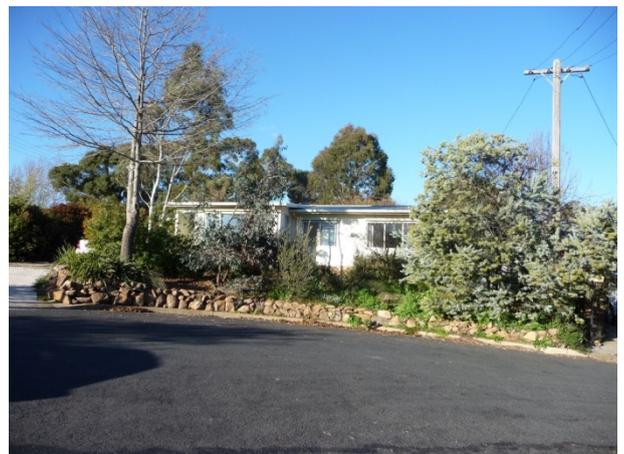
Figure 83 26 George Street - Block 13 Section 11 (ACT Heritage, 2014).

- Block 13 (26 George Street) – A timber framed 1980s or 90s building on brick base with windows of aluminium and wood and salvaged timber framed coloured glass. Stucco texture cladding panels.

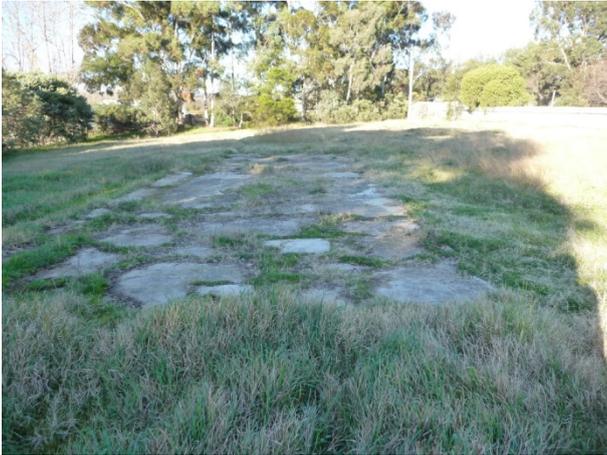
Figure 84 Blocks 14-15 Section 11 (ACT Heritage, 2014).

- Blocks 14-15 – vacant. In 1973 Blocks 14 and 15 had “in principle” support (i.e. they could not object at that point in time) from the NCDC to be developed into flats, but it was noted that the land would be acquired by the Commonwealth in the near future after which it would be uncertain if an approval would be given. The developers were Pals Investment Pty Ltd. The flats were not built.

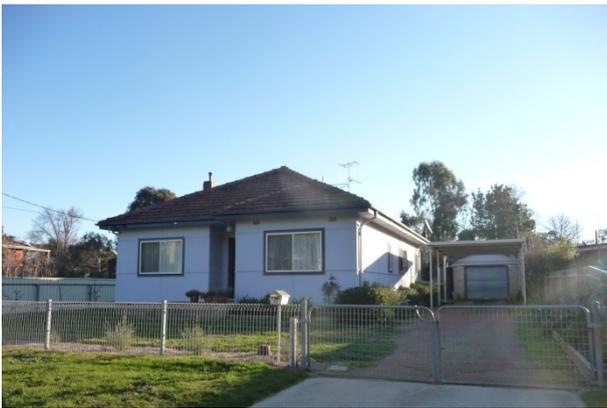
Figure 85 17 William Street - Block 23 Section 11 (ACT Heritage, 2014).

- Block 23 (17 William Street) – An early 1950s War Service Loan timber frame fibro cottage on concrete base with terracotta roof, new aluminium windows and a sympathetic addition to the rear. Detached concrete block garage and steel mesh fence. Fibro house. One of 3 houses (not including Hazelbrook) on the street in the 1950s.

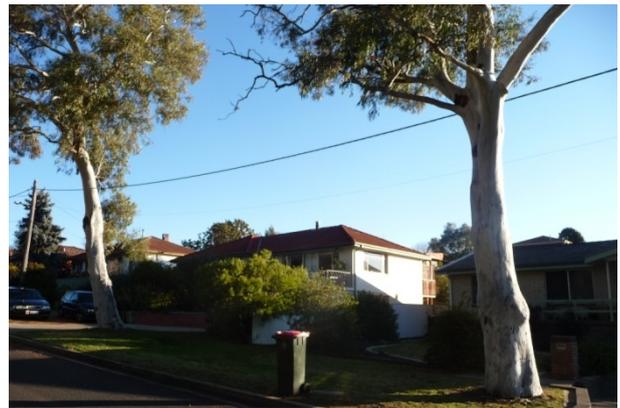
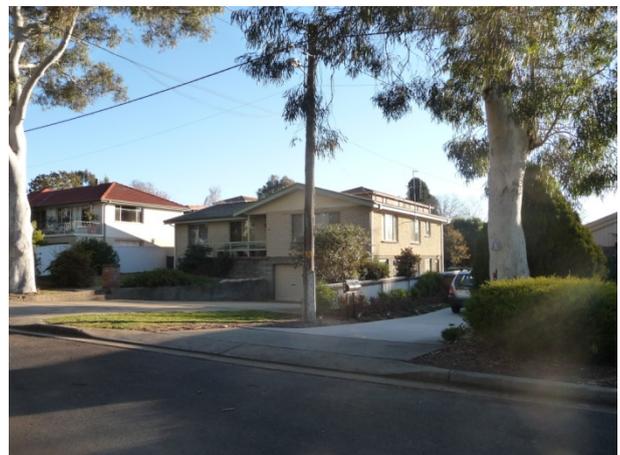
- Block 26 (23 William Street) – A 1950s brick house with concrete tiled roof, steel framed windows, rendered brickwork, and garage underneath.
- Block 27 (25 William Street) – A 1970s brick veneer house with concrete roof tiles, aluminium windows, and a garage underneath.

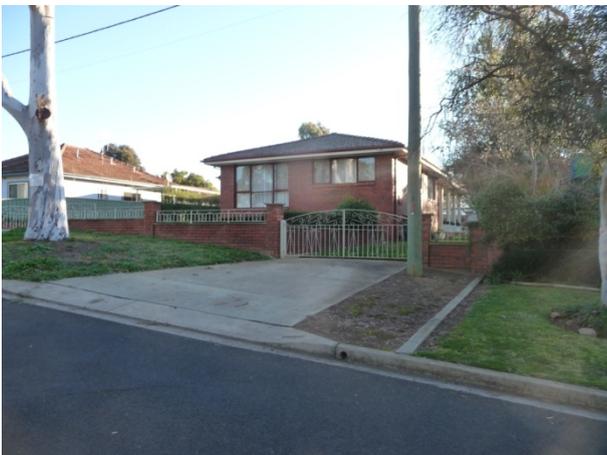
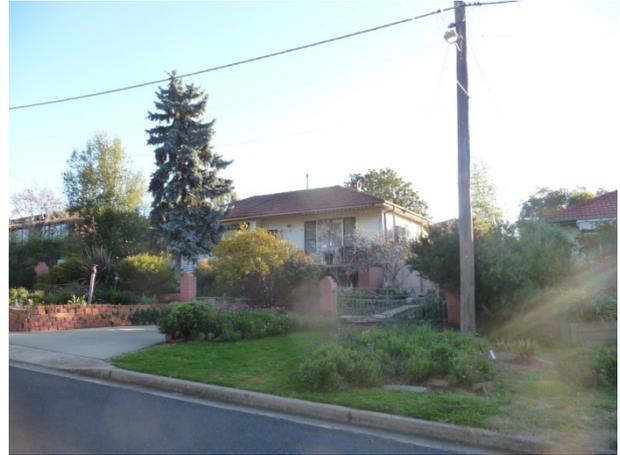
- Block 24 (19 William Street) – A brick veneer house with terracotta tiled roof and timber windows.
- Block 25 (21 William Street) – A timber framed fibro house with concrete roof tiles and a garage underneath.

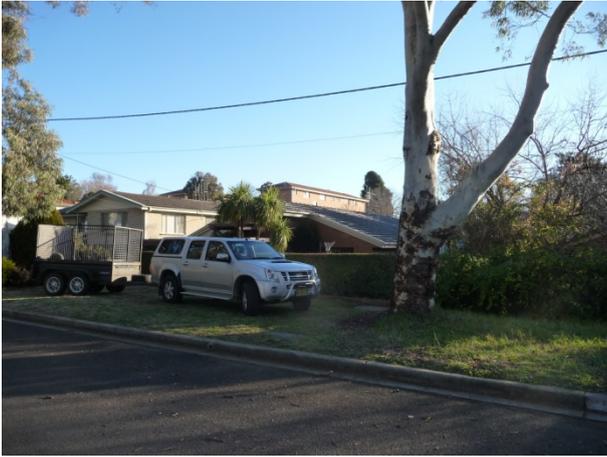
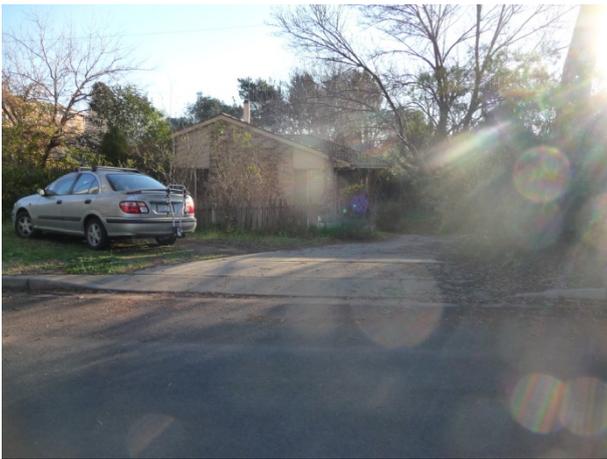
- Block 28 (27 William Street) – A 1980s brick veneer house with aluminium windows, and dual occupancy house of similar design to rear.
- Block 29 (29 William Street) – A 1980s brick veneer house with concrete roof tiles and aluminium windows.

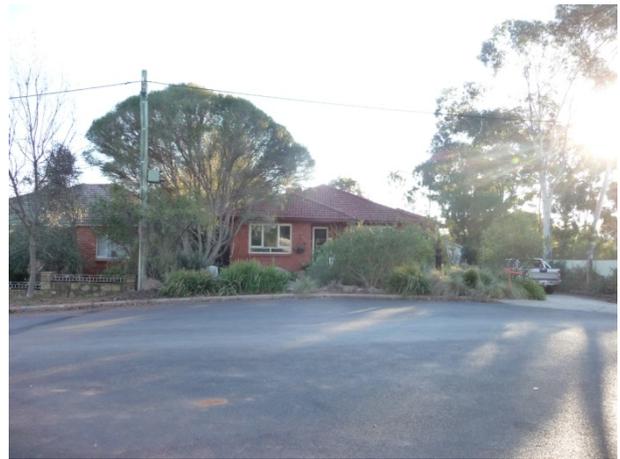
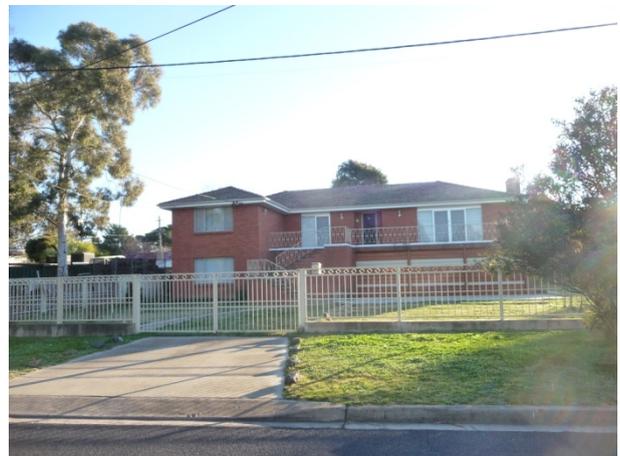
- Block 32 (35 William Street) – A 1960s brick veneer house with concrete tile roof and timber or PVC windows.
- Block 37 (13-15 William Street) – A two storey 1960s red brick house with terracotta tile roof, aluminium windows and a concrete terrace and a large metal shed.

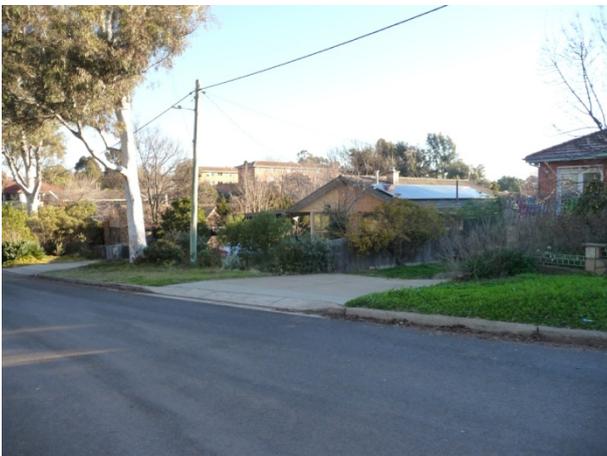
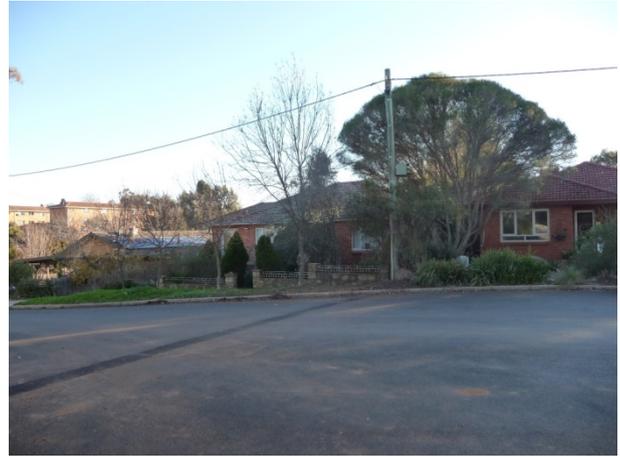
- Block 30 (31 William Street) – A 1970s brick veneer house with concrete tile roof, aluminium windows, skillion carport, and a metal shed at rear.
- Block 31 (33 William Street) – A 1950s brick house with terracotta tile roof, timber windows, stone facing to lower level and a garage underneath.

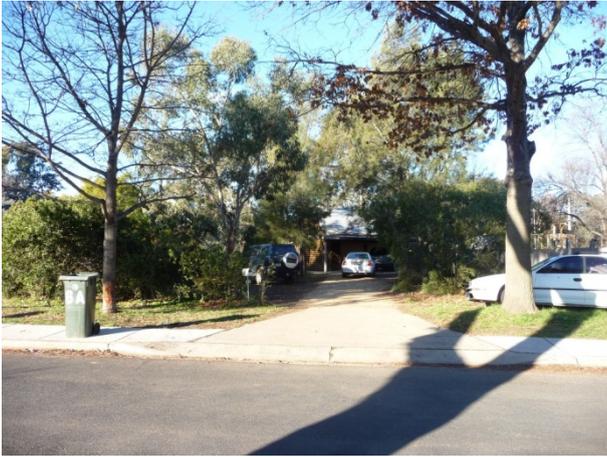
Figure 96 6a George Street - Block 38 Section 11 (ACT Heritage, 2014).

- 6a George Street (previously Block 2). A 1990s (the previous house was demolished in 1996) two storey weatherboard and red brick house, gabled Colorbond roof, set back on block, with a modern timber garage.

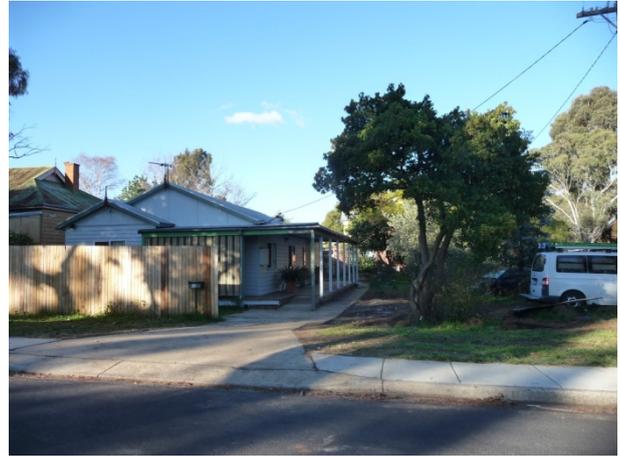
Figure 97 6b George Street - Block 38 Section 11 (ACT Heritage, 2014).

- 6b George Street (previously Block 3). A 1925 weatherboard cottage that has been extensively remodelled with new additions. The second house at the back of the block was put in after this time and sometime after the 1950s the house at the back was extended and raised to a second storey.

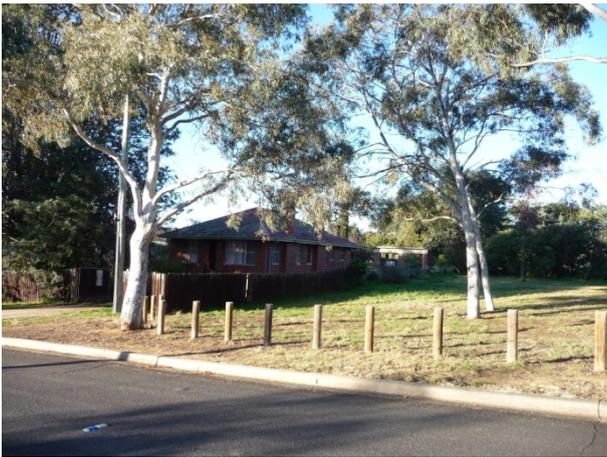
Figure 98 8 William Street - Block 20 Section 12 (ACT Heritage, 2014).

- **Section 12** is located between William Street and the Queanbeyan River. Section 12 is in historic Section L which was only developed at the northern and southern ends as the topography steeply slopes to the river the middle blocks would not have allowed much room for building:
 - Block 20 (8 William Street) – A 1950s house with Canberra Red brick veneer, timber windows, terracotta roof tile. Separate brick garage. c.1946-47 a weatherboard house was built followed in 1953 with a new house on the same block of a brick construction.
 - Block 21 (10 William Street) – A timber frame house at the rear of the block. Mature Cyprus trees likely predate current house.
 - Block 22 (12 William Street) – A timber frame weatherboard cottage at the rear of the block with corrugated iron roof and timber framed windows. A Colorbond garage is located at the front of the block.
